Thermal Imaging Survey

Date 6/3/2016

Inspection Report

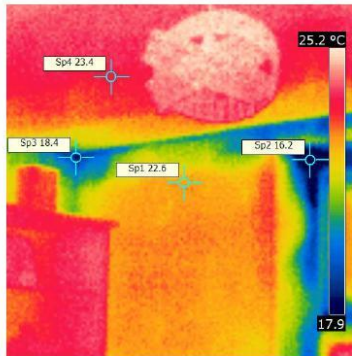
Dining room bay window. Considerable air leakage behind the dry lining, this is most likely coming from the roof of the bay window.

There was considerable air leakage behind the dry lining along the front wall adjacent to the bay window, this is likely to be air penetration from the bay window roof. This area around the window should be fully air sealed to prevent this kind of air infiltration. (See images 1,3 and 4).

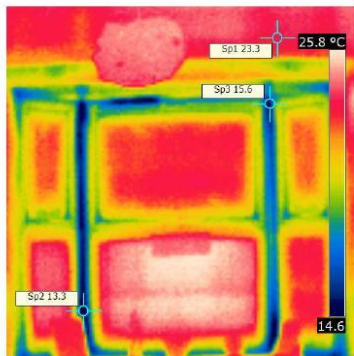
View of the bay window, there is considerable air leakage and cold evident around the window frame at the junction where the window returns into the house from the bay.

The front bay window itself has considerable air leakage and cold along the junction of the angled front and side panels. This junction has cladding on the external corner creating an uninsulated void with a poor seal along the internal joint. This void should be fully air sealed and there should be thermal insulation within this void to maintain the thermal integrity of the whole

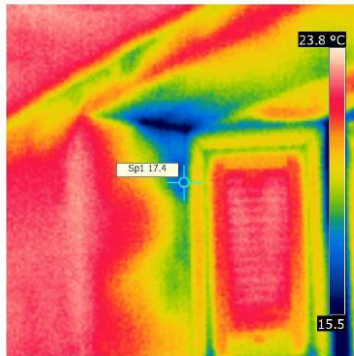
Another view of the bay window.

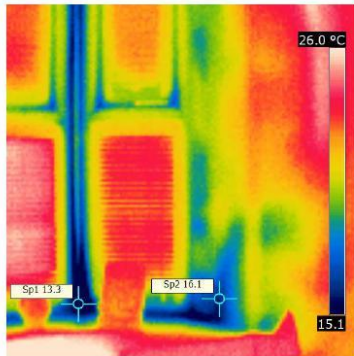
The bay window again, the bottom r/h corner shows significant heat loss in this area with cold air leaking behind the plasterboard dry lining.

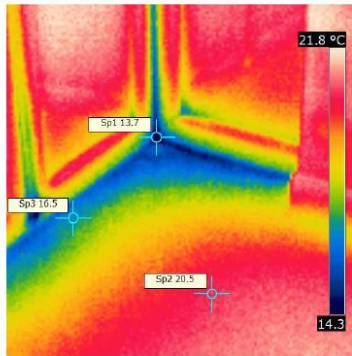
The rear bay window of the kitchen, this shows cold areas around the bottom of the window progressing into the kitchen, also air leakage on the window frame.

There is considerable cold evident on the floor adjacent to these windows indicating thermal bridging under the windows. There is also similar detailing, as seen in the front bay window, along the angled junction where there is air leakage. (See images 5 and 6 above).

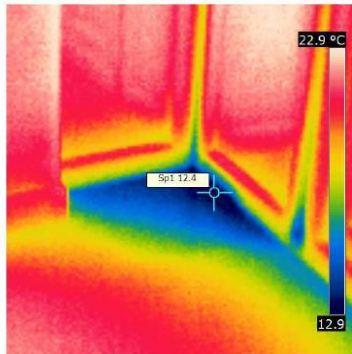
The opposite corner of the rear kitchen bay window. Again, significant cold in this area of the floor.

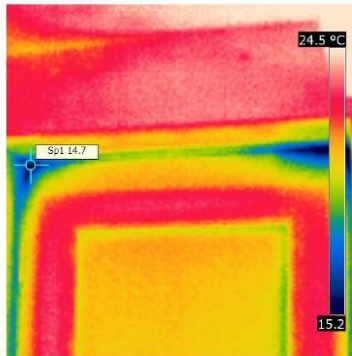
Back door to the utility room, air leakage/ draughts around the door frame.

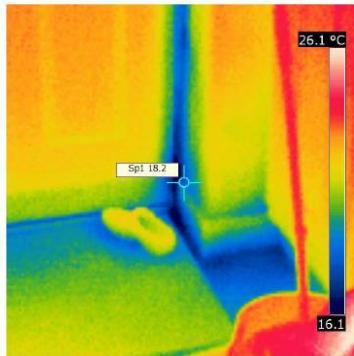
Draughts around the bottom of the back door.

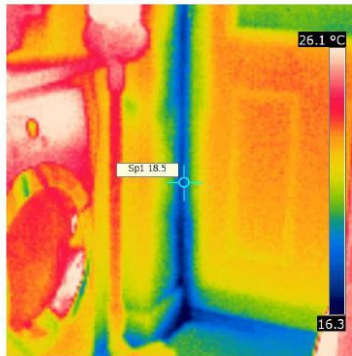
The hinge side of the back door showing air leakage/ draughts.

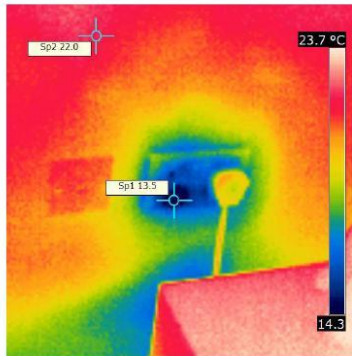
This is the socket to the right of the front dining room bay window, there was a significant draught coming from this socket outlet.

Draughts were seen flowing from many of the sockets, image 10 above shows the socket adjacent to the right hand side of the front bay window. The dry lining may be fully fire sealed all around each board to improve the integrity of the lining to prevent air movement through the cavity. (See BS8212:1995 Code of practice for dry lining and partitioning using gypsum plasterboard: Section 3.11). This sealing is essential to maximise the thermal integrity of the lining. Air leakage behind the plasterboard and through sockets is an indication that the boards have not been adequately sealed as per best practice.

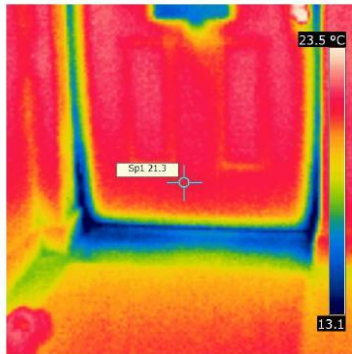
The front door, there was a significant draught around the bottom of the door.

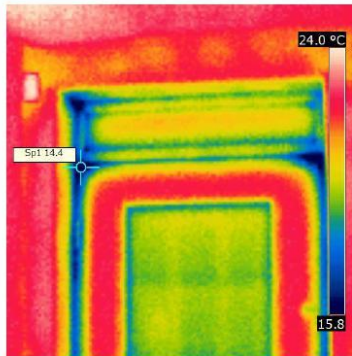
The top of the front door, again, significant draughts in the corners of the frame.

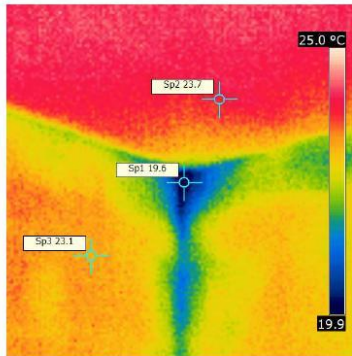
Left hand corner of the study showing some air leakage behind the dry lining causing cooling of the wall.

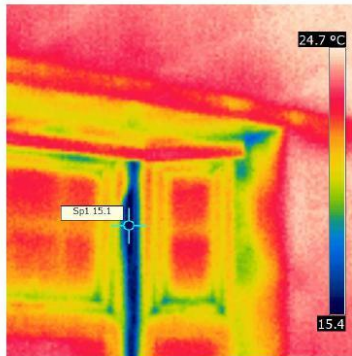
Lounge bay window showing the same cold along the angled corner as seen in the dining room.

The living room has a similar bay window to that seen in the dining room, the same issues were identified on and around this window construction. (see images 14, 15 and 16 above). In addition the bay window ceiling was cold indicating missing or poorly installed insulation. (See image 16).

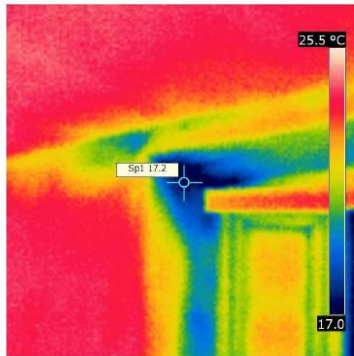
Top left hand corner of the lounge bay window showing significant air leakage behind the dry lining, likely coming from the bay window roof.

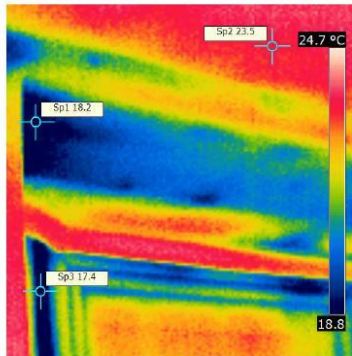
Ceiling of the lounge bay window, this shows poor or missing insulation above the ceiling with likely air leakage around/ under the insulation.

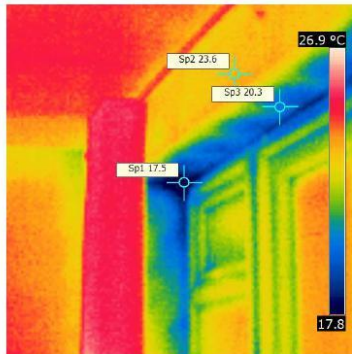
Lounge patio doors, left hand corner. There is significant thermal bridging around the aperture and some air leakage behind the dry lining.

The living room patio door showed signs of thermal bridging and air leakage behind the dry lining along the top of the window aperture. (See image 17).

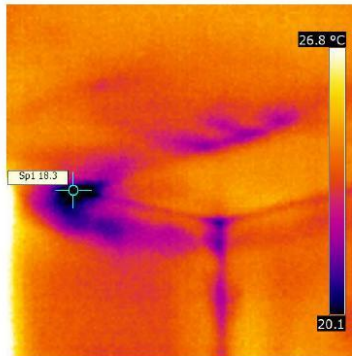
External corner of bedroom 3 showing air leakage behind the dry lining and missing insulation.

- 1) The external corner of bedroom 3 had a significant cold spot behind the top of the dry lining and above the ceiling (see image 18) which indicates air leakage from the eaves into the roof void and behind the dry lining and across the ceiling.

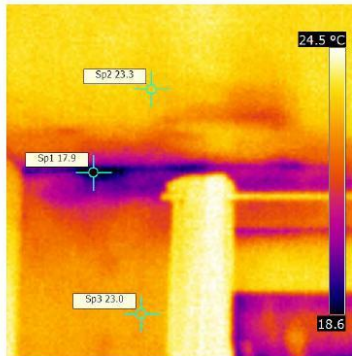
Bedroom 1 external corner adjacent to the ensuit bathroom, air leakage behind the dry lining and air flow above the ceiling.

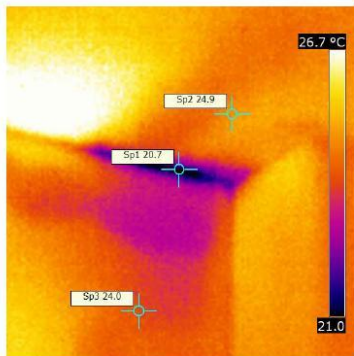
External l/h corner of bedroom 1, air leakage above the ceiling.

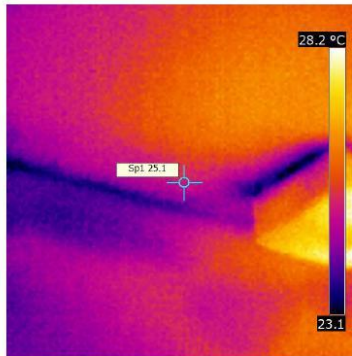
Bedroom 1 ensuit bathroom, air leakage around the extractor fan, above the ceiling.

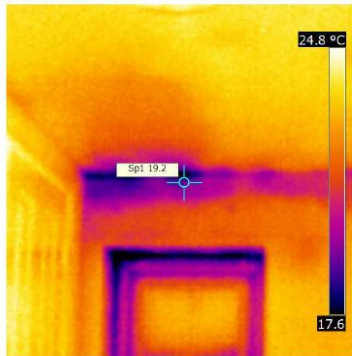
Bedroom 1 ensuit bathroom above the window, air leakage onto the ceiling above and behind the dry lining.

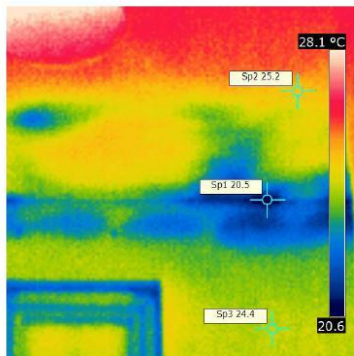
Bathroom, air leakage above the ceiling and behind the dry lining.

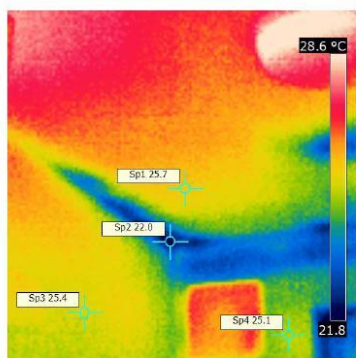
Bathroom l/h corner, air leakage above ceiling and behind dry lining.

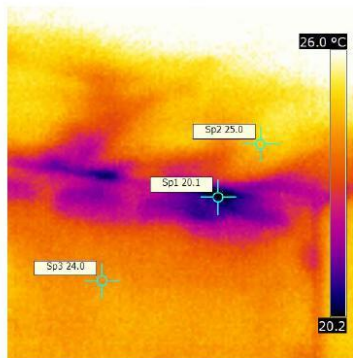
Right hand corner of bedroom 5, significant air leakage behind the dry lining and air flow above the ceiling from the roof eaves.

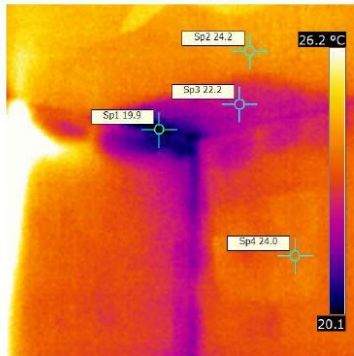
External corner of bedroom 5, again significant air leakage behind dry lining and air flow above ceiling.

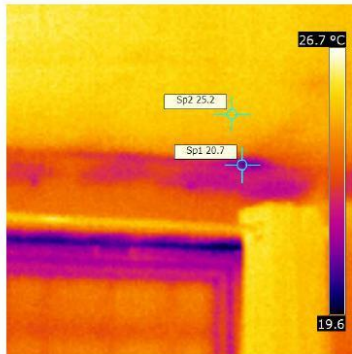
Bedroom 5 above the window, air leakage behind dry lining.

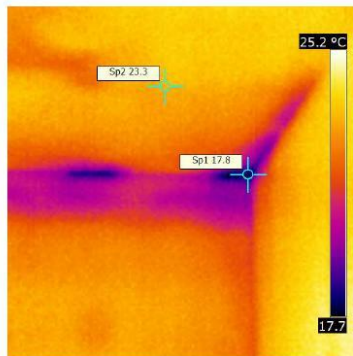
Bedroom 4 right hand corner, air leakage behind the dry lining and air flow over the ceiling.

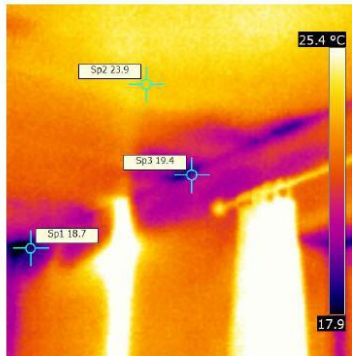
Bedroom 4, significant air leakage behind dry lining and and air flow over ceiling.

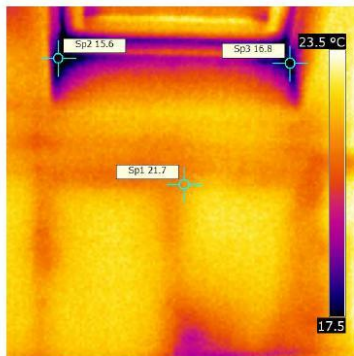
Top floor landing, bottom of the roof light window, there is air leakage behind the plasterboard in the bottom corners of the window aperture.

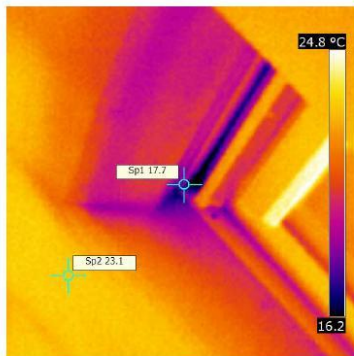
Top of the landing roof light with air leakage from the window.

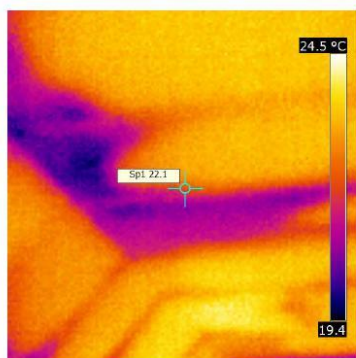
Landing ceiling showing poorly installed/ missing insulation.

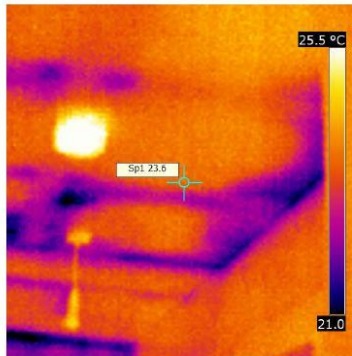
Landing ceiling again showing poorly installed and missing insulation.

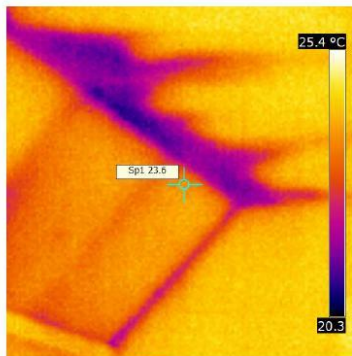
Bedroom 2, again poorly installed and missing insulation.

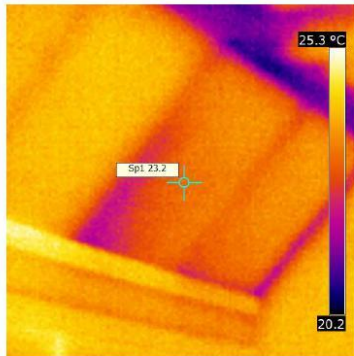
Bedroom 2 again, air leakage behind the plasterboard ceiling.

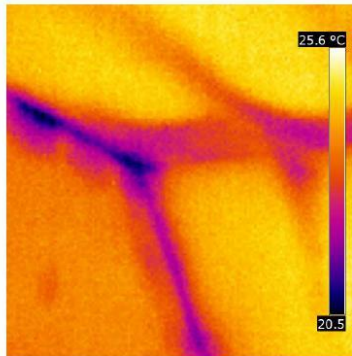
Bedroom 2, poor insulation and air leakage behind dry lining on gable end wall.

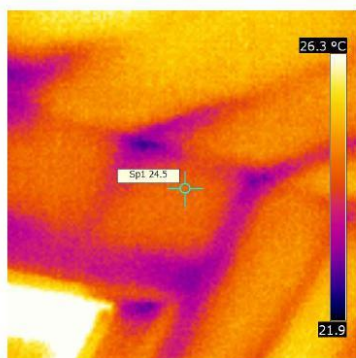
Bedroom 2, air leakage around roof joists and rafters, poorly installed insulation.

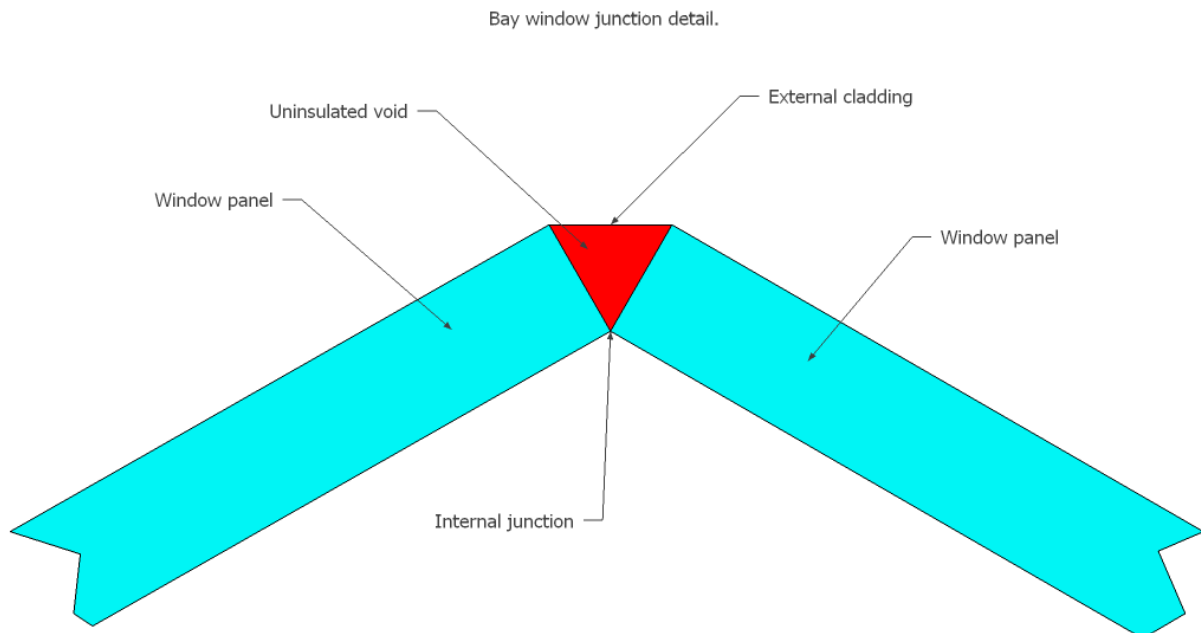
window. (See detail below and images 2 and 4 above).

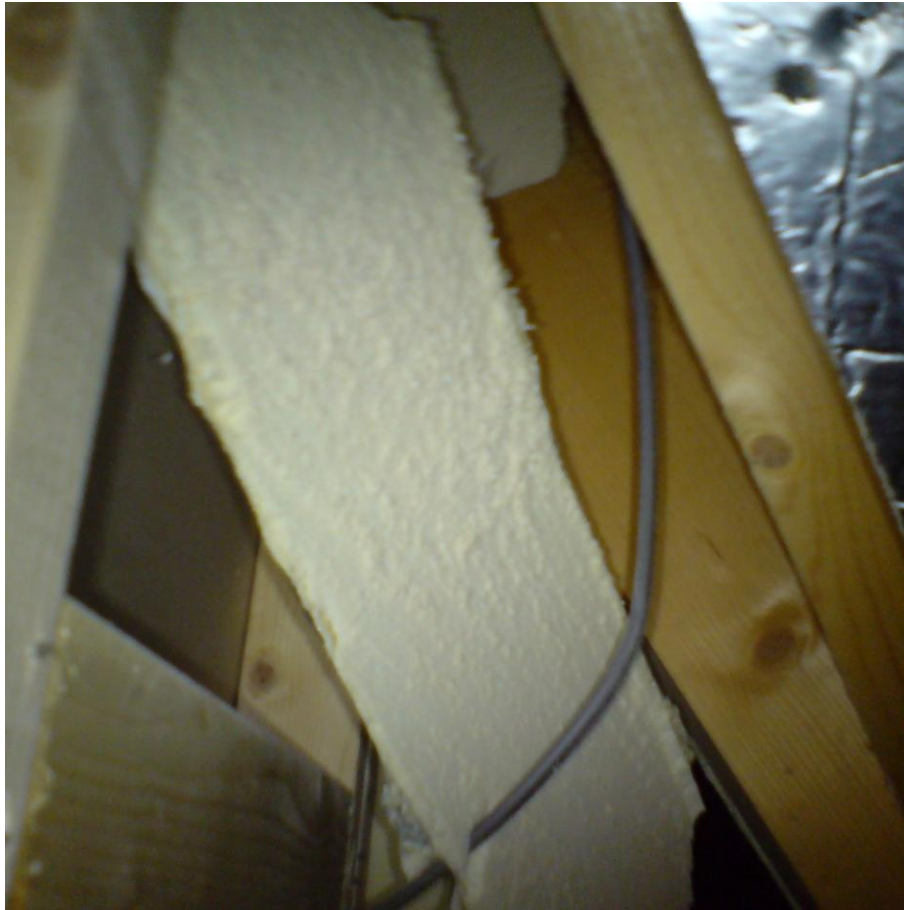
The roof void has been insulated between the rafters, its integrity and position between the rafters is solely reliant on the insulation remaining in place on its own. It has not been fixed in any way and is liable to fall out of its position due to natural expansion of the building due to atmospheric temperature variation. I have seen, in similar cases, all the insulation fall out of position and become totally ineffective.

With the insulation on the outside of the roof void, this space should be treated as heated internal space, which it has not. The roof void should be fully air sealed, for insulation installed in this way, to be effective and should be within the air seal line of the building when an air test is carried out. There was a significant draught within the roof void and several areas were seen to be fully open to external air movement, with free air flowing through the roof void the insulation is bypassed and ineffective.

The photograph above shows a piece of the rafter insulation that has actually fallen out of position, it is actually being prevented from fully falling out by an electrical cable which is supporting it! Above this piece of insulation is the underside of the roofing felt allowing free external air to flow into the roof void.

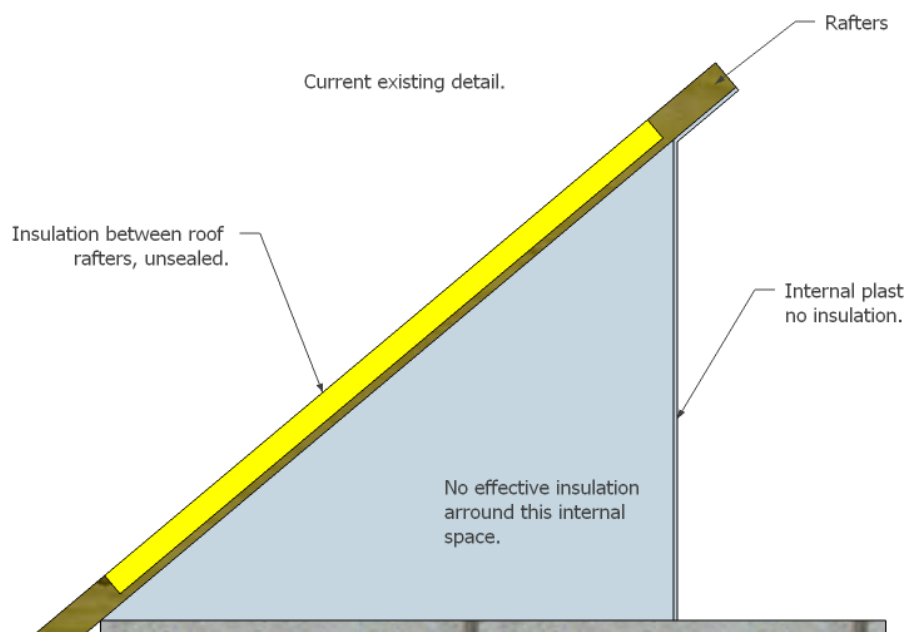
The detail drawing above shows a basic version of the insulation detailing within the roof void. Free flowing external air is passing through and around the current insulation effectively making the 12.5mm plasterboard internal knee wall the only effective thermal resistance for the walls of the top floor. The roof does need to be ventilated but this is generally a 50mm air gap between the top of the insulation and the underside of the roofing felt, not within the roof void itself.

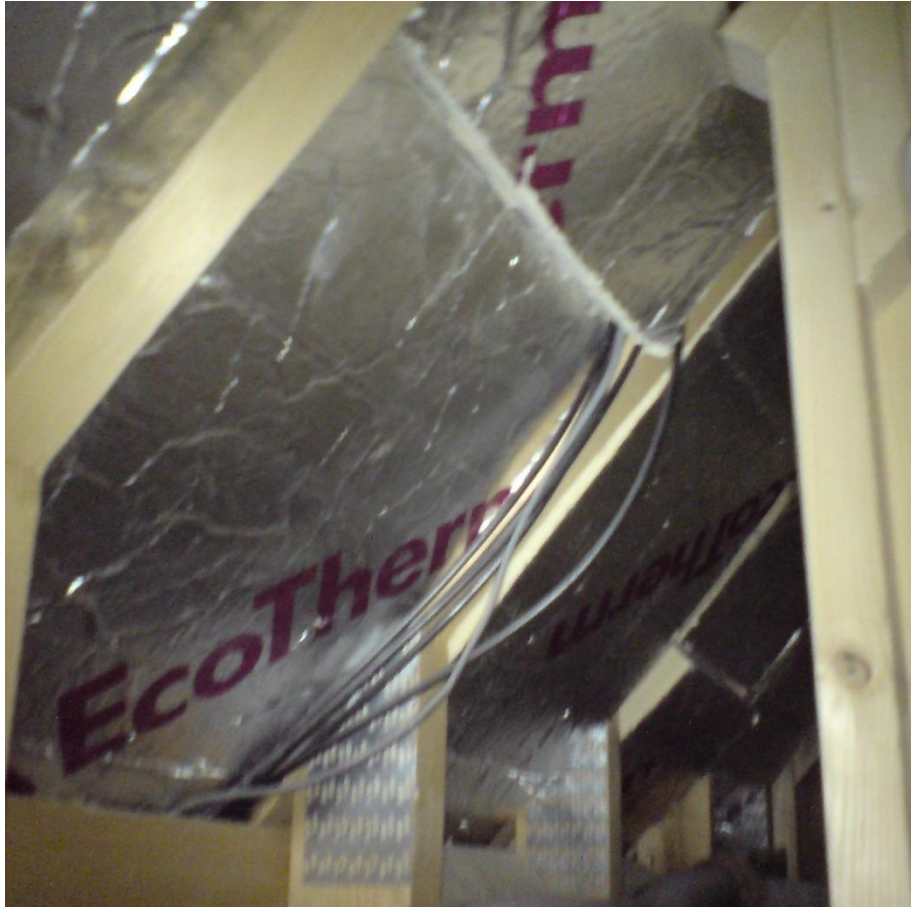
This photograph shows clearly that the insulation has not been fixed in any way within the rafters, some of the insulation can be seen to have moved, none of the joints have been sealed or taped to prevent air flow around them. Cables can be seen threaded through an open joint.

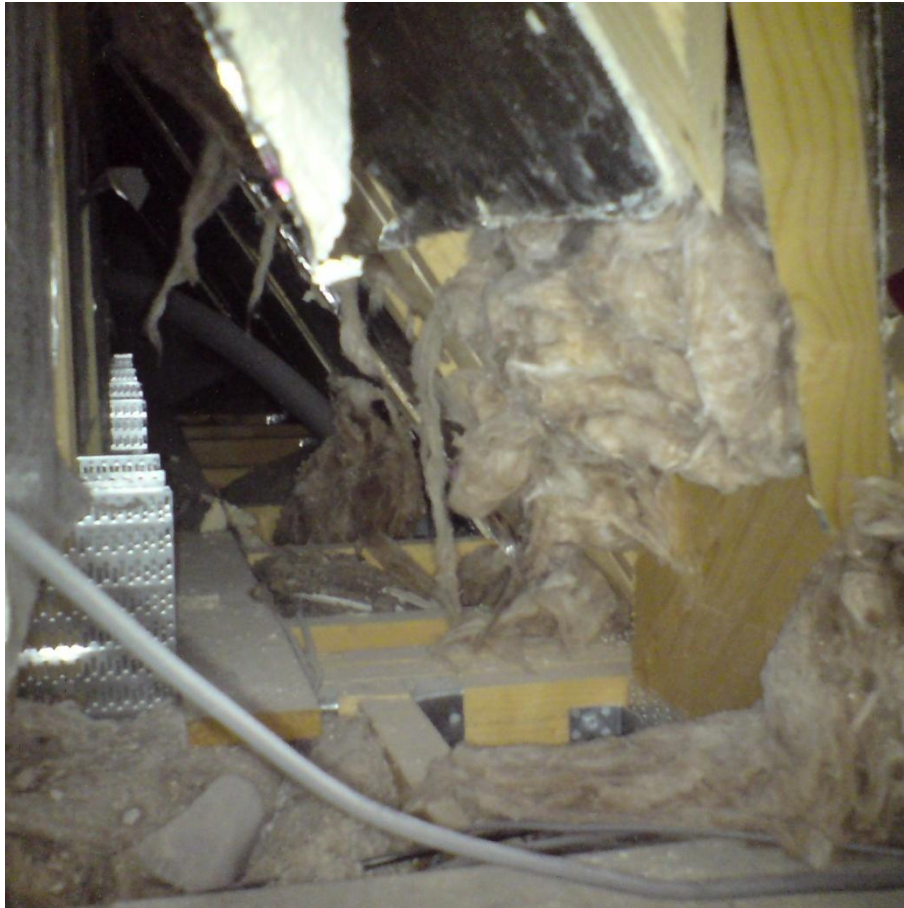
This photograph shows insulation falling out of position, fibre glass insulation has been stuffed into some of the gaps between the solid insulation board, it is poorly installed and likely to fall out over time and looks like a 'bodge job', not what you would expect to see produced by a professional builder.

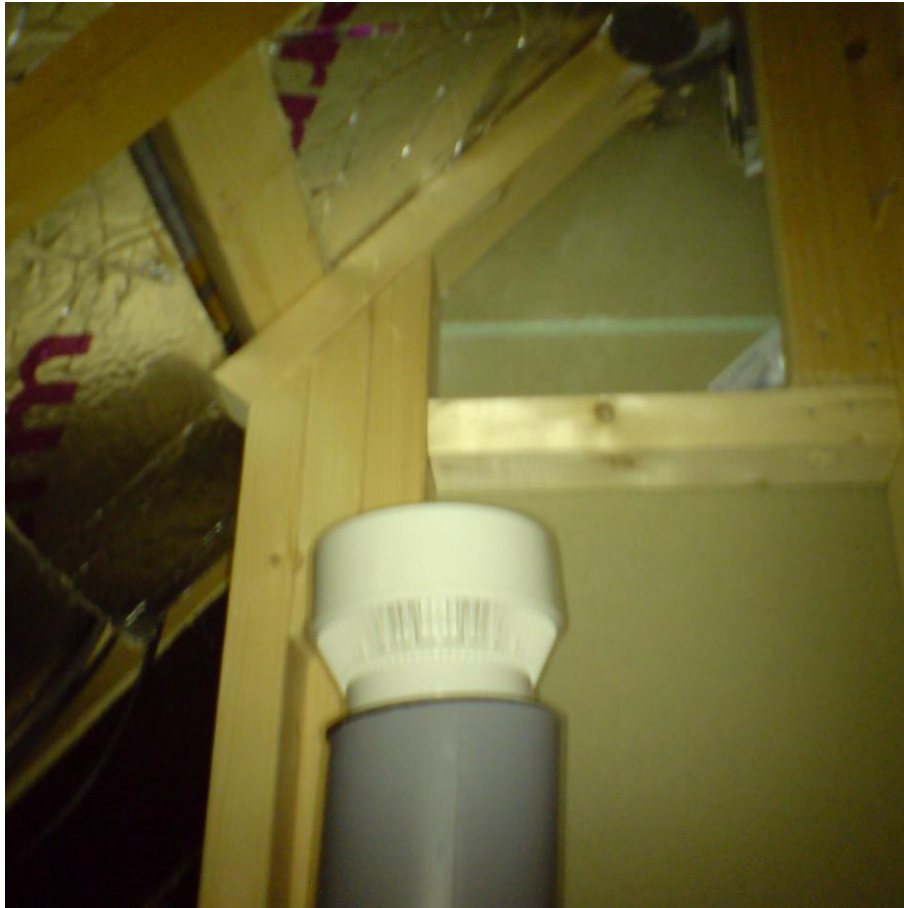
The photograph below shows the top of the soil pipe with the air admittance valve, this valve should have an insulating cap fitted. It also shows a gap in the insulation and the roofing felt can be seen above, this gap will allow free flowing external air to enter the roof void, it will also allow heat to escape through the roof.

The studwork of the knee wall is clearly visible with the single skin of the 12.5mm plasterboard fixed to the inside, this is the only effective thermal resistance for the walls between internal heated space and external air flow. The EPC states that the average thermal transmittance of the walls is $0.25\text{W/m}^2\text{k}$ and is given a 5 star rating, the thermal transmittance of 12.5mm of plasterboard alone is $4.9\text{W/m}^2\text{k}$ which is well below building regulations of $0.35\text{W/m}^2\text{k}$.

Within the roof void air will also be able to flow freely underneath the floor of the loft rooms because there is no insulation between the 1st floor ceilings and the flooring, this will draw heat out of these rooms.
