Thermal imaging report for;

The building is a traditionally built 2 storey detached house built in 2016.

Sustainable Lifestyles Ltd were commissioned to carry out a thermal imaging survey of the property in response to concerns raised by the owner, [client name] with regards to cold areas of the house indicative of defective construction. We undertook thermography and air tightness testing, to identify air paths, location of air leakages and cold areas indicating possible missing, limited or poorly installed insulation and other potential issues such as damp.

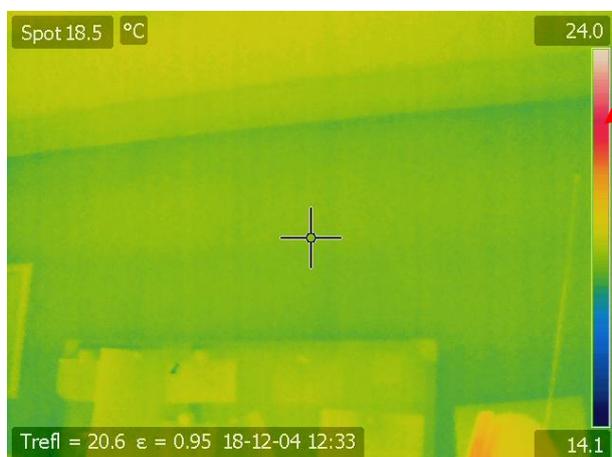
Temperature span 14.1 - 24°C

Image 1 - this is an image of a top floor bedroom wall, there are no anomalies and the temperature and colour variation is small with a relatively uniform colour across the image. This is what you would expect to see in a well-sealed and insulated house with no defects. The house was built in the early 1960's and would probably have an EPC rating of D or C.

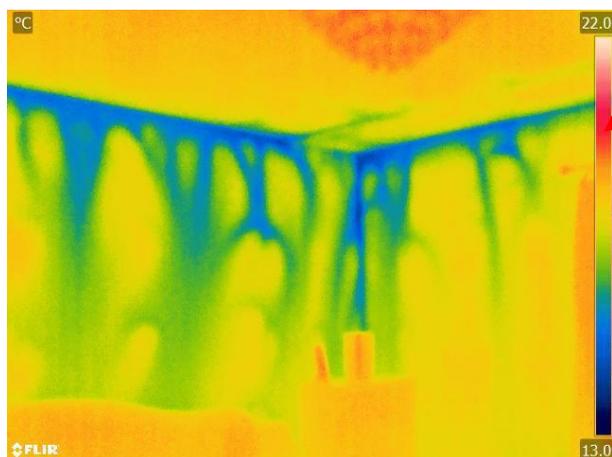
Temperature span 13 - 22°C

Image 2 – this is a similar image of a top floor bedroom wall under similar conditions. Clearly seen is a significant temperature variation and a lot of colour. This is indicative of defective construction and would not be expected in a new modern, energy efficient house. This house was built in around 2017 with an EPC rating of B.

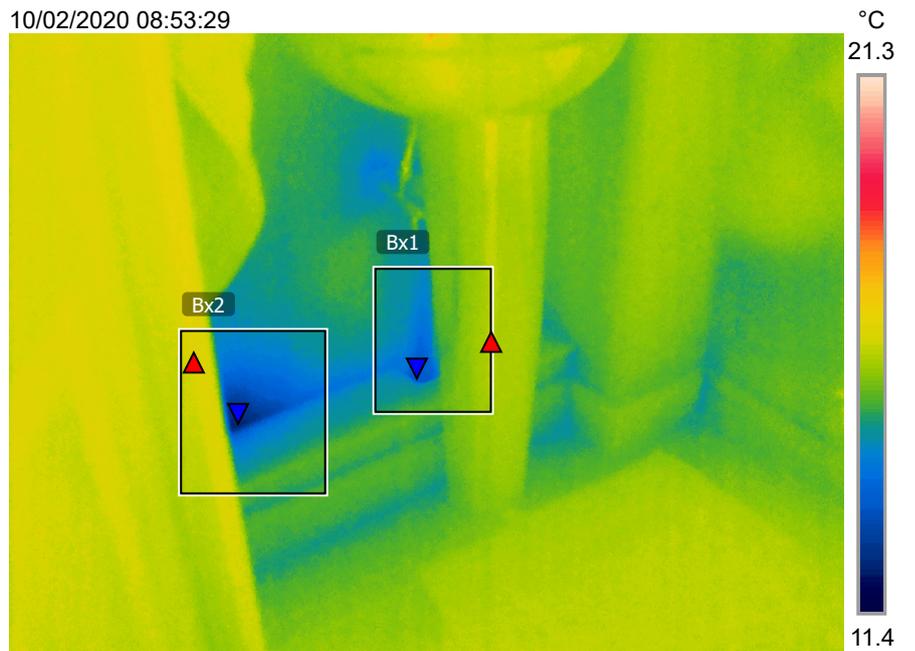
Ground floor W/C showing draughts flowing from the service boxing along the skirting below the sink and a cold area just above the boxing.

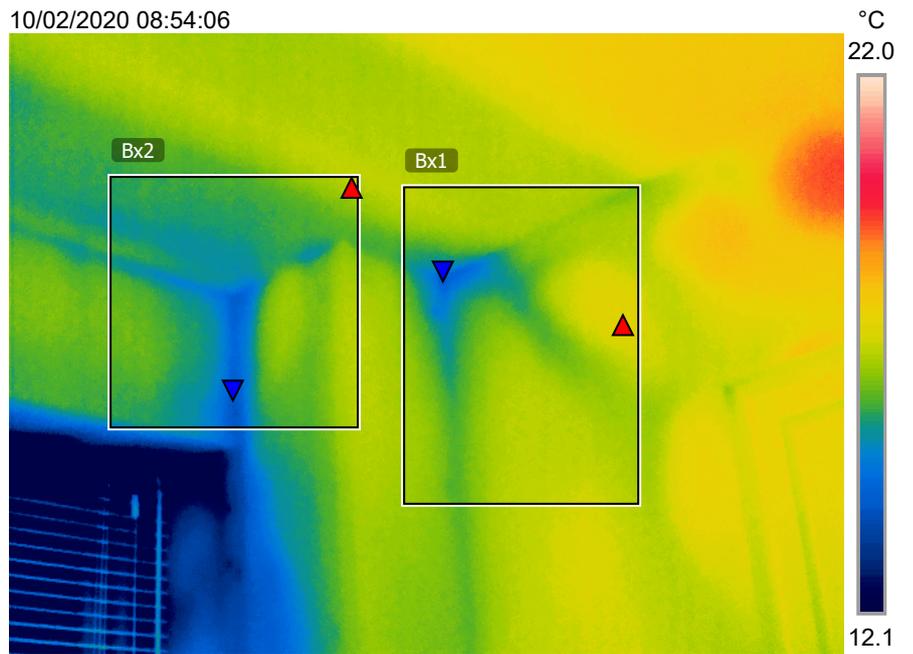
Ground floor W/C showing the top of the soil vent pipe (SVP) boxing and indications of air flow behind the dry lining coming from behind the boxing.

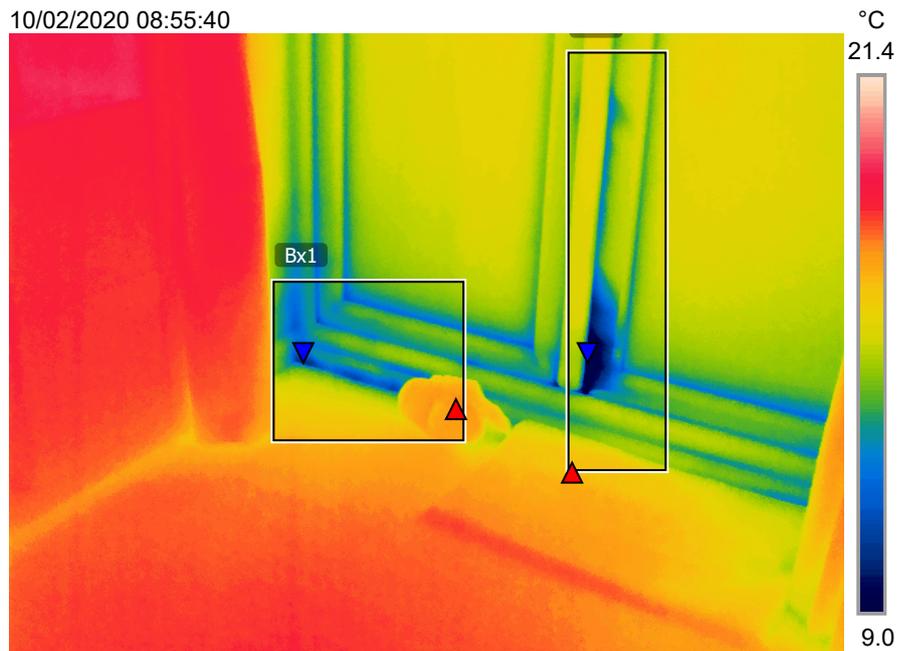
Living room patio doors showing draughts flowing from under the door frame along the bottom and through the seal between the doors.

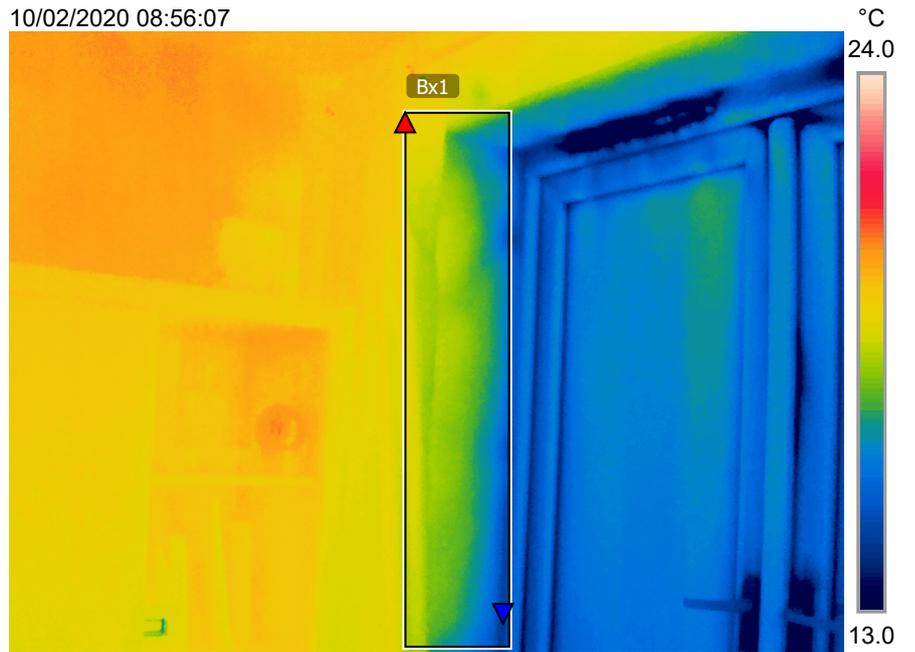
Living room patio doors showing indications of air infiltration behind the plasterboard of the reveals.

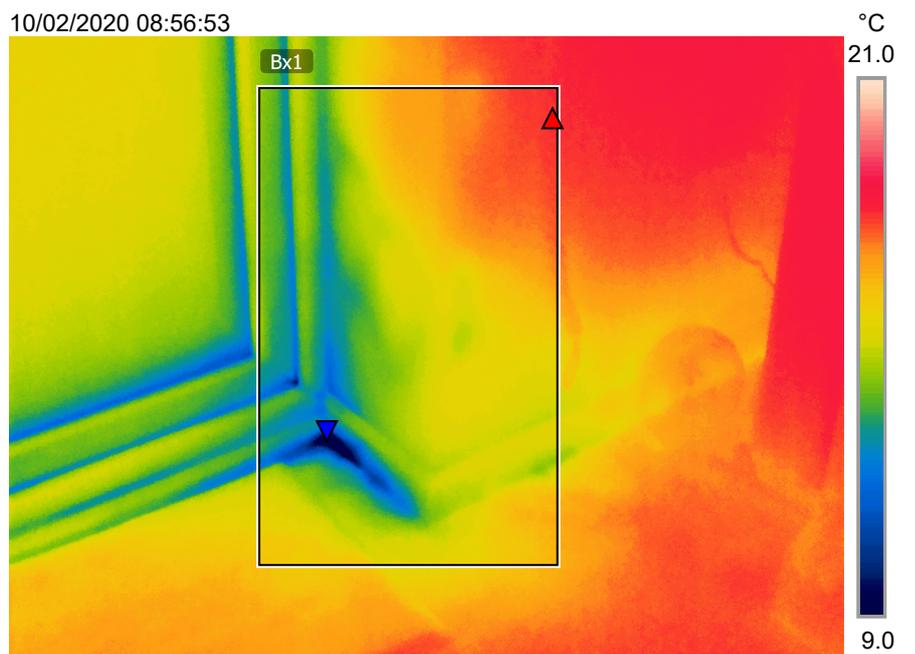
Living room patio doors again showing similar draughts from the skirting of the reveal and air infiltration behind the plasterboard of the reveal.

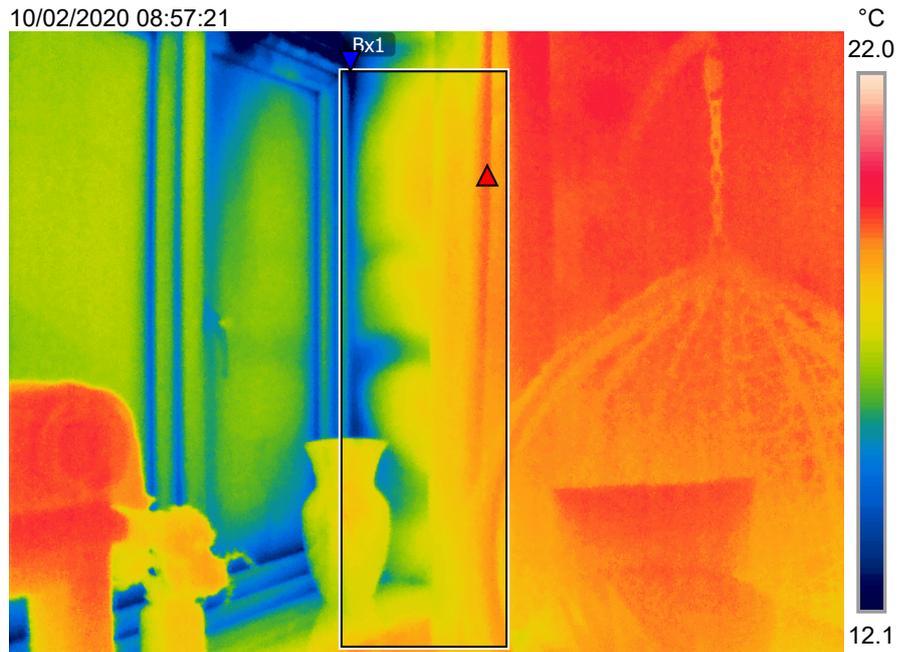
Living room window showing air flow behind the dry lining of the reveal where it has not been fully sealed.

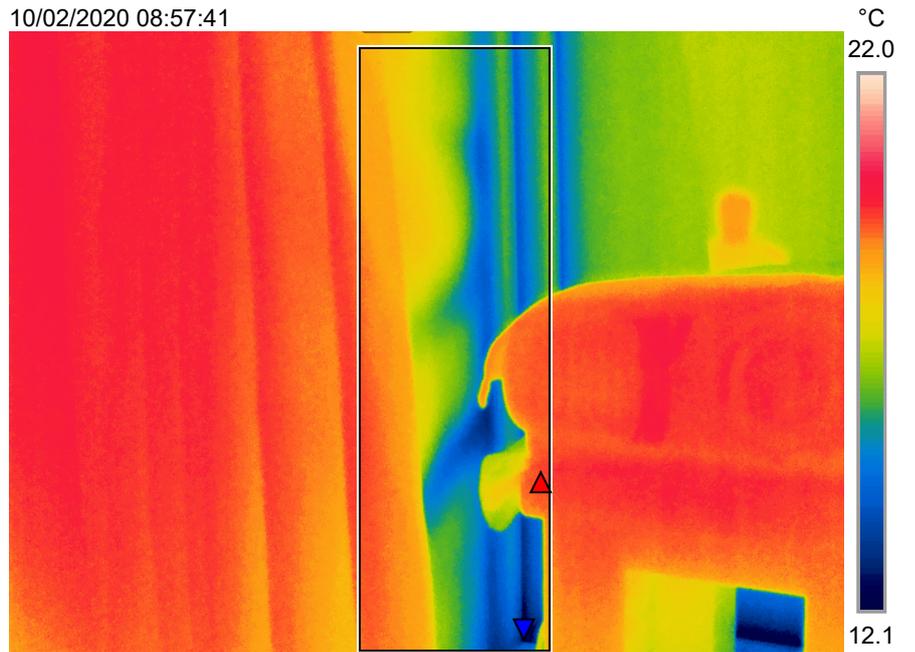
The opposite side of the living room window showing similar air flow behind the plasterboard of the reveal.

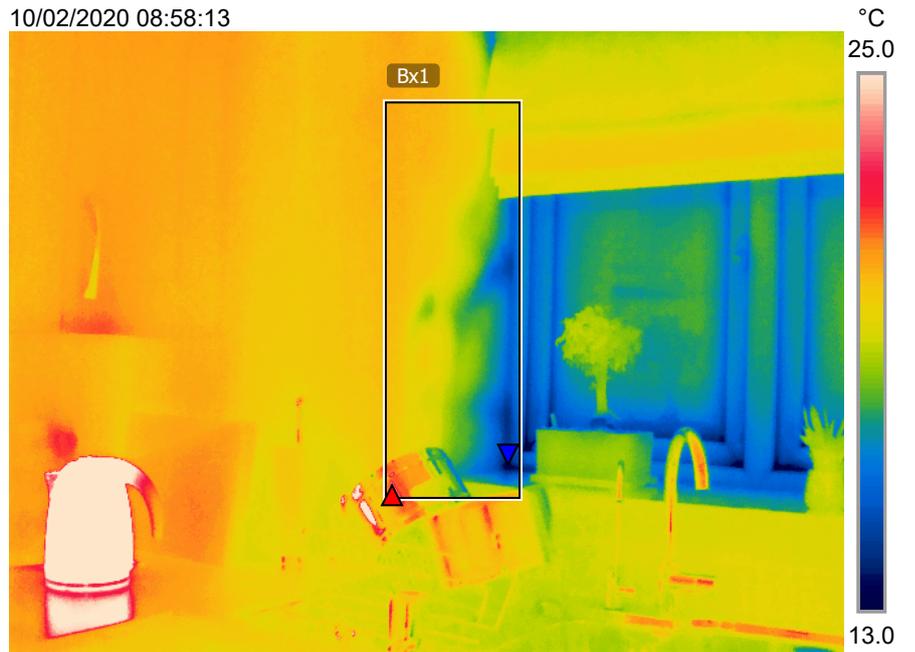
Kitchen window showing air flow behind the dry lining of the reveal and flowing into the wall adjacent.

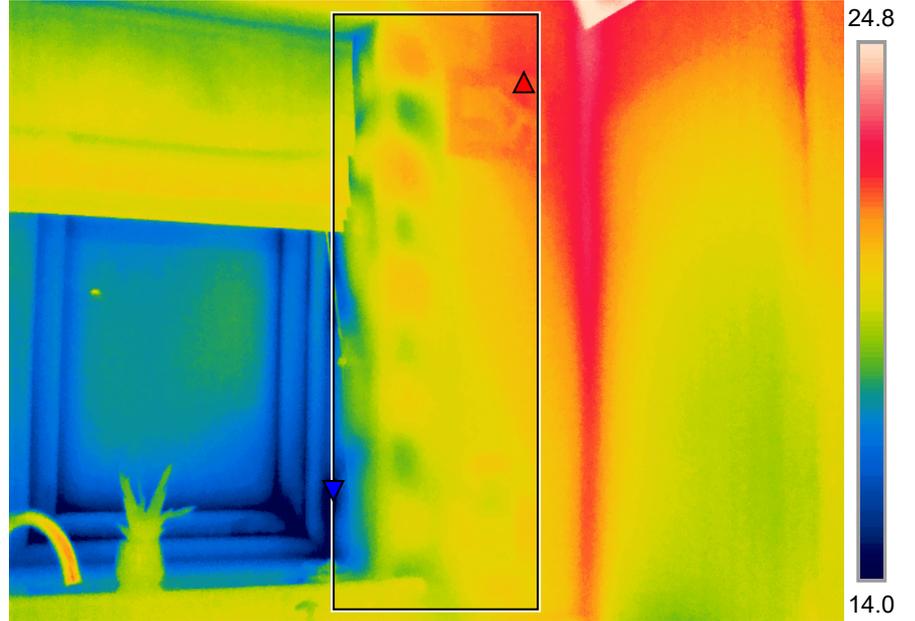
The other side of the kitchen window showing air flow behind the dry lining of the reveal and the adjacent wall.

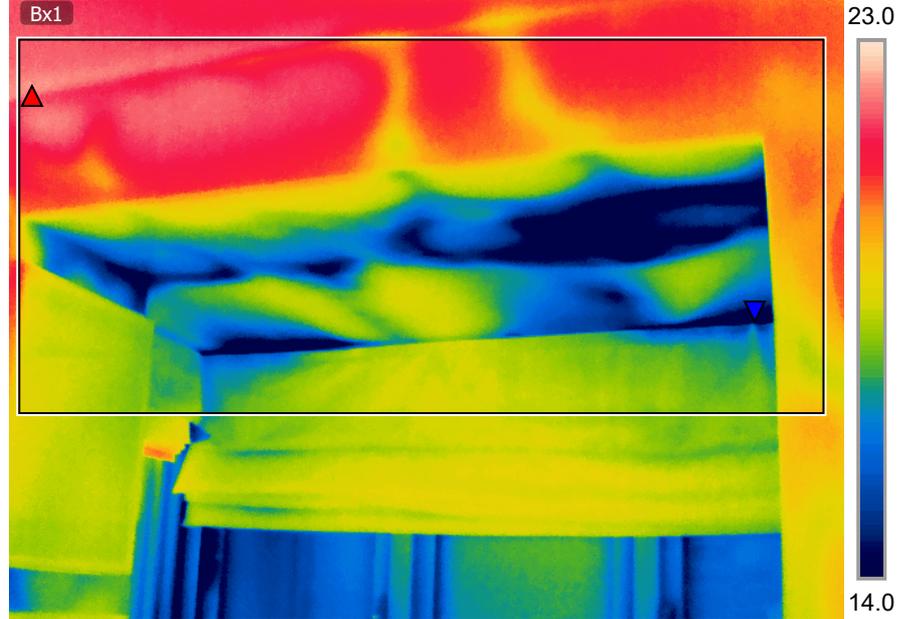
Kitchen bay window ceiling showing missing or ineffective insulation in the roof above and lack of sealing. There is considerable air flow above the ceiling and flowing into the wall above the bay behind the dry lining.

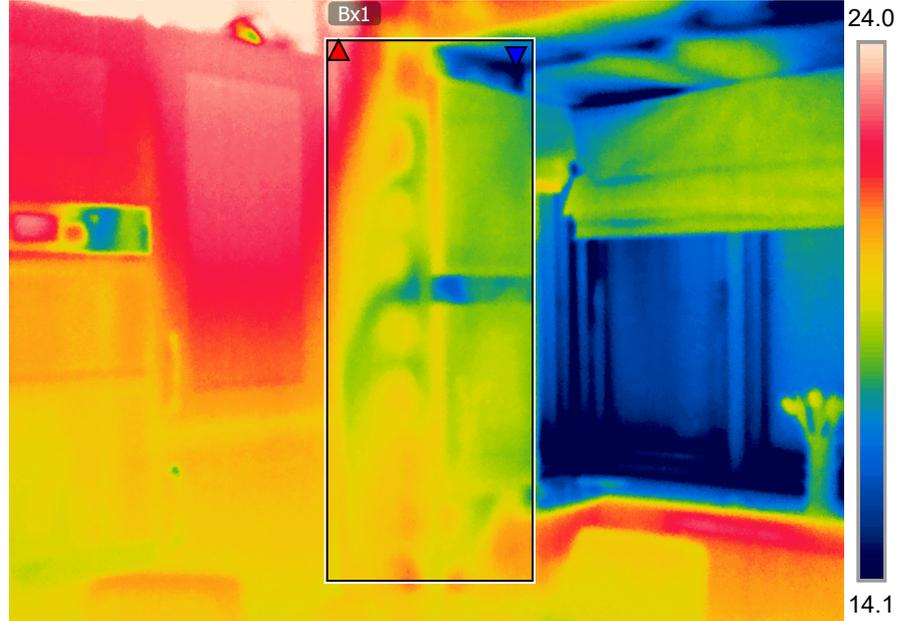
Air flow behind the dry lining of the window reveal and flowing into the adjacent wall.

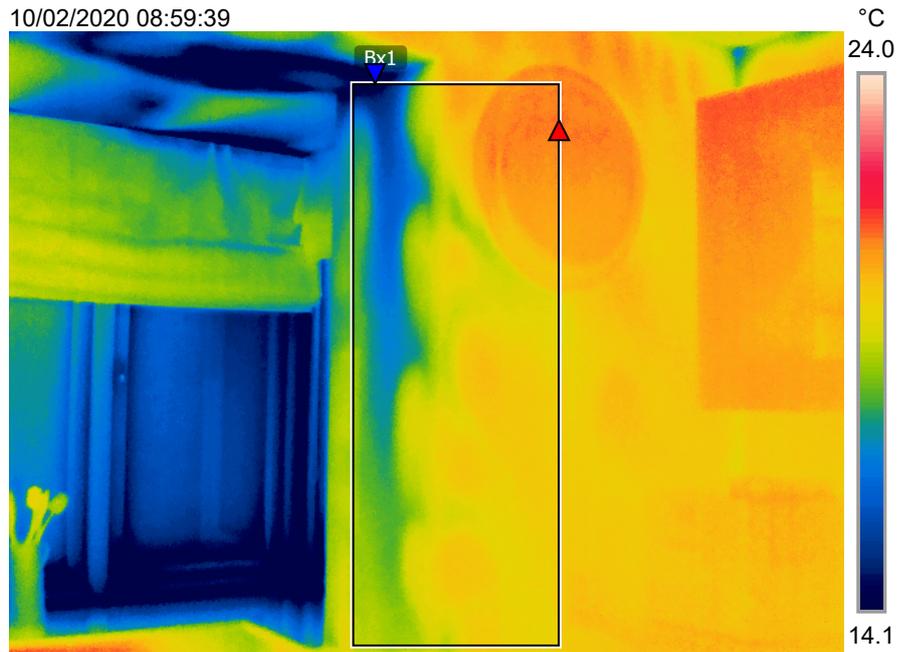
The other side of the bay reveal showing similar air flow behind the dry lining and into the adjacent wall.

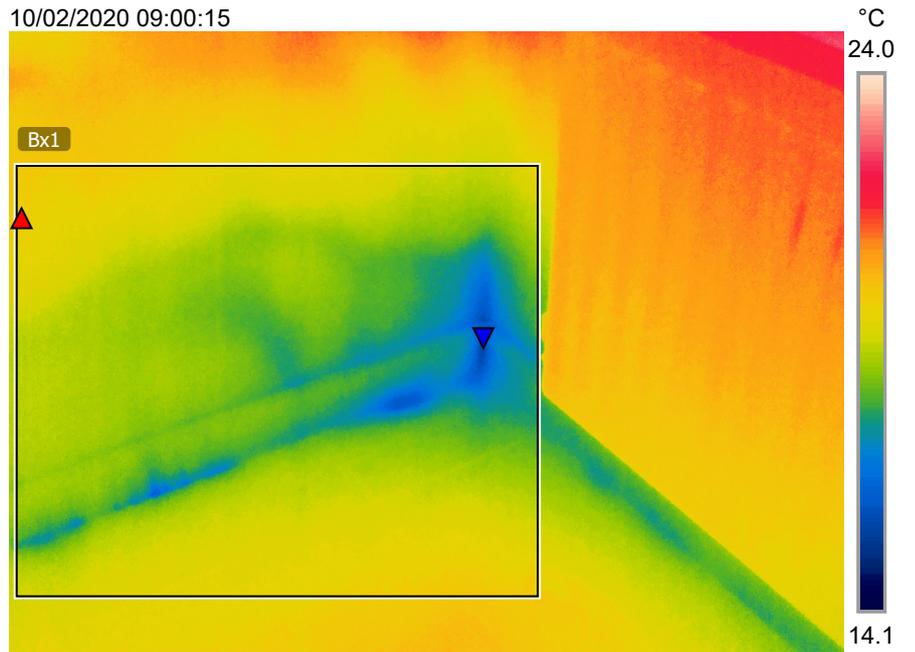
Bottom of the bay window side wall showing draughts flowing from under the skirting and behind the dry lining above. It is likely this air flow is coming from under the block and beam floor.

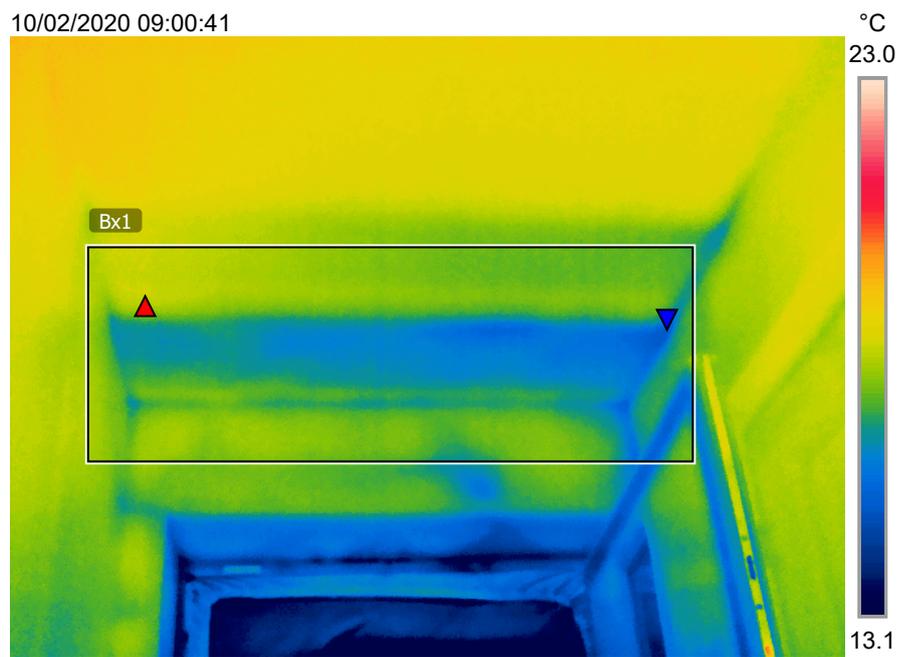
Cold area across the ceiling above the front door. This indicates air flow within the void between the joists above and could be flowing from the SVP boxing of the ground floor W/C. This requires further investigation.

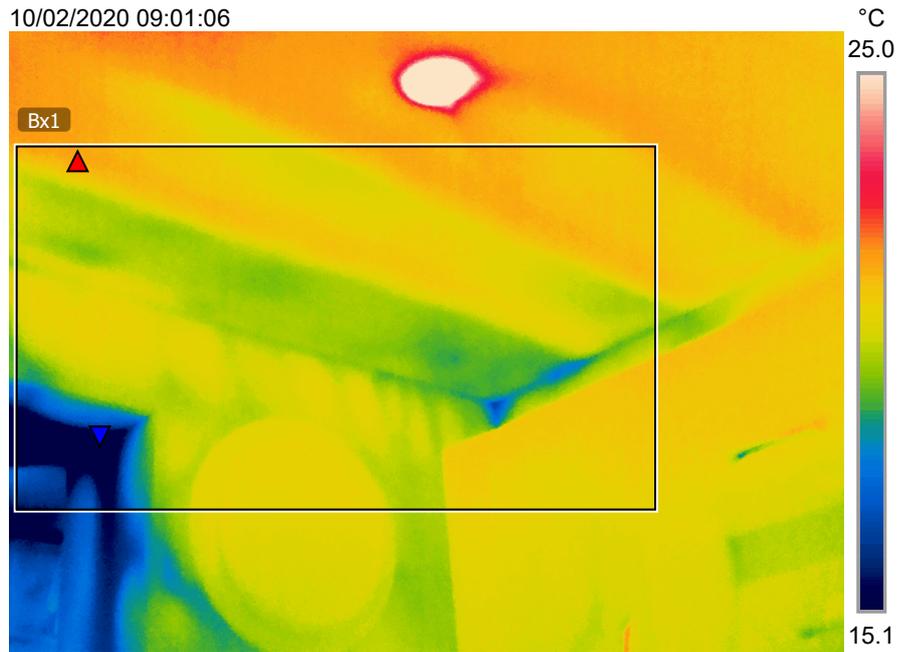
This is the ceiling adjacent to the bay window area and shows the air flow identified above the front door continuing across the kitchen ceiling. Note the indication of individual adhesive dabs along the top of the wall where there should be a continuous seal of adhesive.

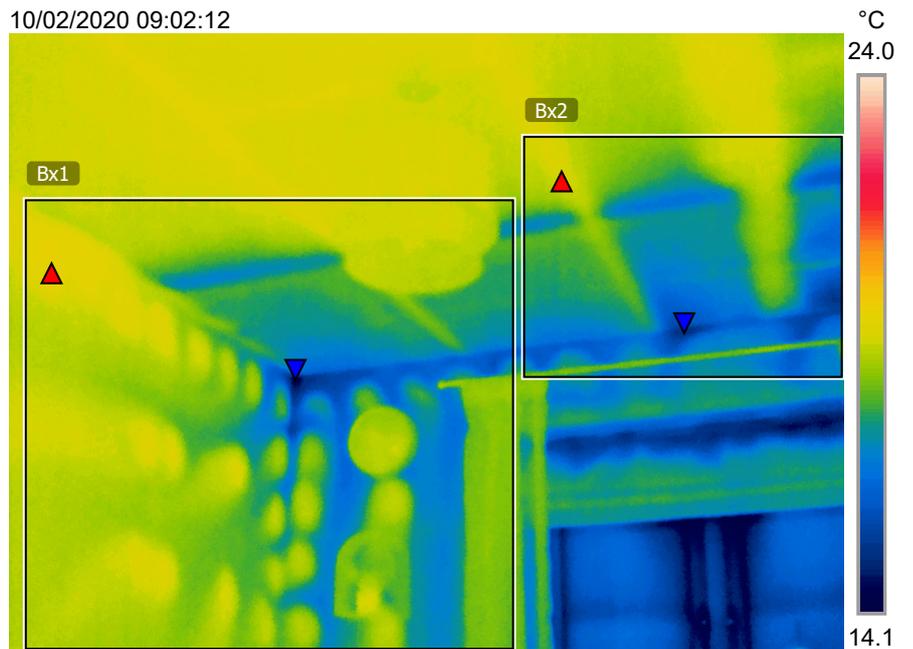
Rear R/H bedroom showing significant air flow behind the dry lining on the walls with individual adhesive dabs clearly shown. The ceiling along the rear of the bedroom shows missing, limited or poorly installed insulation above within the roof void of the top floor.

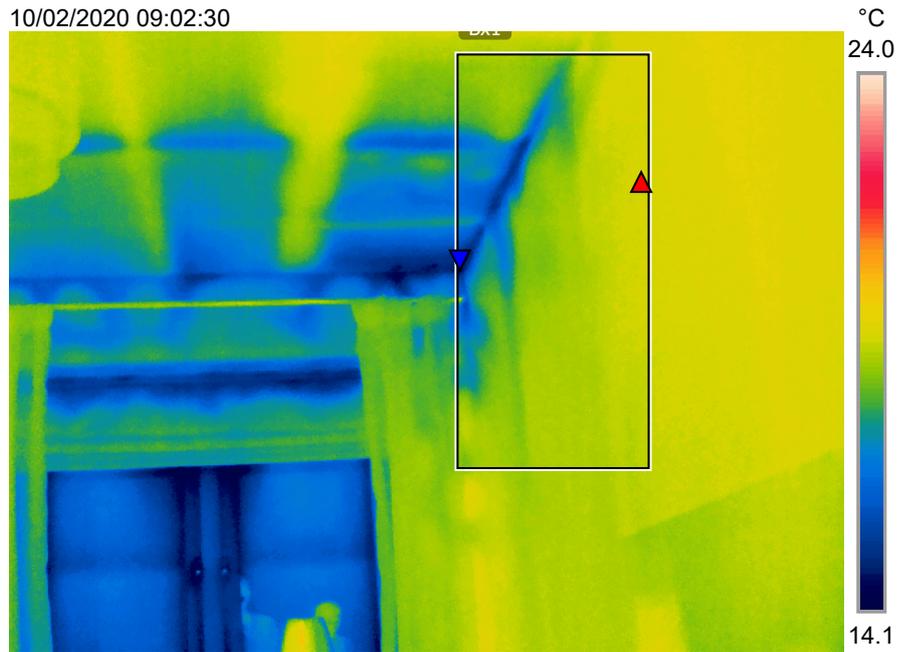
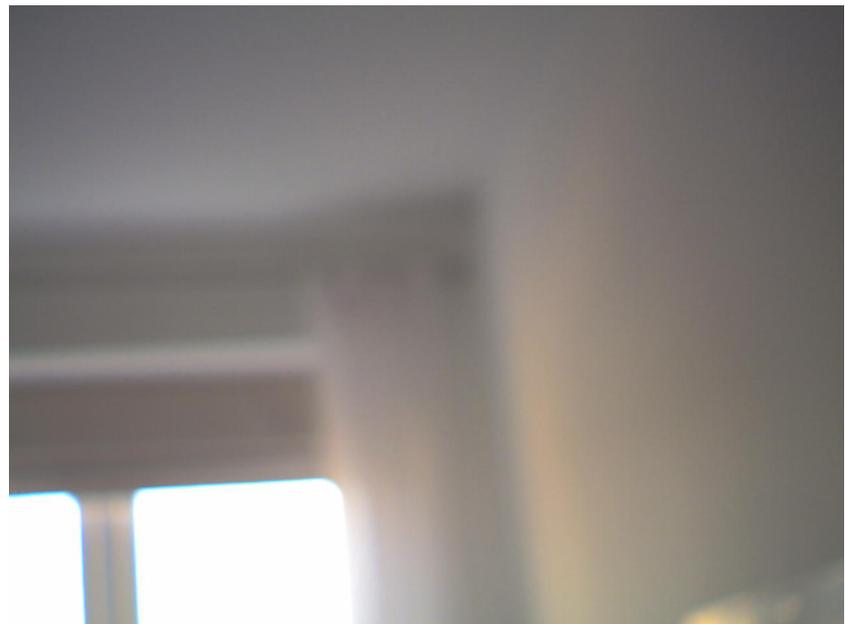
Rear R/H bedroom again showing air infiltration into the internal stud wall and again, missing insulation above the ceiling.

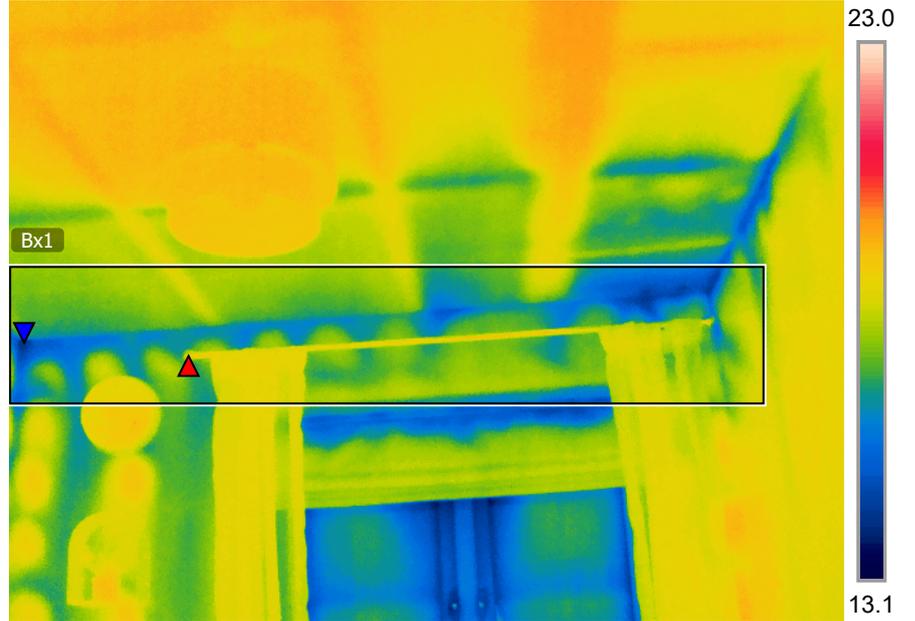
Over voev of the rear R/H bedroom clearly showing individual adhesive dabs along the top of the wall.

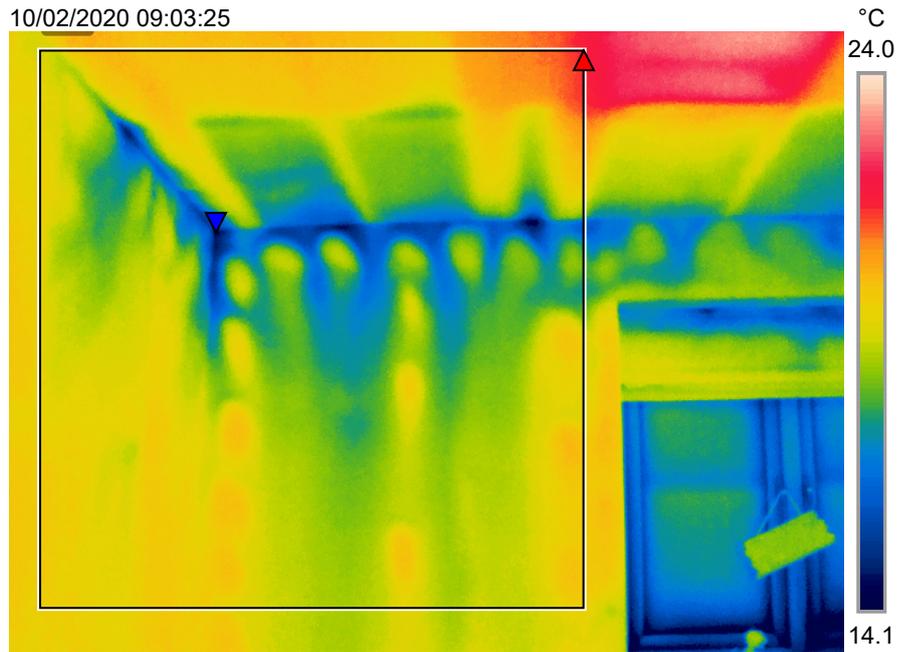
Rear L/H bedroom showing air infiltration behind the dry lining and individual adhesiver dabs. Again there is air infiltration into the internal stud wall and missing, limited or poorly installed insulation above the ceiling.

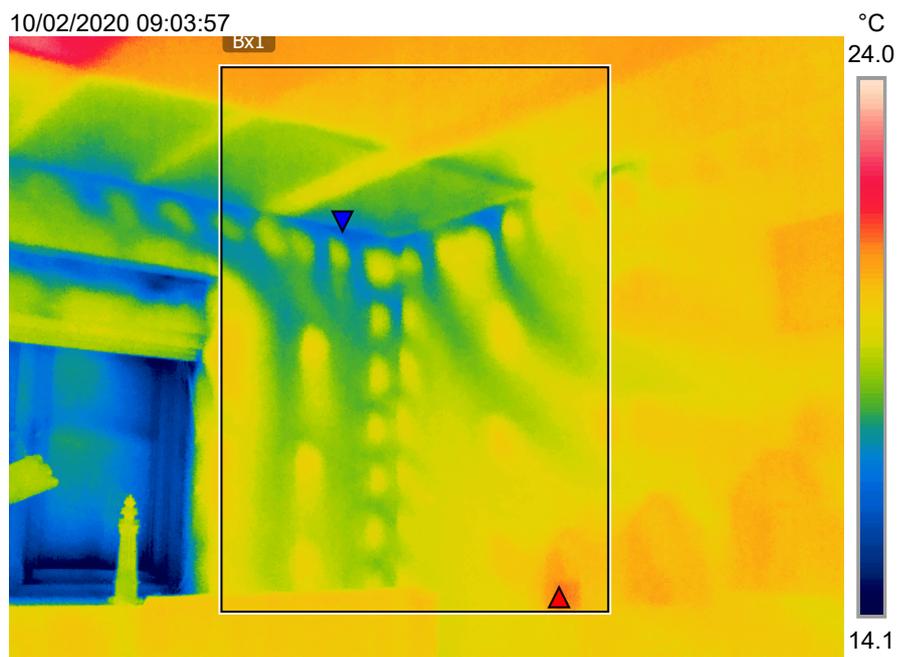
Rear L/H bedroom again showing air flow behind the dry lining, individual adhesive dabs and missing insulation above the ceiling.

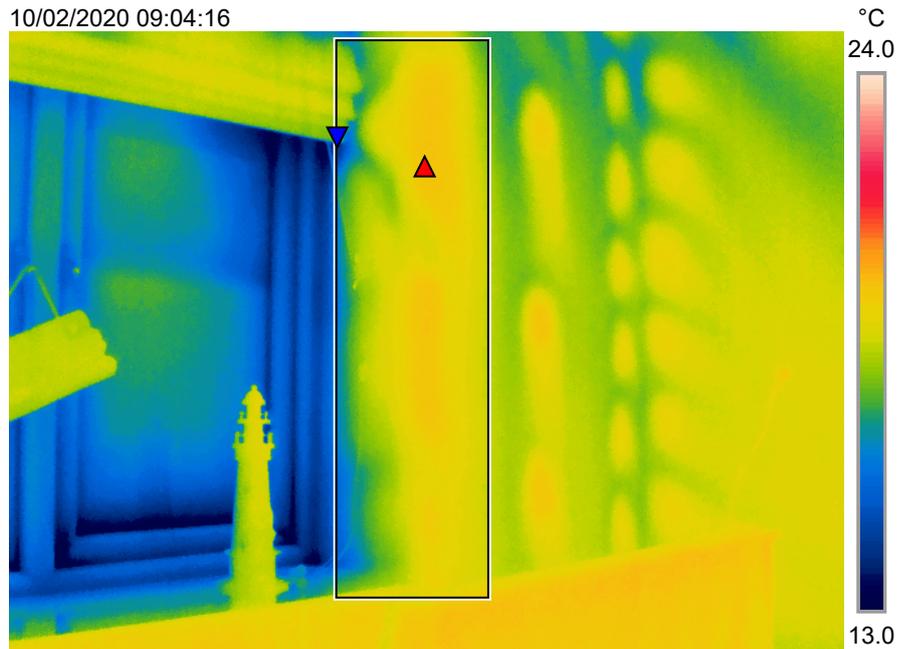
Rear L/H bedroom showing air flow behind the dry lining of the window reveal.

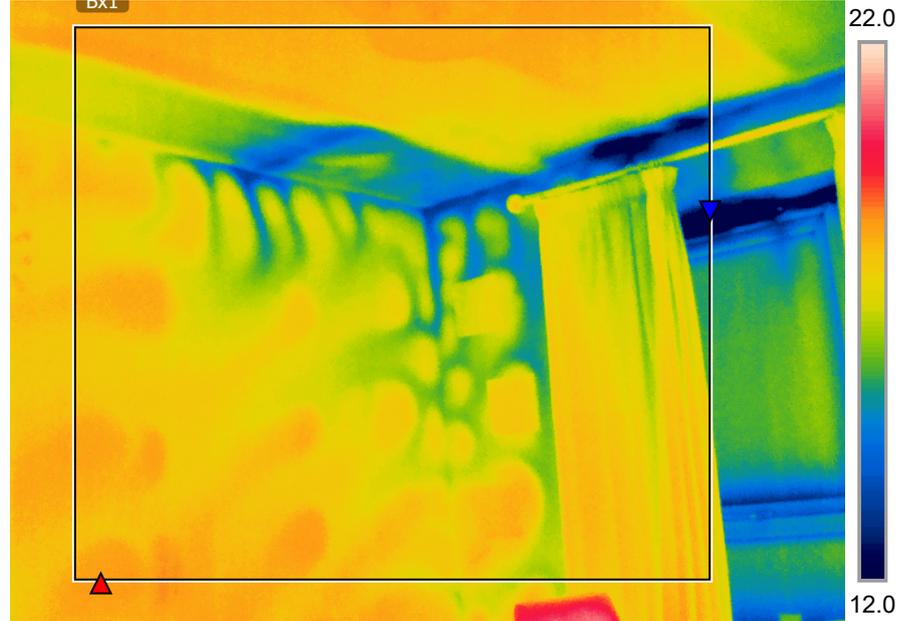
Front bedroom showing air flow behind the dry lining and individual adhesive dabs. There is also missing insulation above the ceiling.

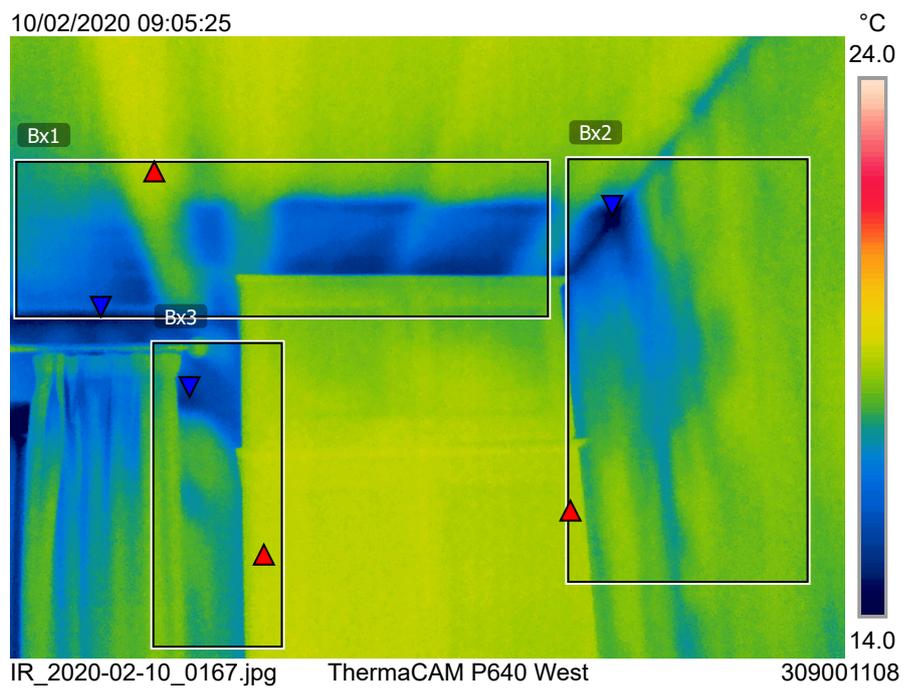
Front bedroom showing missing or limited insulation above the ceiling, air infiltration into the internal stud wall and air infiltration from the window reveals.

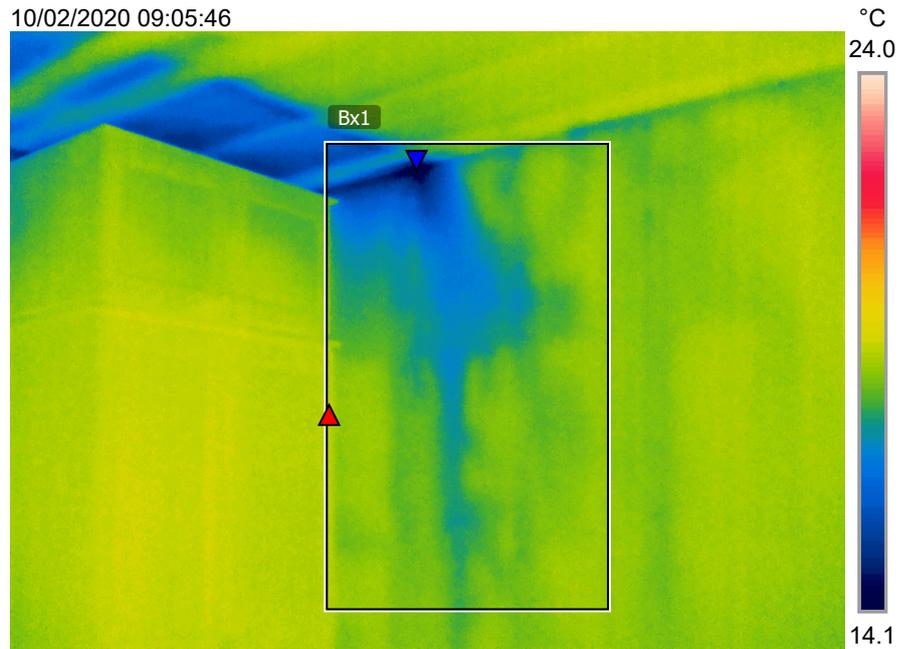
Front bedroom showing air infiltration into the internal stud wall.

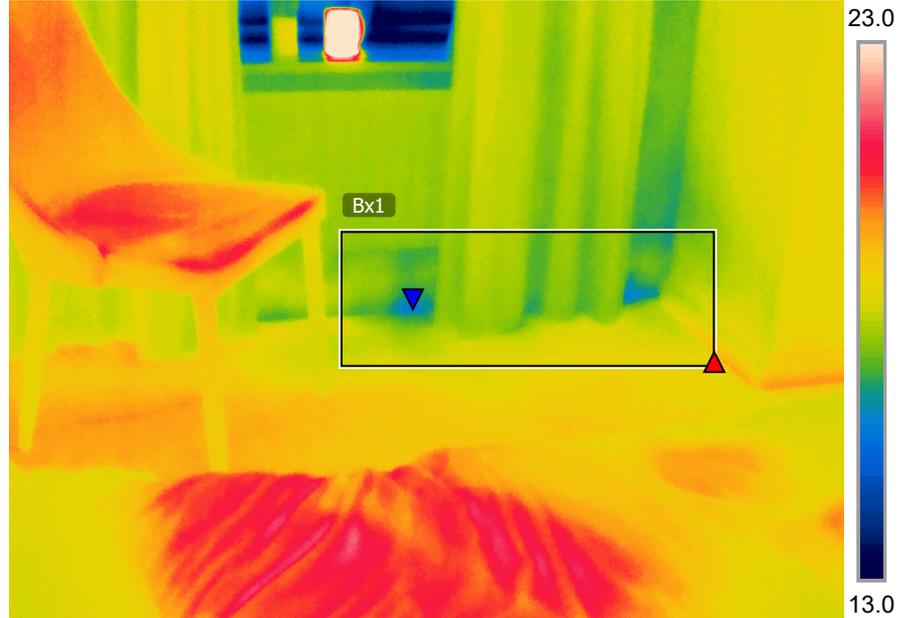
Front bedroom showing draughts flowing from under the skirting. This is directly over the bay window area where air flow was identified above the ceiling, this is consistent with the draughts here.

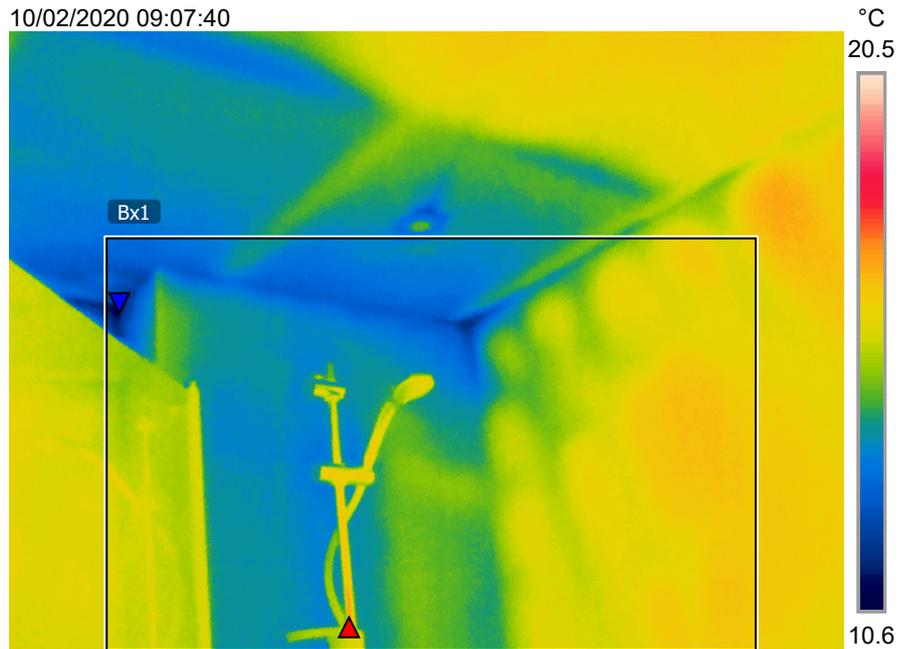
Bathroom showing the service void at the end of the bath as cold indicating the top of the void is fully open to the roof void above. There is also missing insulation above the ceiling and air flow behind the dry lining of the side wall and individual adhesive dabs.

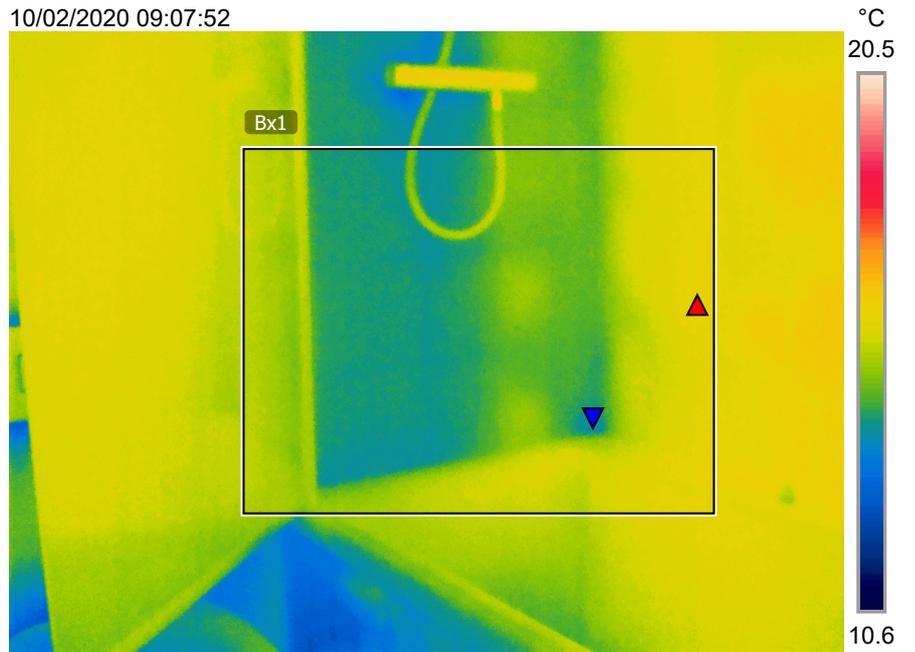
Cold boxing at the end of the bath.

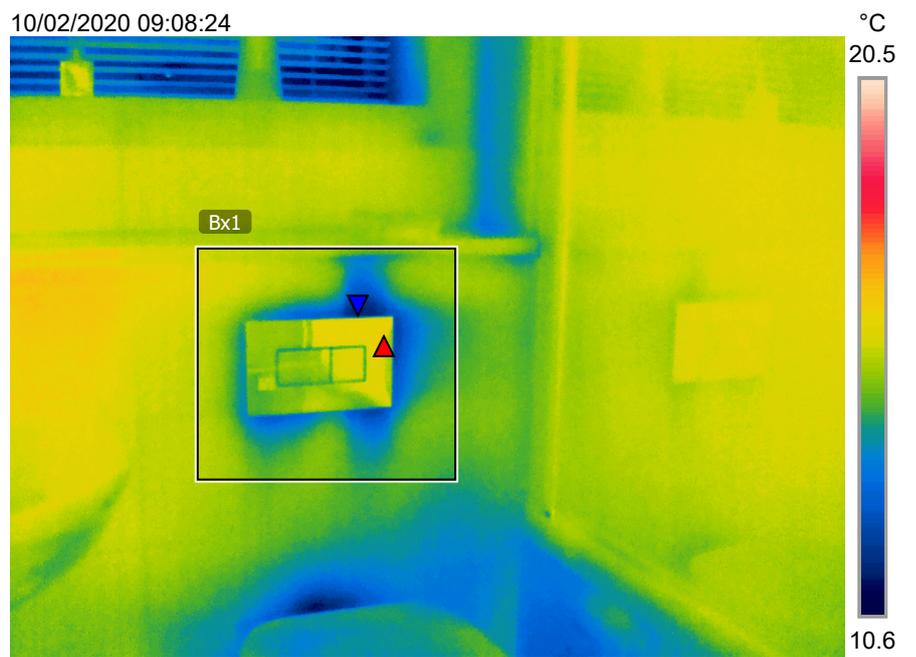
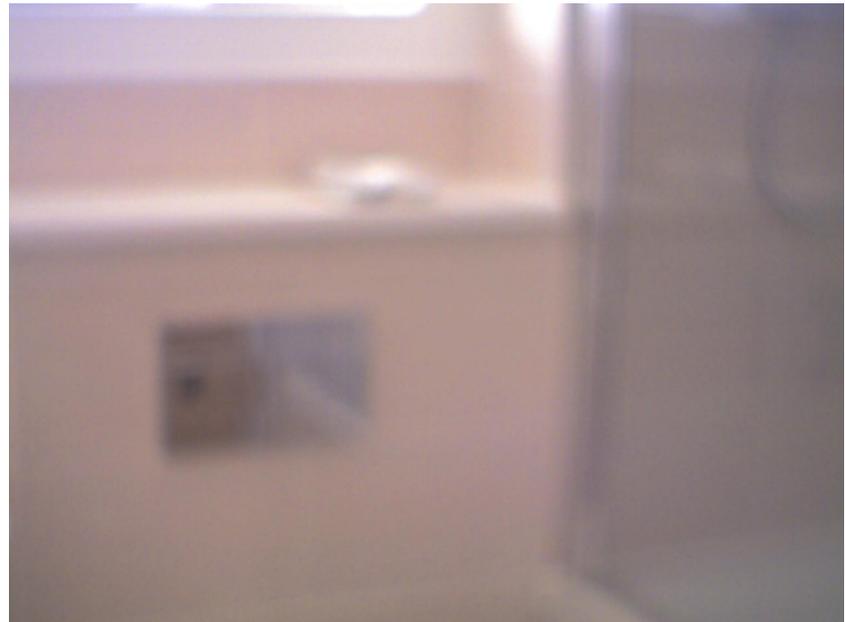
Draughts flowing from behind the toilet flush panel indicating the boxing behind has cold flowing air within, this is consistent with the cold boxing at the end of the bath being fully open at the top.

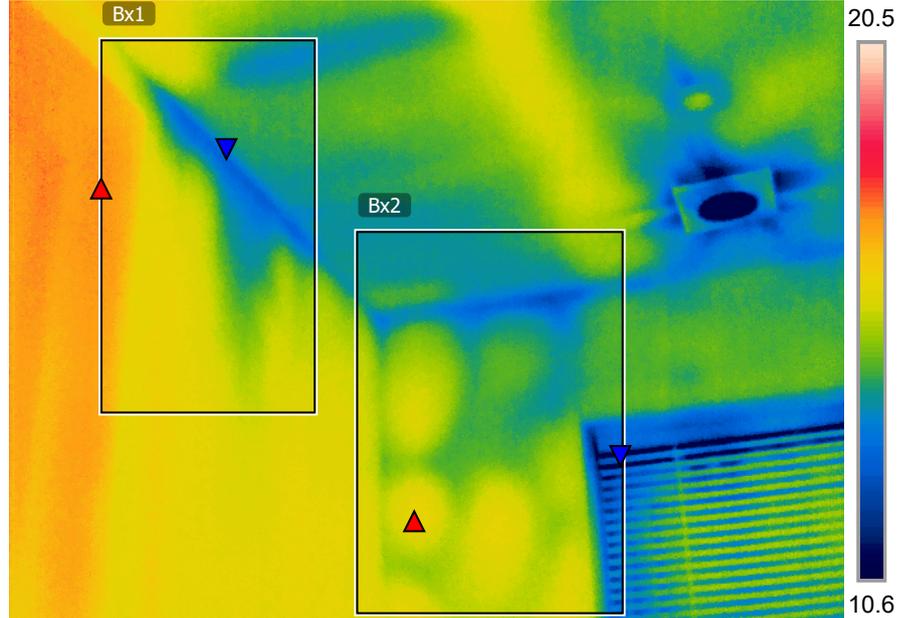
Bathroom showing air infiltration into the internal stud wall, consistent with that see in the front bedroom. Individual adhesive dabs and air flow behind the plasterboard on the wall.

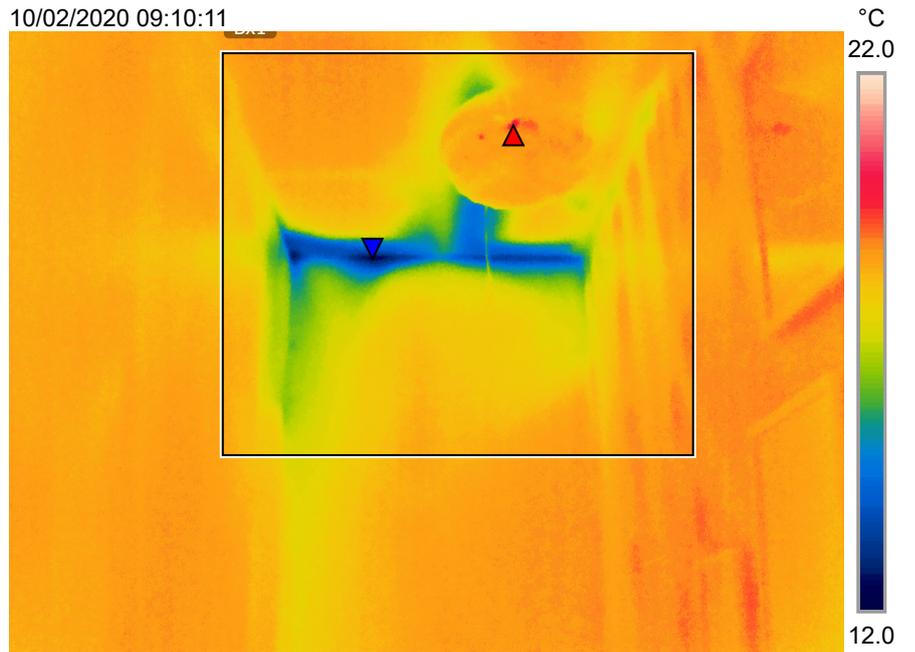
Top of the stairwell showing missing or limited insulation along the wall ceiling junction and above the ceiling.

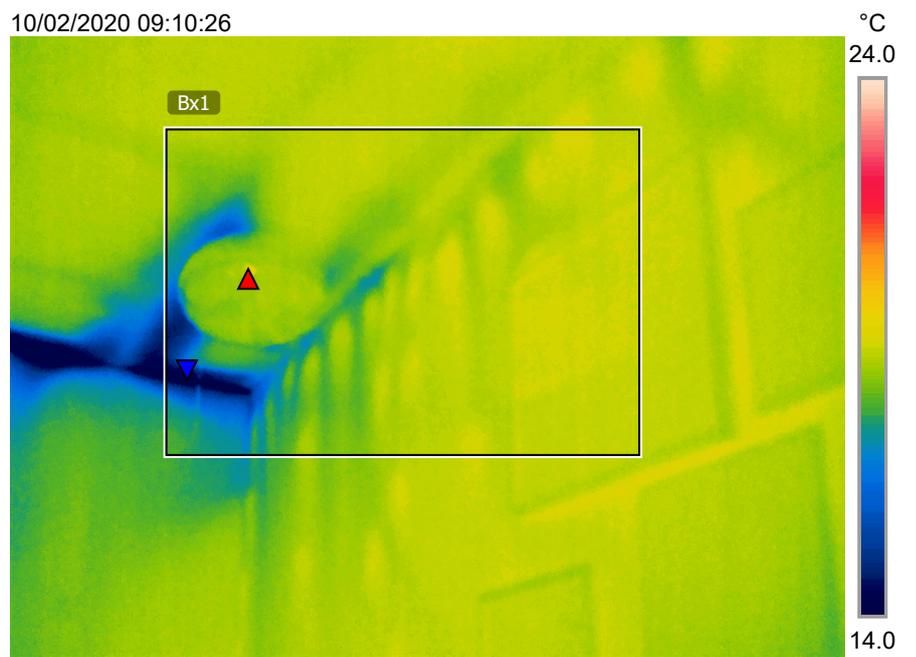
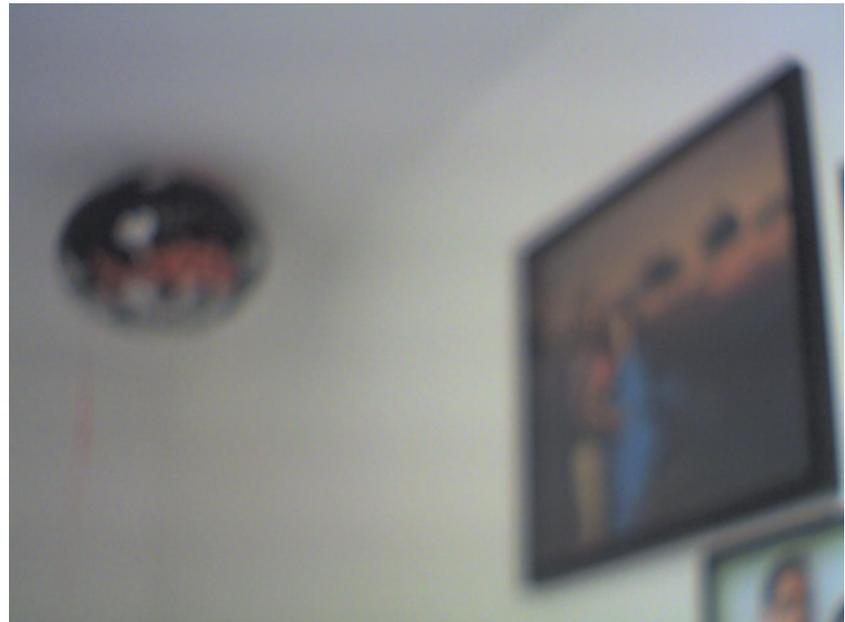
Individual adhesive dabs along the top of the stairwell wall and air infiltration behind the dry lining.

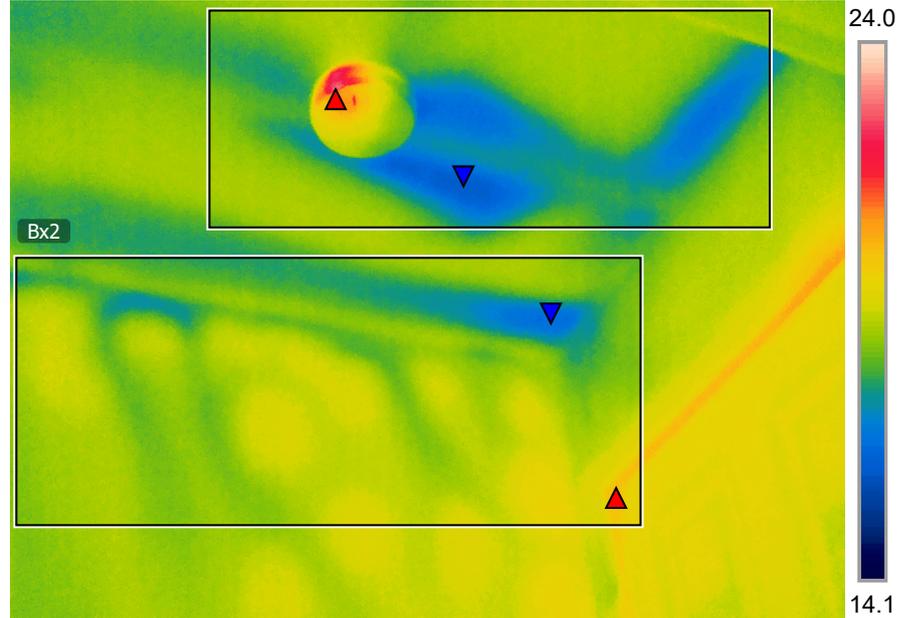
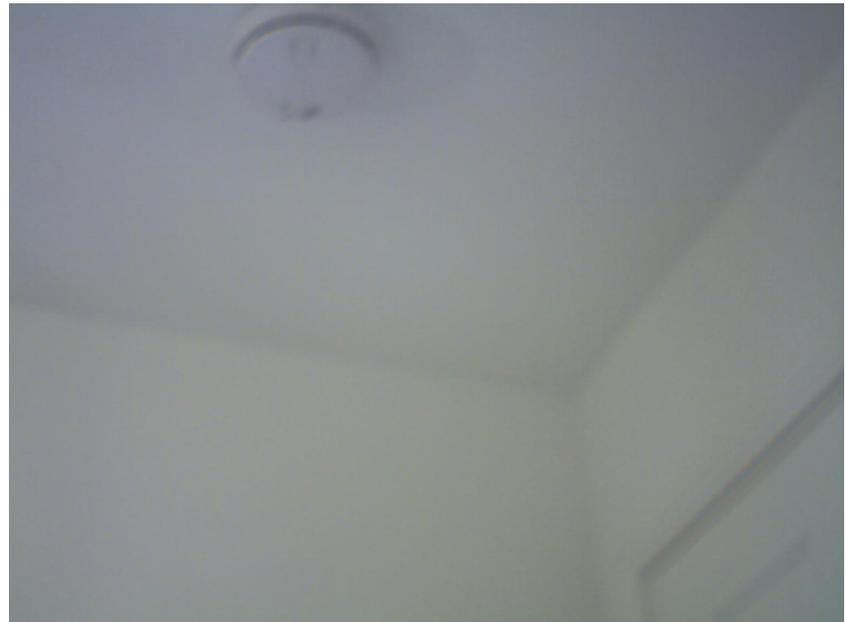
Missing insulation above the ceiling at the top of the stairs and air flow behind the dry lining of the side wall.
