Thermal imaging report for;

The building is a traditionally built 2 storey detached house built in 2016.

Sustainable Lifestyles Ltd were commissioned to carry out a thermal imaging survey of the property in response to concerns raised by the owner, [client name] with regards to cold areas of the house indicative of defective construction. We undertook thermography and air tightness testing, to identify air paths, location of air leakages and cold areas indicating possible missing, limited or poorly installed insulation and other potential issues such as damp.

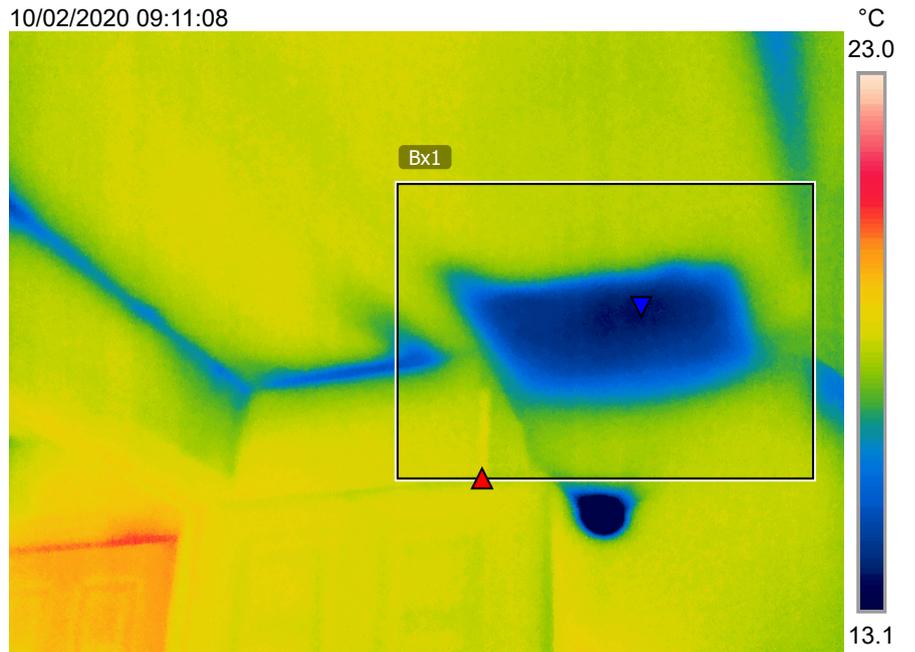
Missing insulation above the ceiling on the top floor.

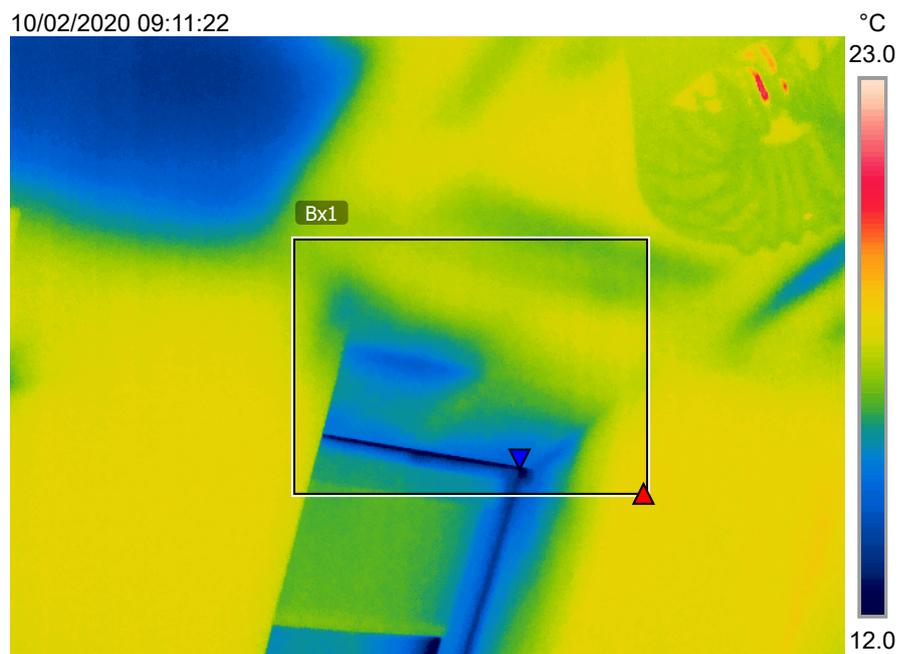
Missing insulation or air flow bypassing the insulation of the top reveal of the rear roof light.

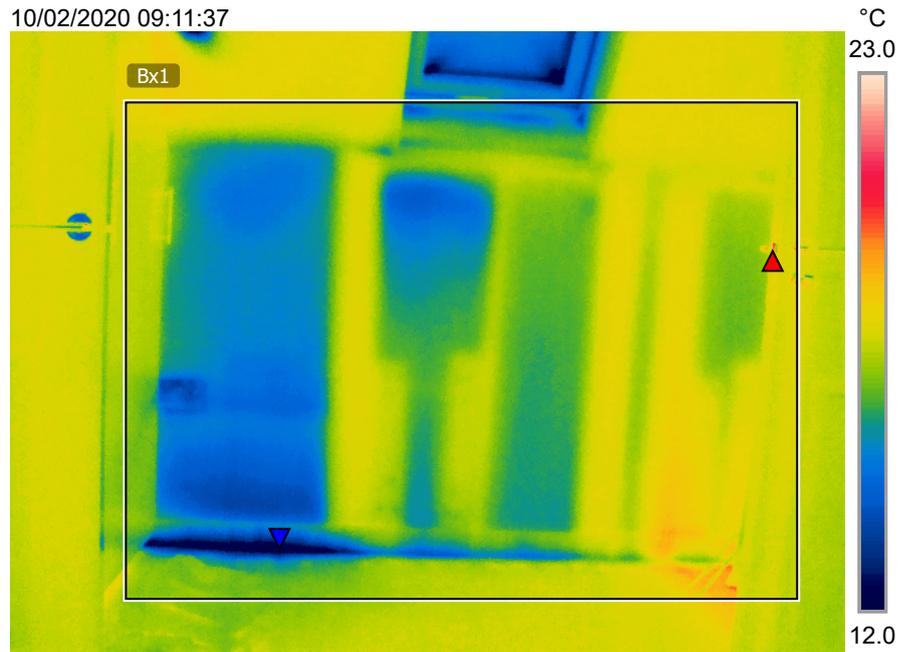
Ne effective insulation present on the rear knee wall for the top floor. There are also draughts flowing from under the skirting.

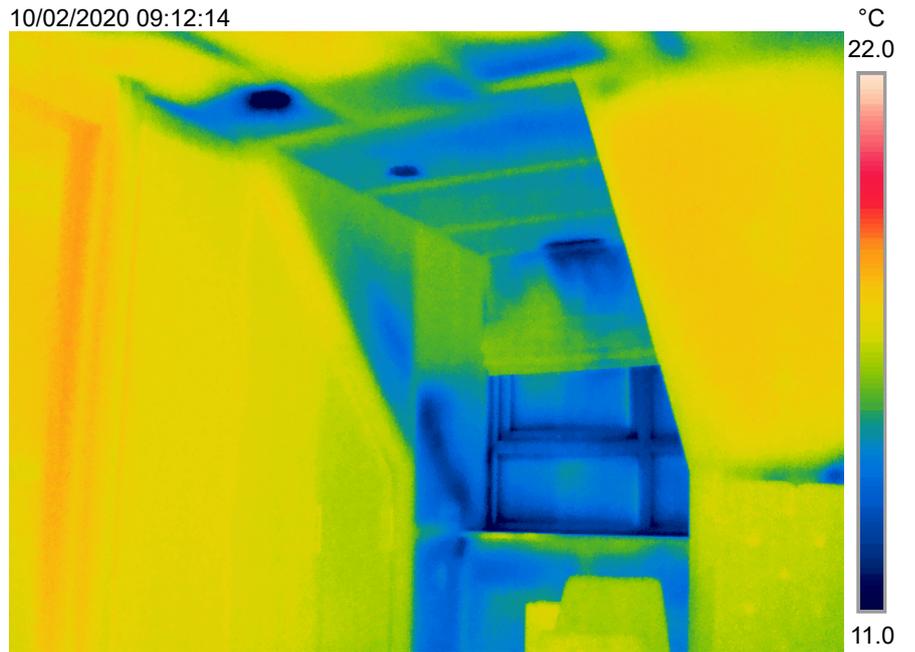
Front dormer showing little or no insulation above the ceiling or on the side walls.

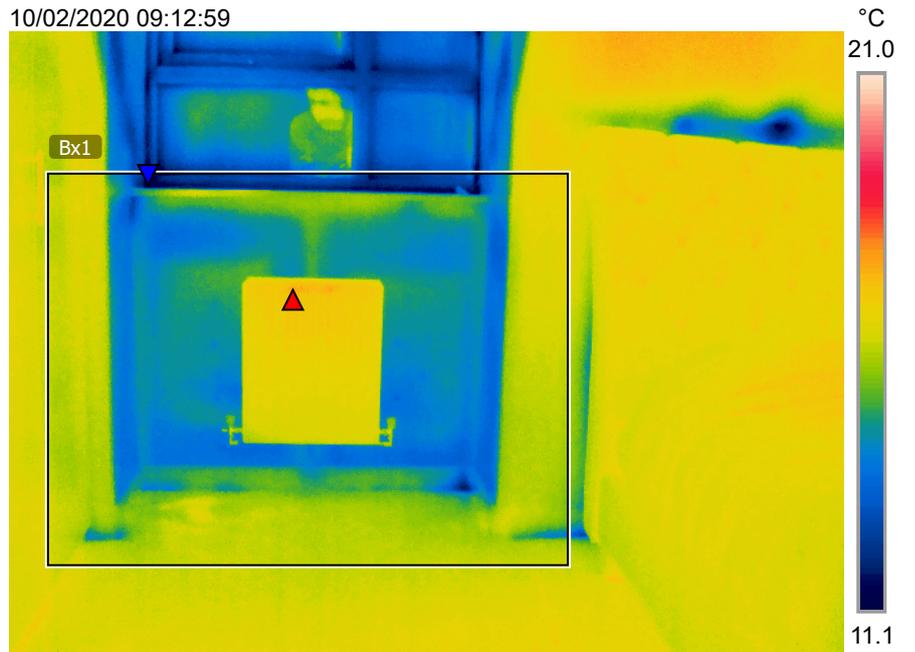
Knee wall below the dormer window showing no effective insulation.

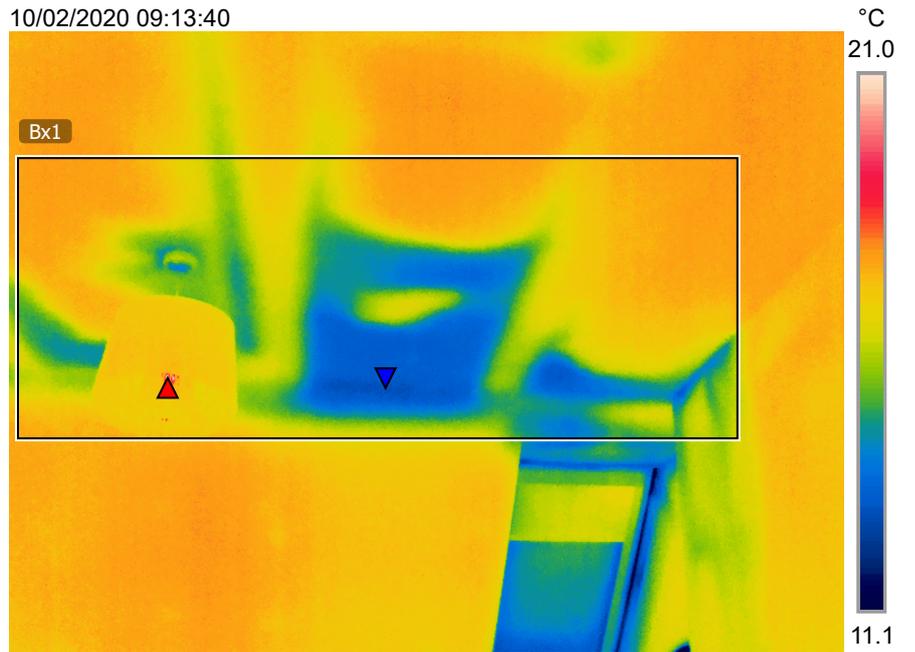
Missing insulation above the top floor ceiling.

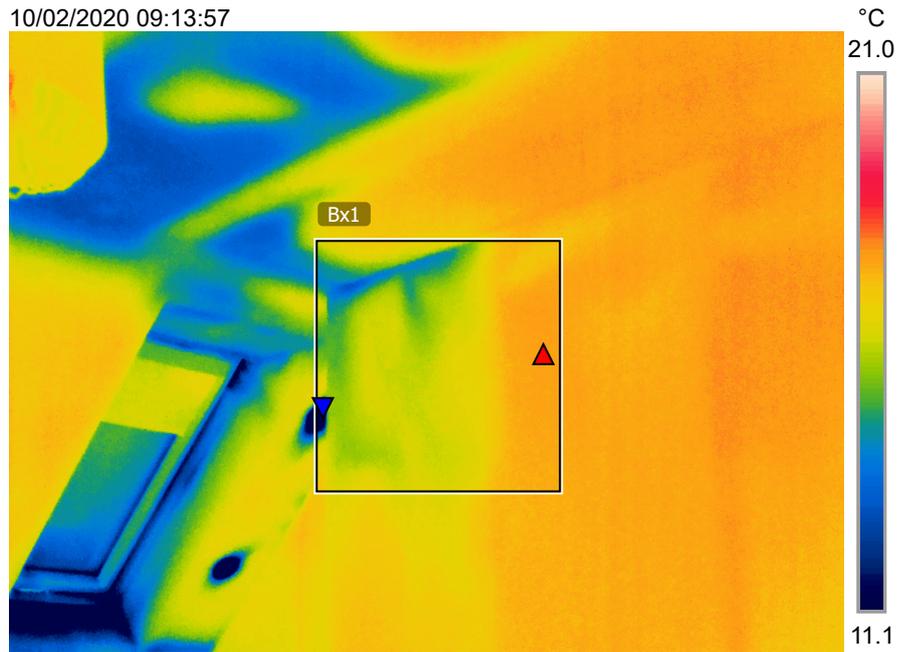
Air infiltration into the internal stud wall of the top floor.

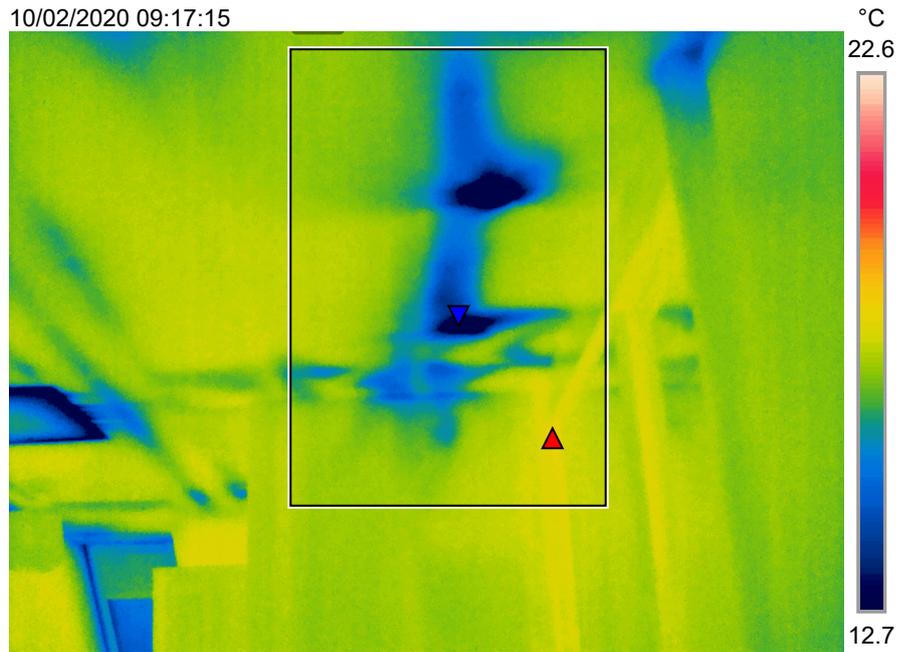
Missing or limited insulation above the top floor ceiling.

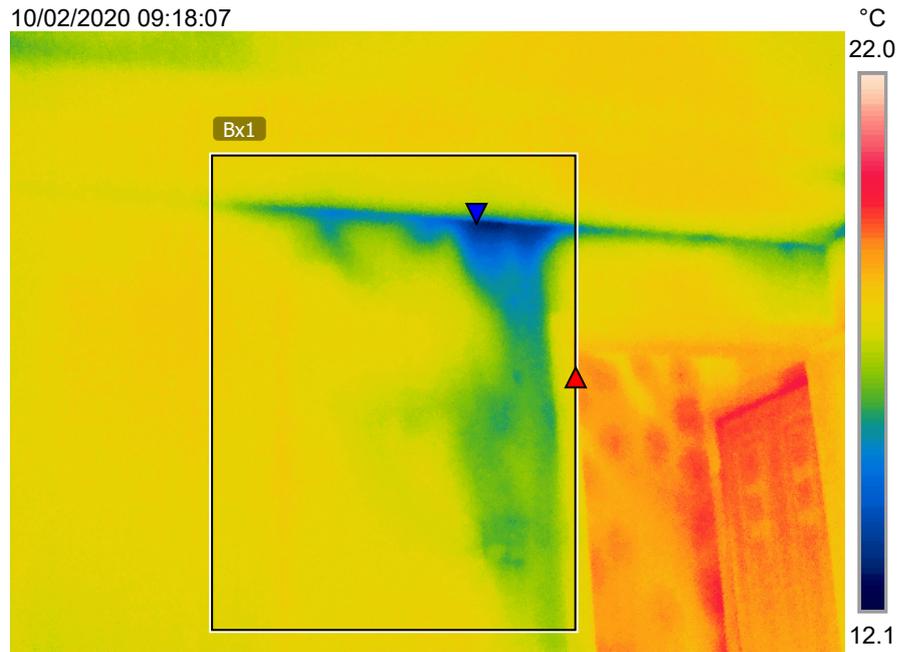
Air infiltration into the top floor internal stud wall to the stairwell.
