Urea Formaldehyde cavity wall insulation,
after many years of service is it still
insulating adequately and was it ever fit
for purpose?

Paul Buckingham

MSc Architecture: Advanced Environmental and Energy
Studies.

July 2011

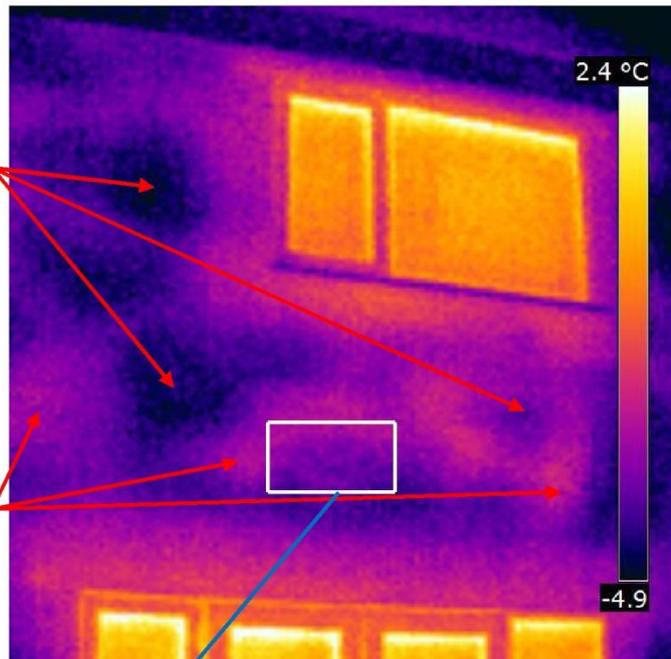
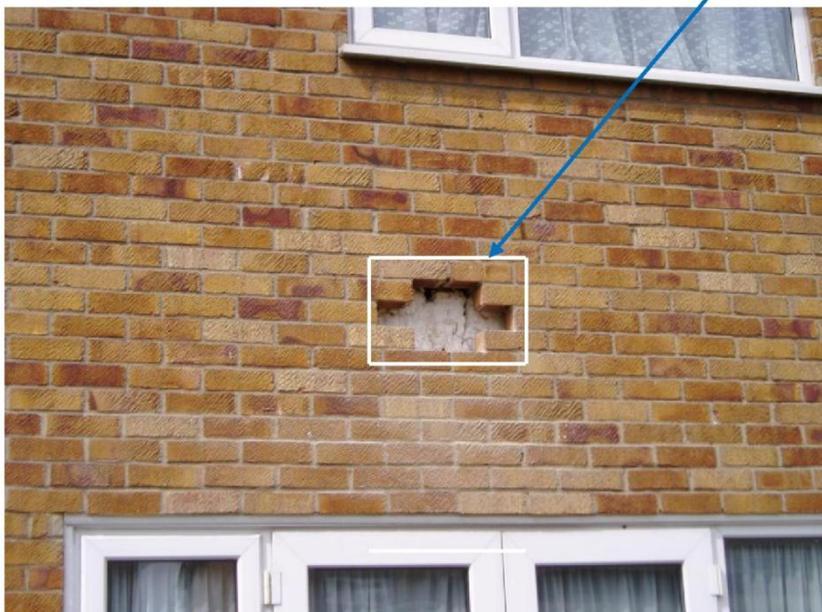
These dark patches indicate cold areas that were assumed to be insulated with UFFI, they also appear to correspond to an injection pattern that would have been used to inject the insulation.

These lighter patches indicate warm areas where heat is escaping through the wall due to an assumed lack of CWI!

Four bricks were removed to expose an area that was seen as a patch on the thermal image. The resulting hole exposed a patch of UFFI in very poor condition and also confirmed the assumption of deteriorated or poorly installed insulation.

Figure 6. The two images here show the patch indicated by the thermal imaging and the corresponding hole where the bricks were removed.

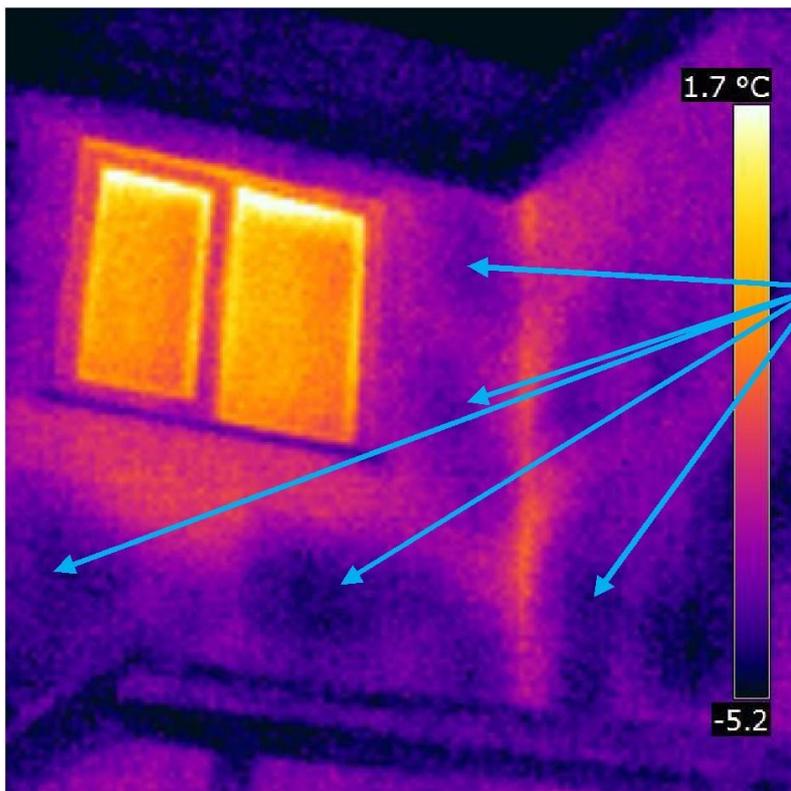
Another view of House 1, again showing light areas indicating heat loss and dark areas assumed to be insulated. (Note the apparent pattern of the dark areas that could indicate the installation injection holes!)

Figure 7. This is a view of the front of the house, again showing patches.

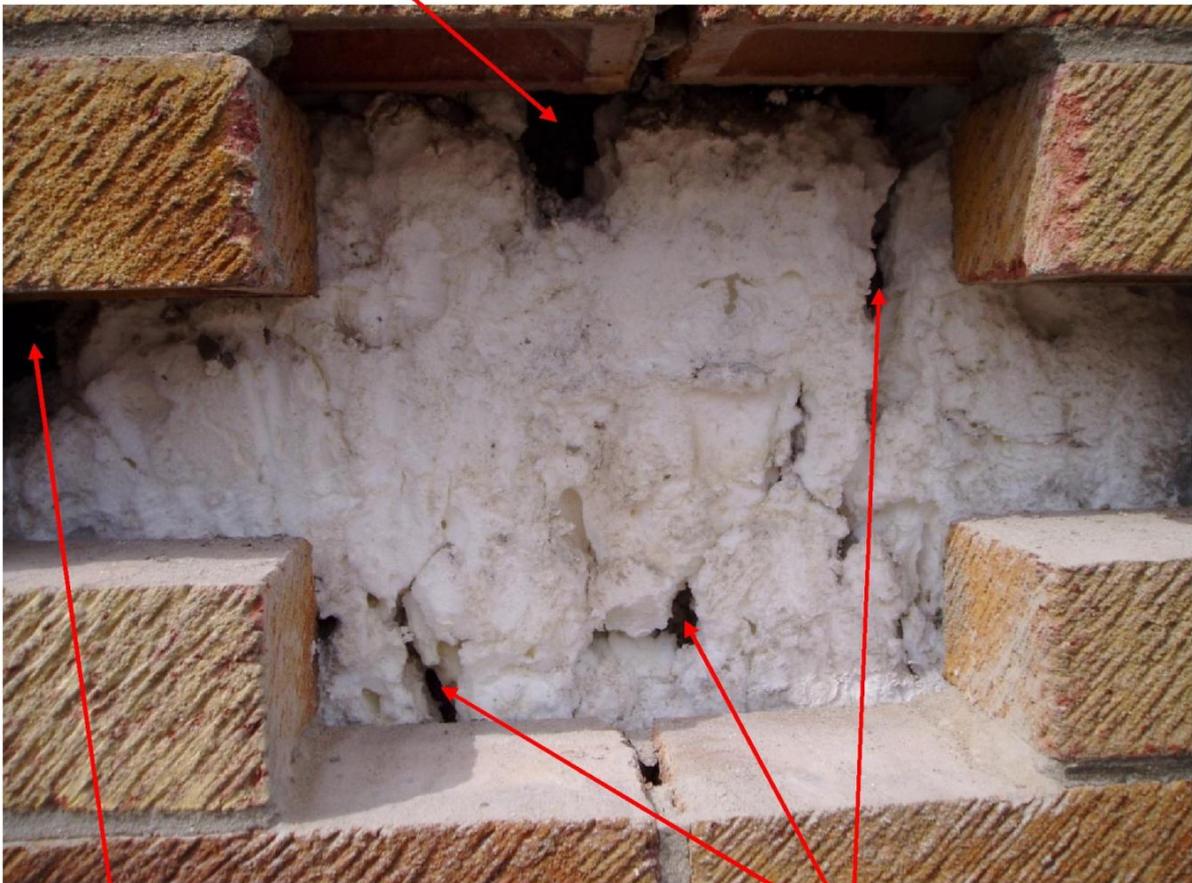
Hole to the top of the brick opening, this gap extended upward approximately 250mm before the next patch of insulation!

Other holes all over the insulation!

Hole to the left of the brick opening, this extended at least 250mm before the next patch of insulation!

Figure 8. This shows the poor condition of the UFFI and the holes within the material and around the patch of insulation.

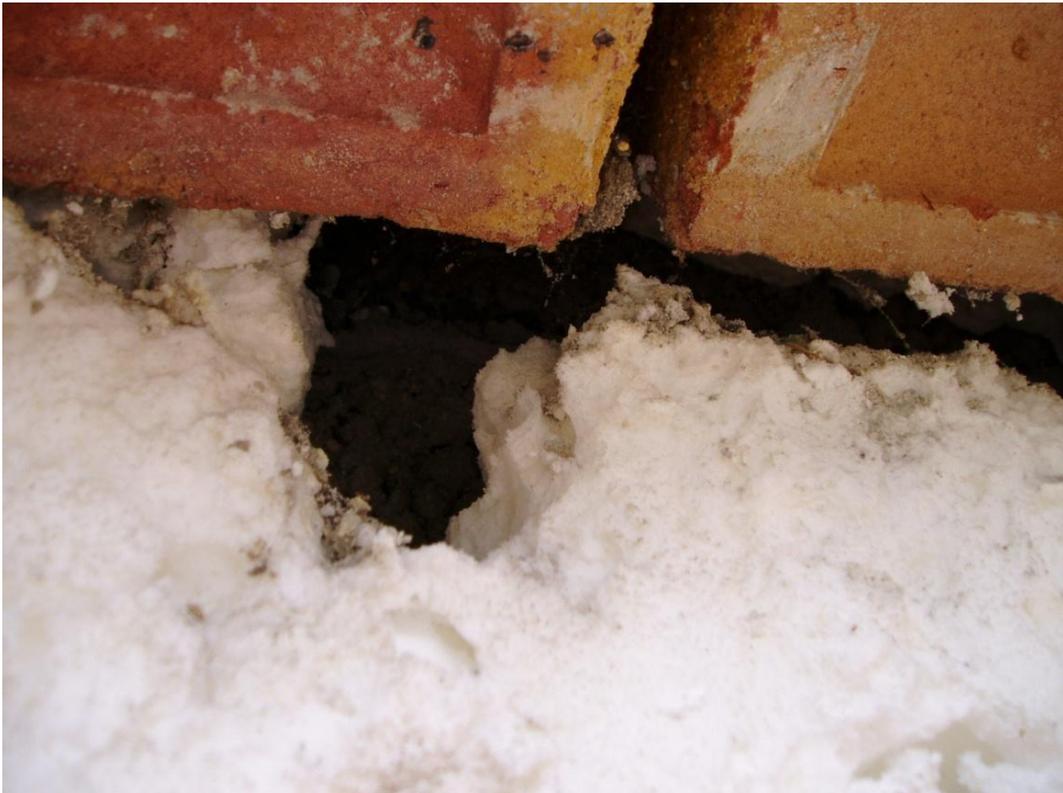
Figure 9. This image shows the hole at the top of the brick opening.

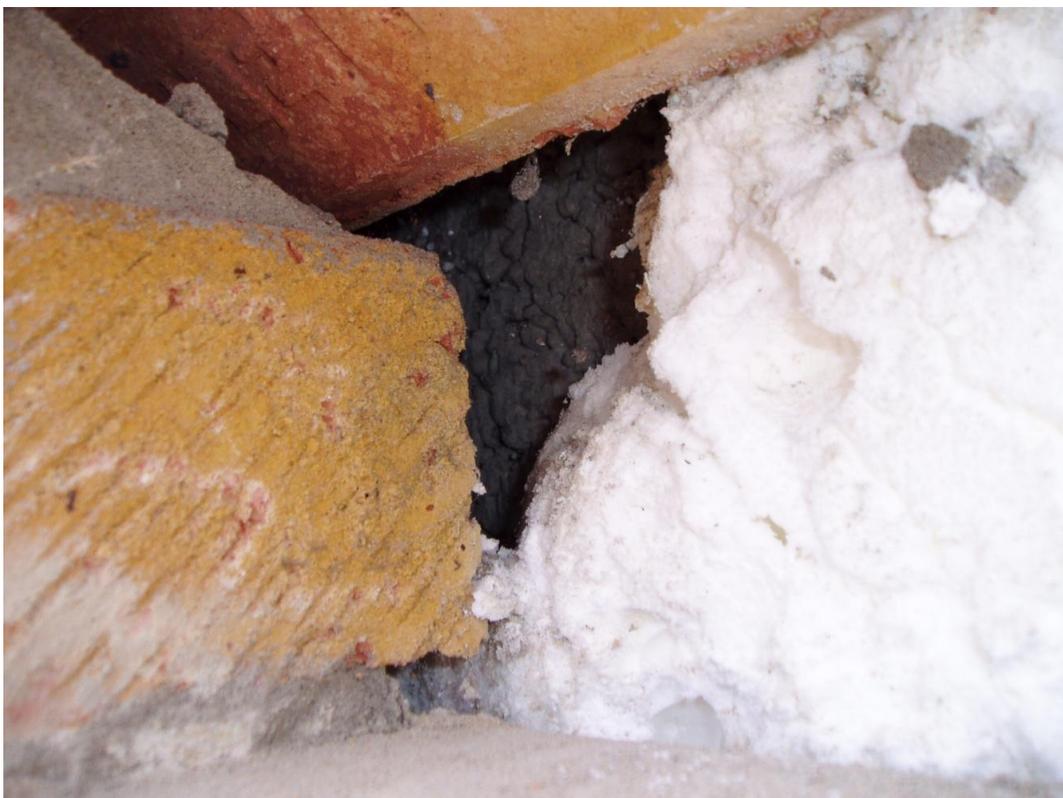
Figure 10. This image shows the hole to the left of the brick opening, the gap between this insulation patch and the next was approximately 250mm.

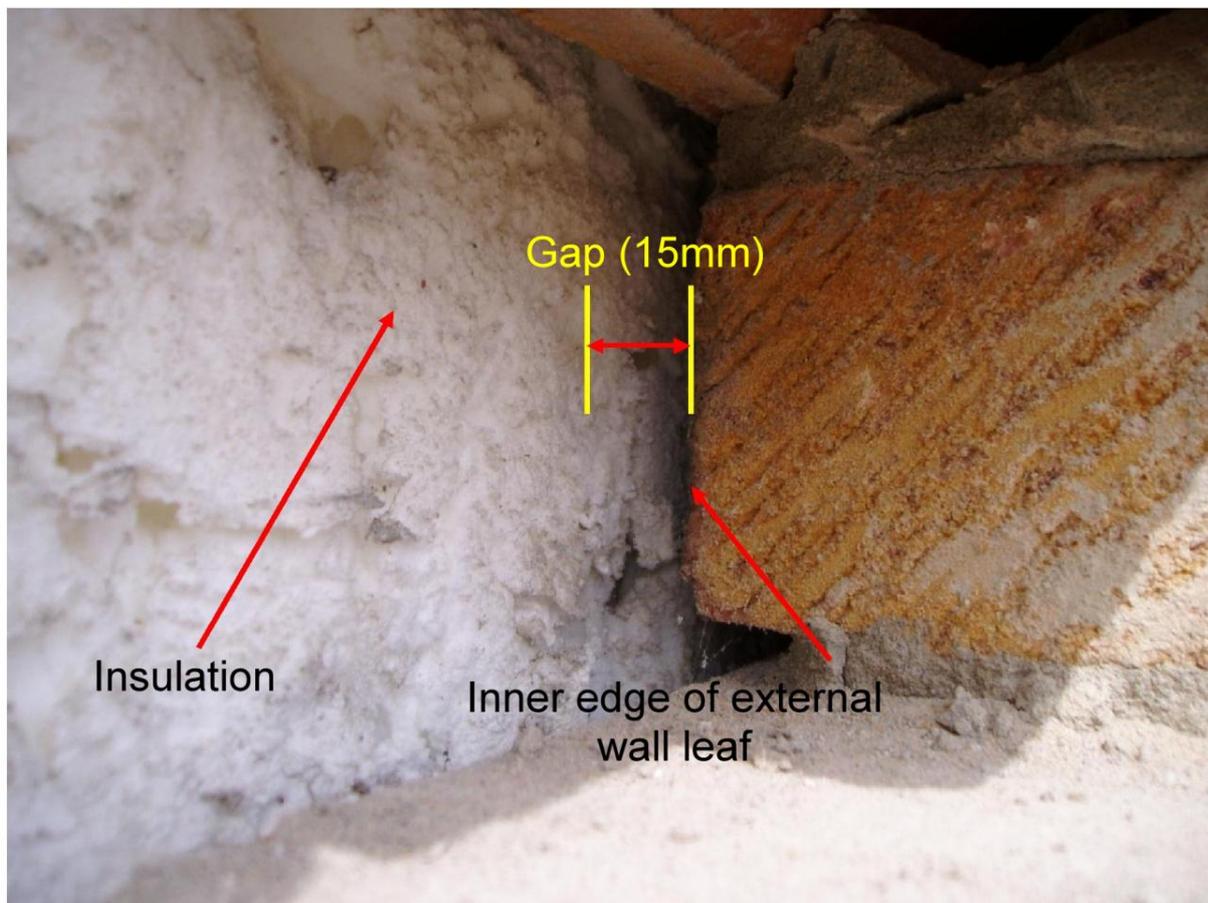
The cavity was approximately 55mm wide and there was a gap of around 15mm between the insulation and the inside of the exterior wall leaf giving an approximate shrinkage of around 27%. (See *Figure 11.*).

Figure 11. A close up view showing the gap between the foam and the external wall leaf.

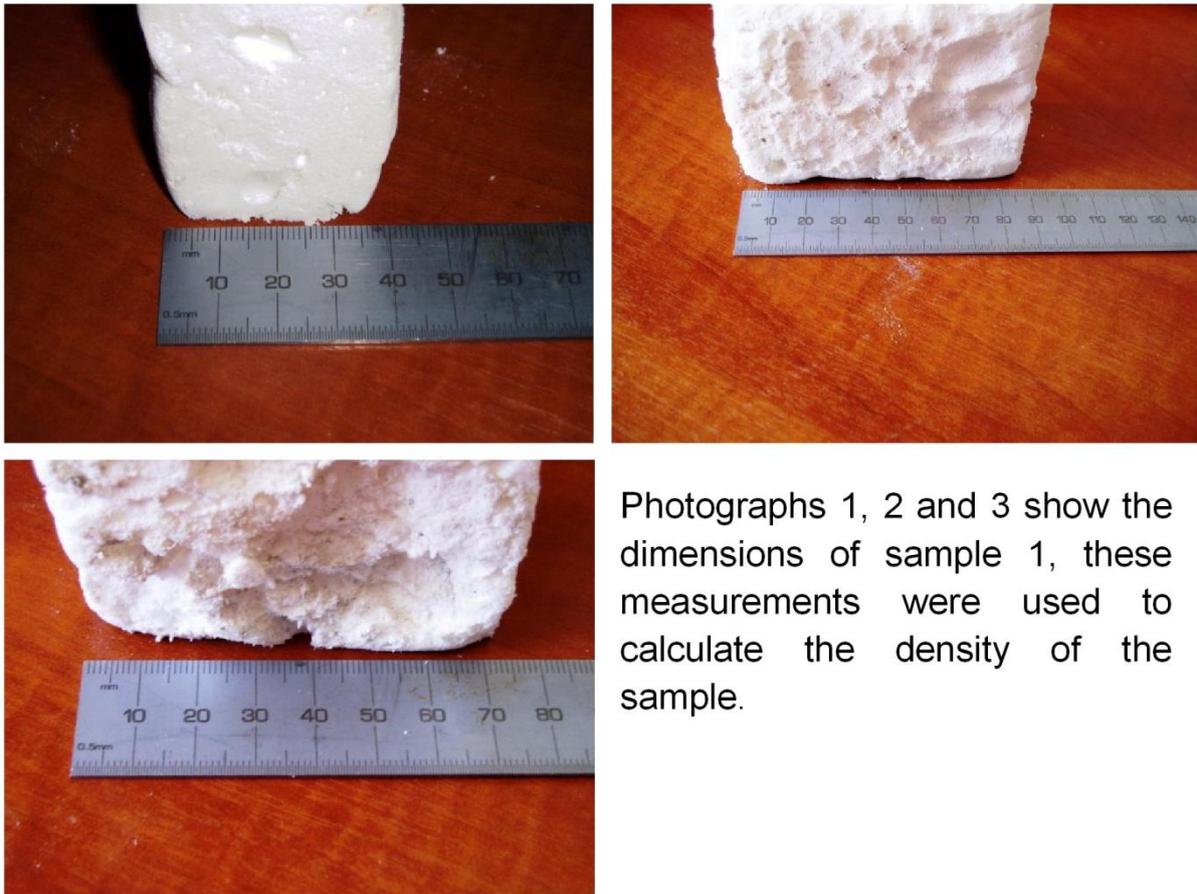
Figure 12. Sample 1.

The sample has a density deficiency of approximately 30% of its target value (this target value was defaulted as 10kg/m³ because no information was available on the supplier or specification of the material), the tolerance is $\pm 25\%$ of the suppliers specification, (See *chapter 2.3.1*). The sample weighs in at 5% below the minimum tolerance allowed but is still within the BS 5618 desired minimum density of 6kg/m³.

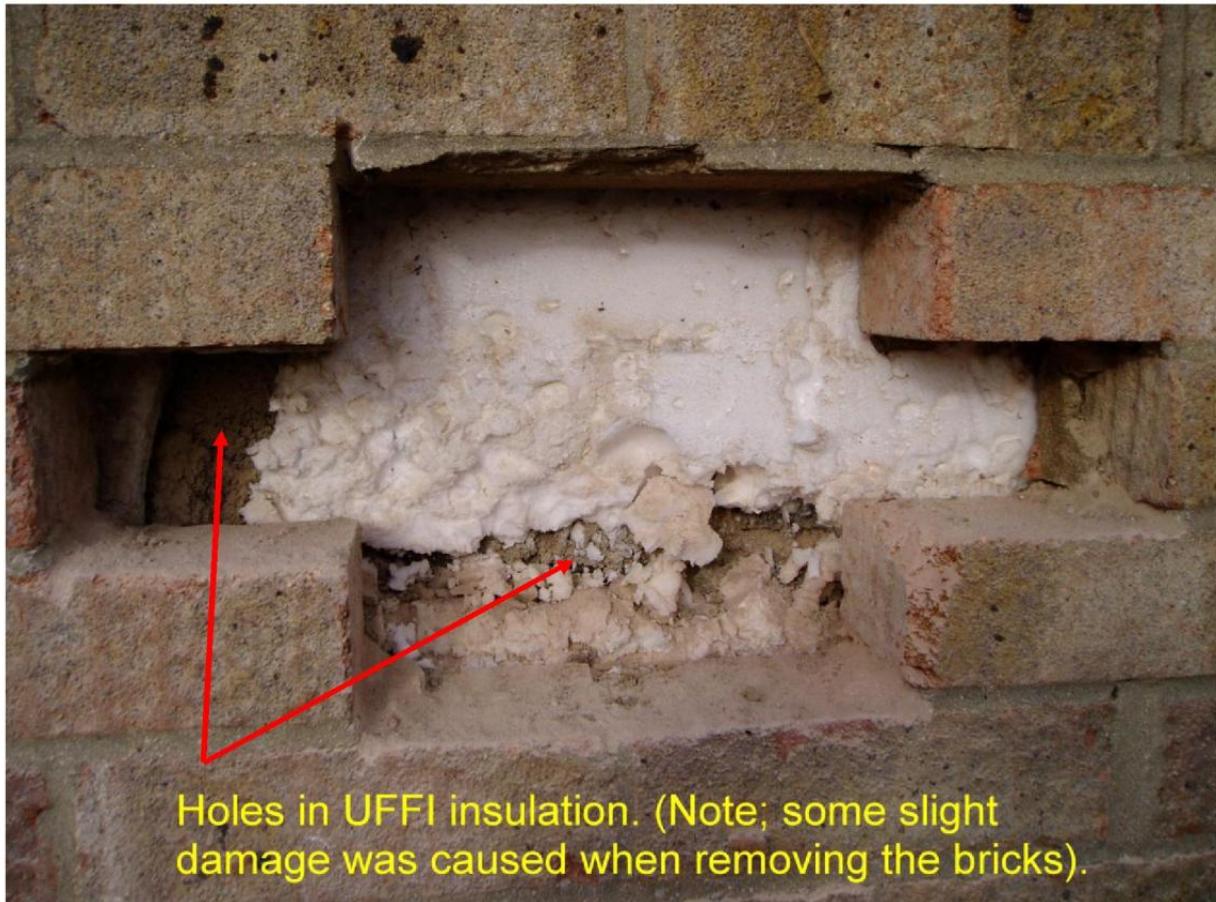
Four bricks were removed from the south facing wall on the ground floor. As can be seen in *Figure 13*, there were gaps in the insulation to the left and the bottom of the hole.

Figure 13. Hole where 4 bricks were removed showing the UFFI within the cavity.

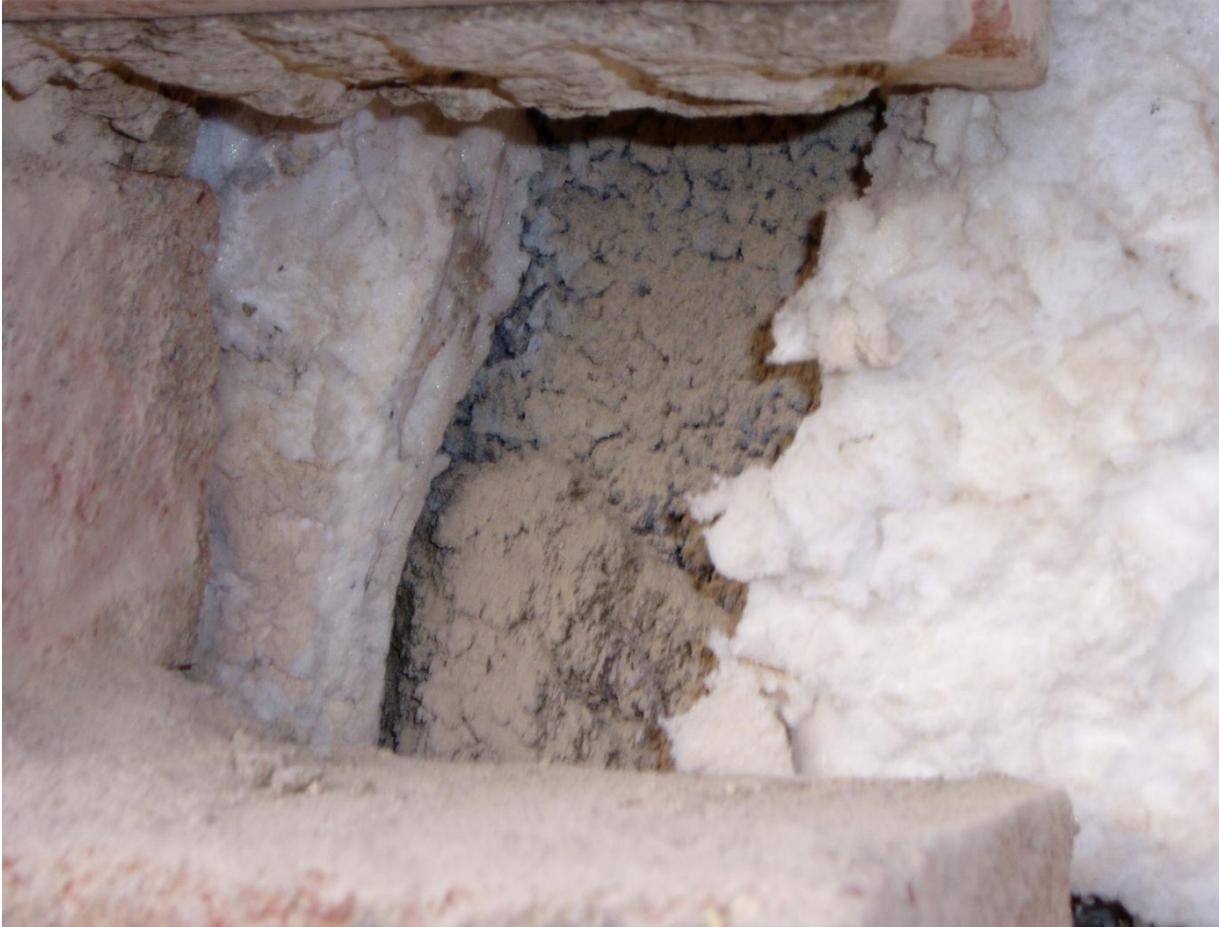
Figure 14. shows a close up of the left hand hole in the insulation. On further inspection the hole appears to be a crack, the edges of the material are parallel so were presumed to have pulled apart along a weak line, most likely where two injections met during installation.

Figure 14. Close up of the crack running vertically to the left of the Investigation hole.

The assumption from finding these cracks is that the foam has been subjected to shrinkage which has effectively produced patches of foam by pulling the foam apart. It would appear that the cracks have developed at the joint where two injections meet, this is likely to be a weak point in the structure of the foam. *Figure 15.* is an impression of how the foam may appear if the UFFI was fully exposed, the centre of each patch being the point of injection. This would be very difficult to prove conclusively without removing the whole of the outer wall leaf, if this did prove to be the case, it would indicate that the wall was incorrectly filled because the foam pattern would not be as specified in BS 5618:1985 and shown in *Figure 5*, chapter 3.

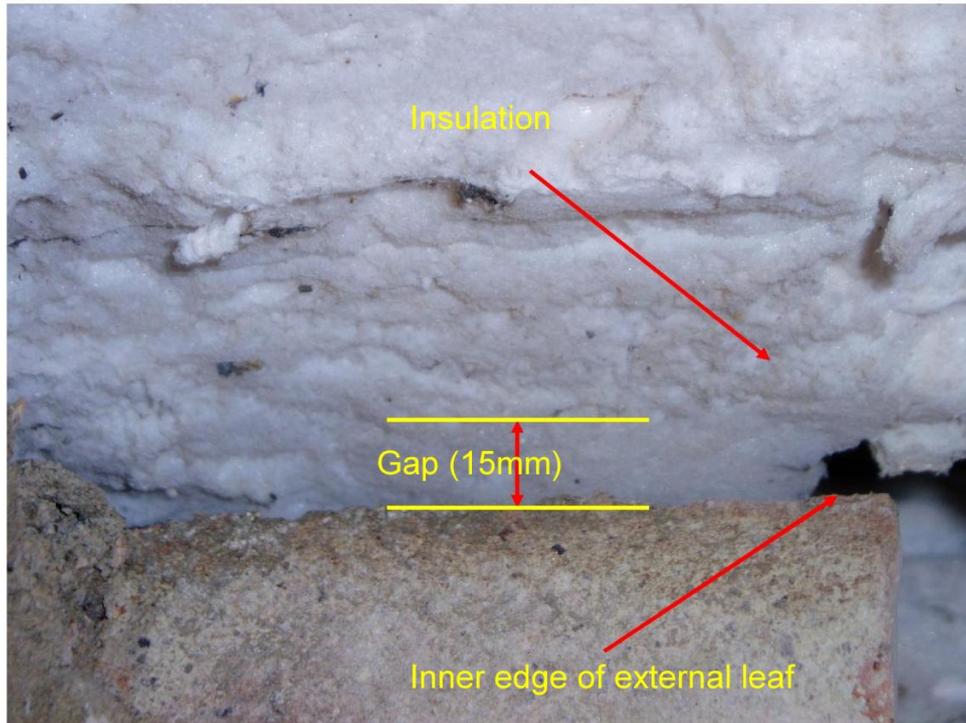
Figure 17. Gap between the inner edge of the outer wall leaf and the insulation.

Figure 17. illustrates a gap between the inside of the exterior wall leaf and the insulation of around 15mm, the cavity was approximately 55mm wide with the insulation being around 40mm thick which indicates an approximate shrinkage of 27% assuming the cavity was fully filled on installation.

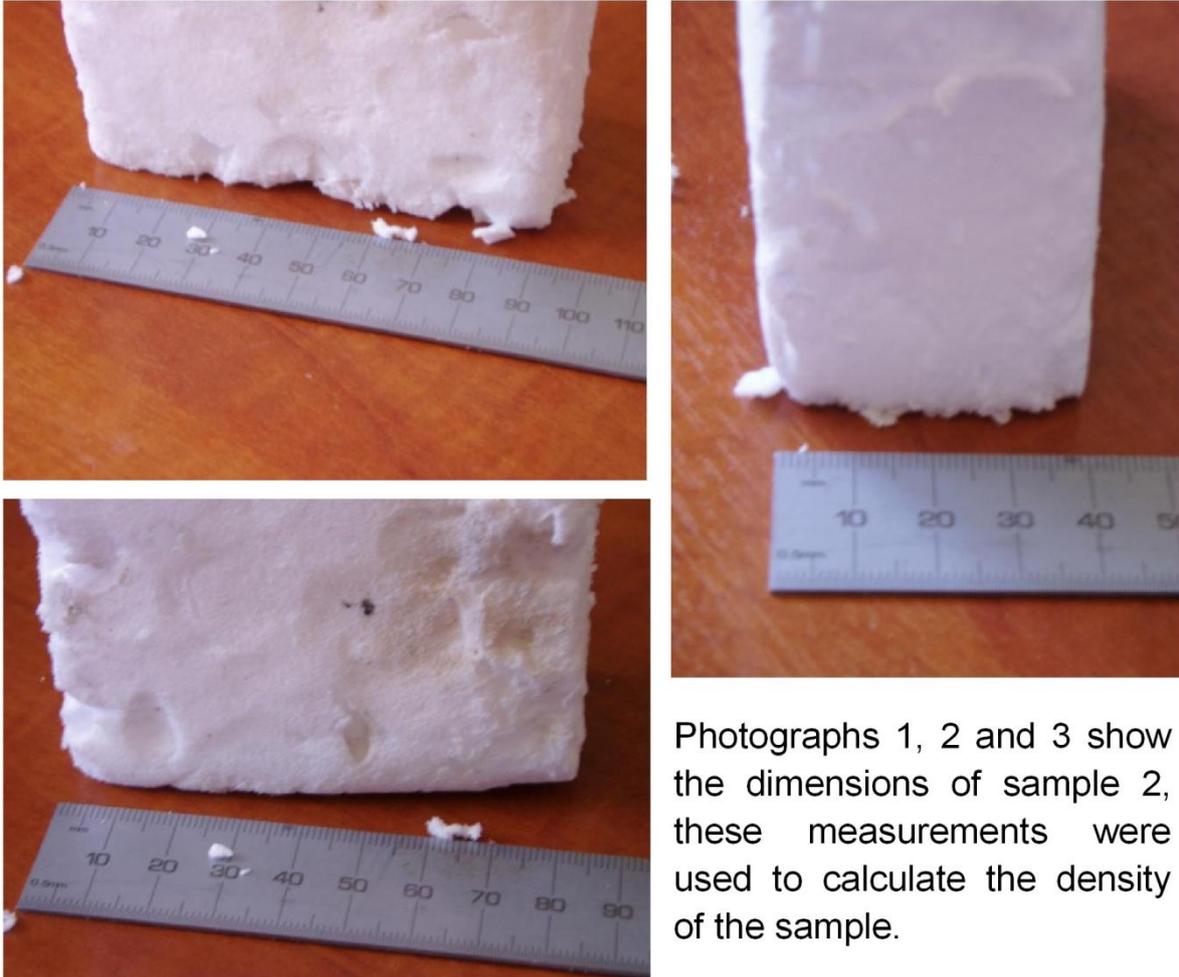
Figure 18. Sample 2.

The sample weighs in at 18% below the minimum tolerance allowed.

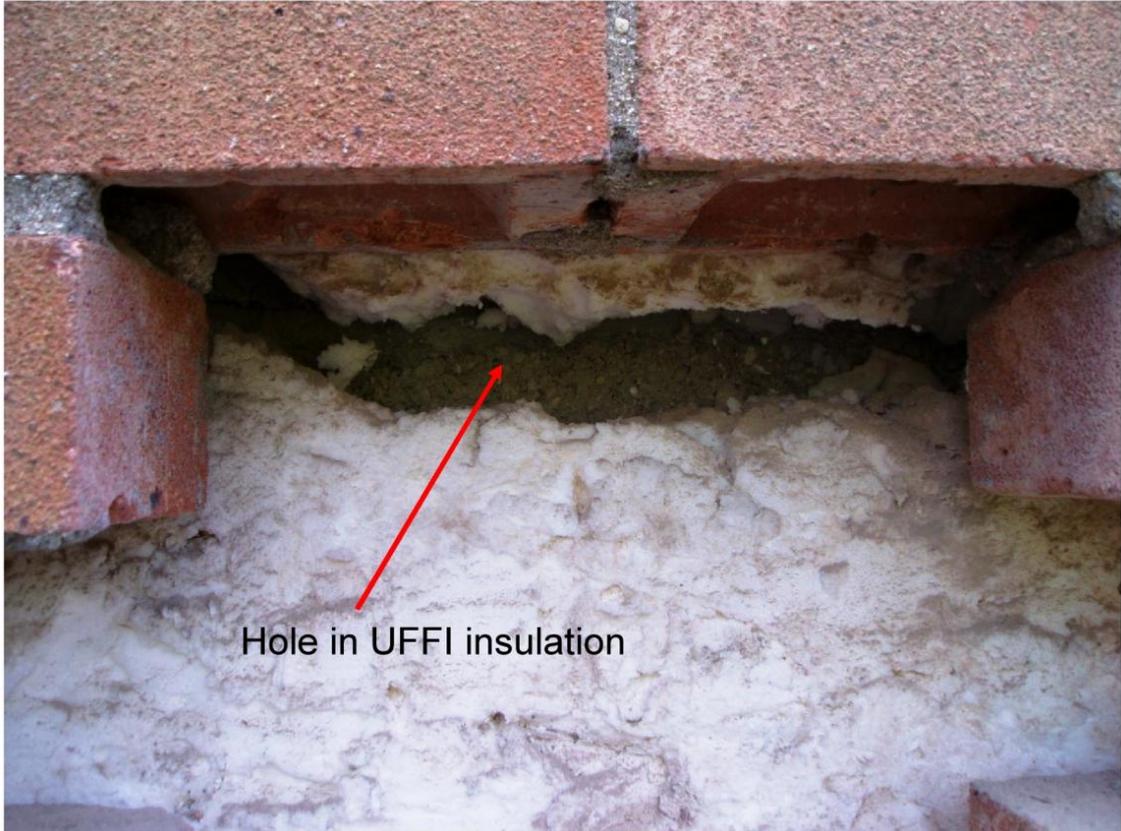
There was a similar crack in the insulation to that found in **House 2**, as can be seen in *Figure 20*. From the injection holes indicated in *Figure 19*, it would appear that the crack has formed half way between the injection holes which would correspond to where the join in the insulation from the separate injections would be. This is evidence that points to the possible cracking pattern illustrated in *Figure 15*, for **House 2** above.

Figure 20. Photograph showing similar cracking to that found in House 2.

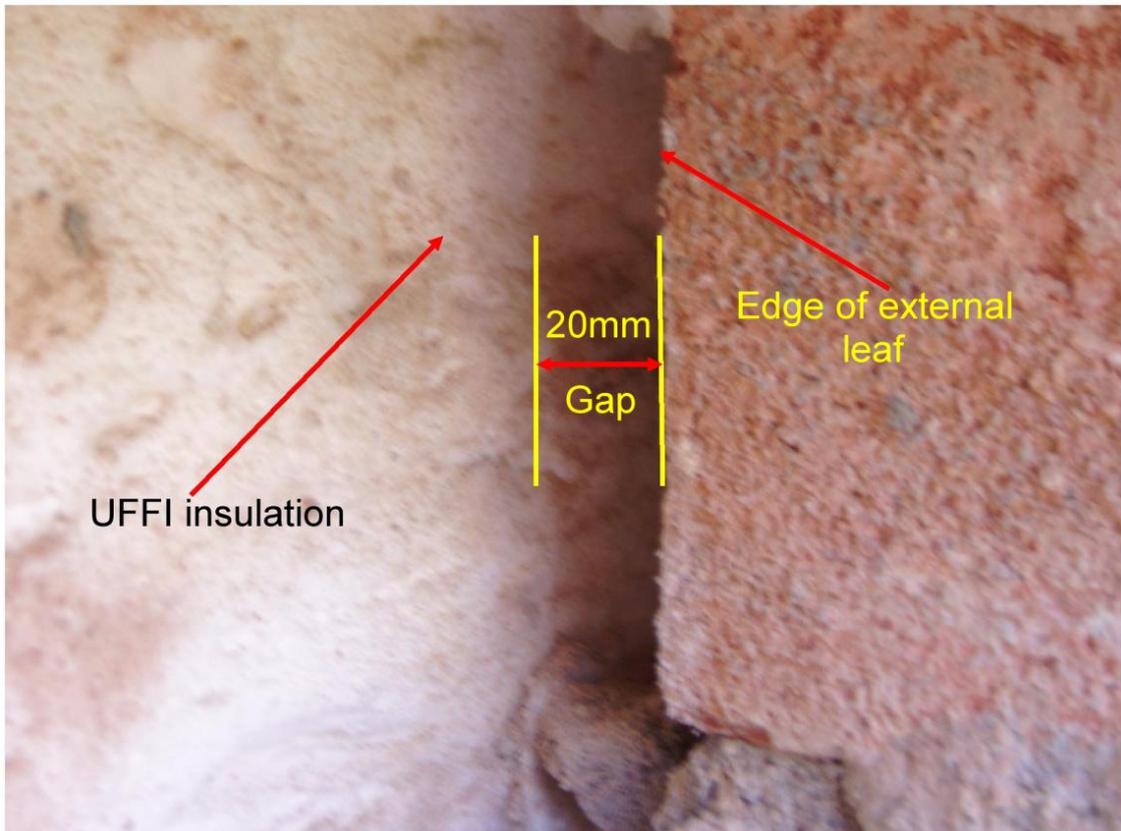
Similar to **House 2**, *Figure 21* shows a significant gap between the inner edge of the external wall leaf and the insulation of around 20mm, the cavity was approximately 70 - 75mm wide so shrinkage of around 15% is evident.

Figure 21. Photograph showing shrinkage gap.

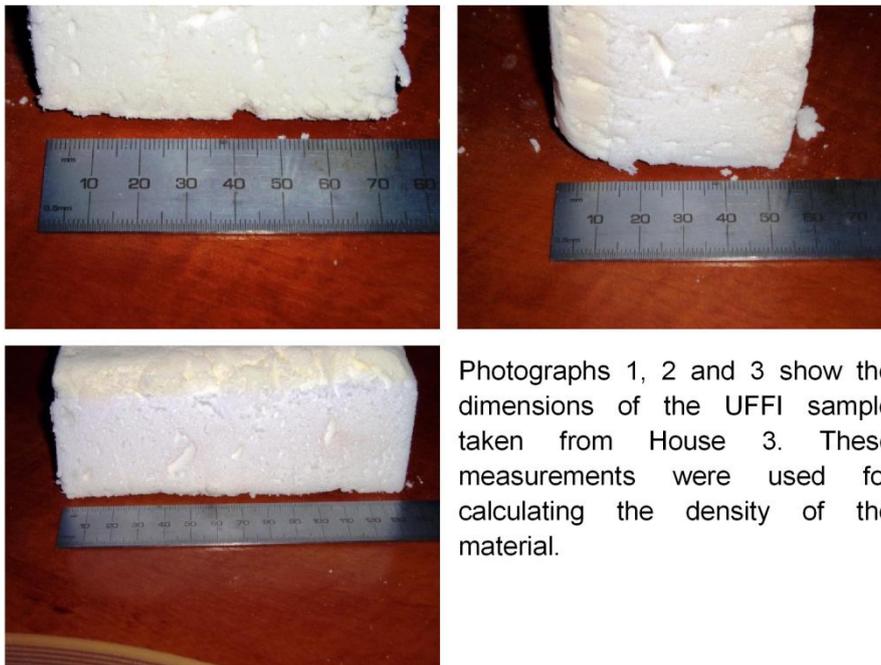
Figure 22. Sample 3.

The density of this sample is well within the allowable tolerance of $\pm 25\%$ assuming the suppliers specification was $10 - 12 \text{kg/m}^3$ (again due to no available installation data this cannot be verified).

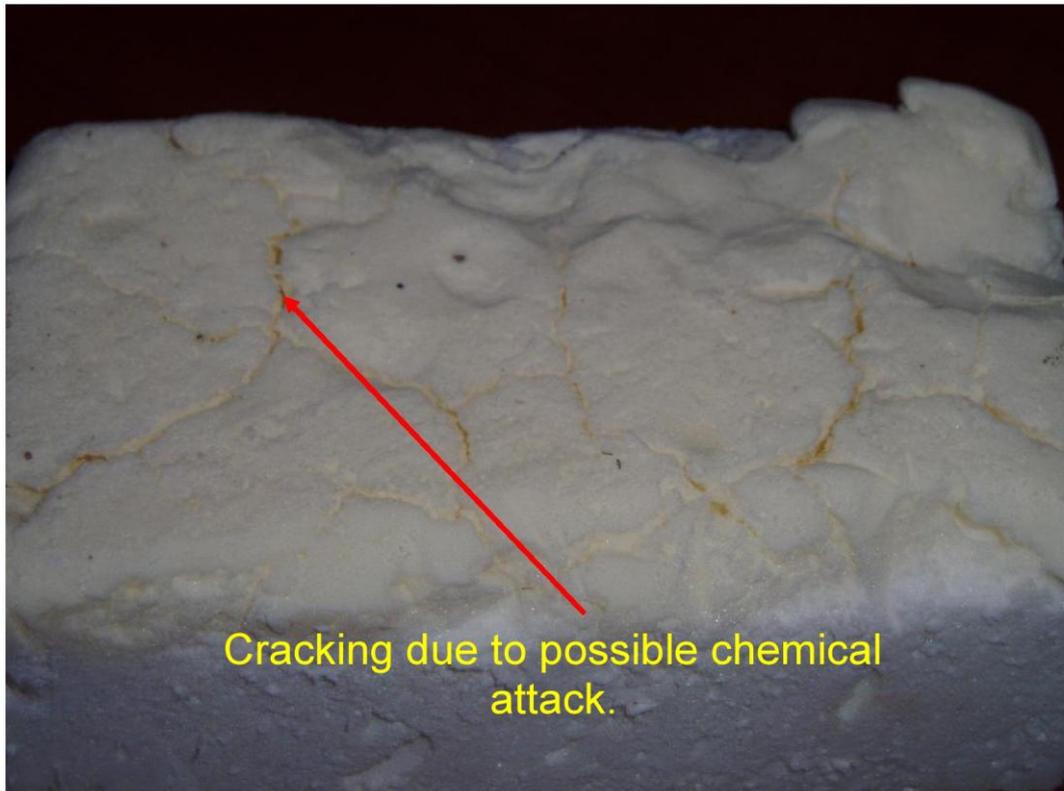
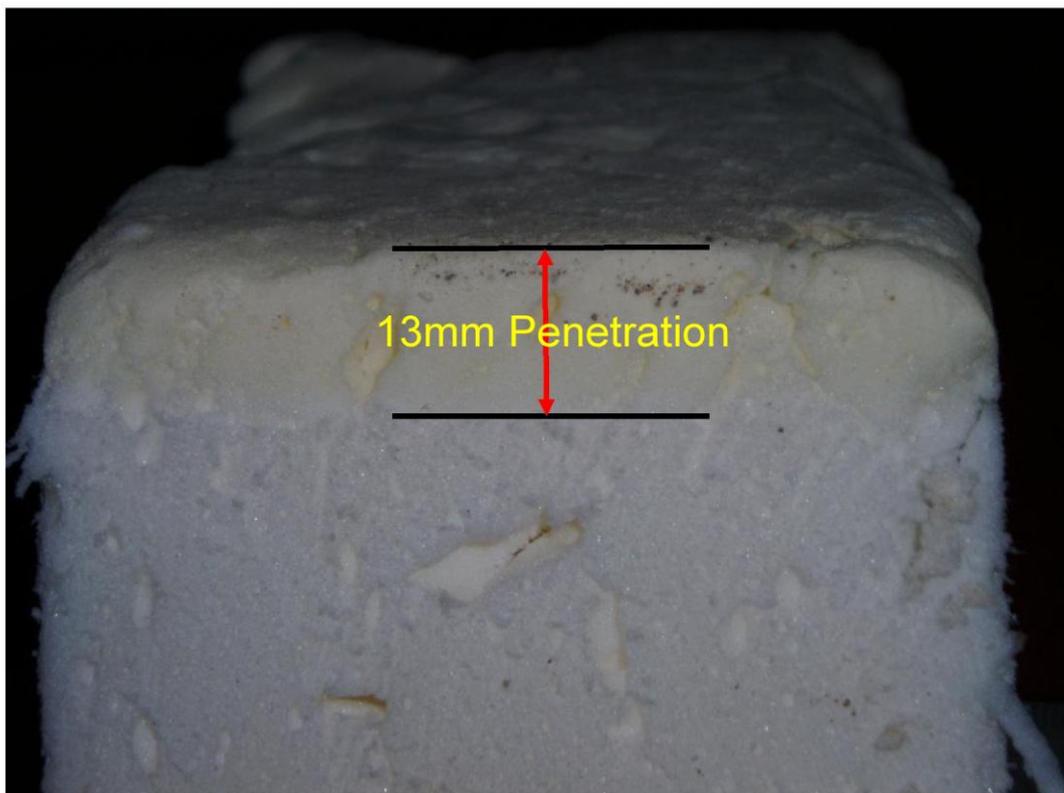
Figure 23. Sample 3 showing signs of chemical damage.

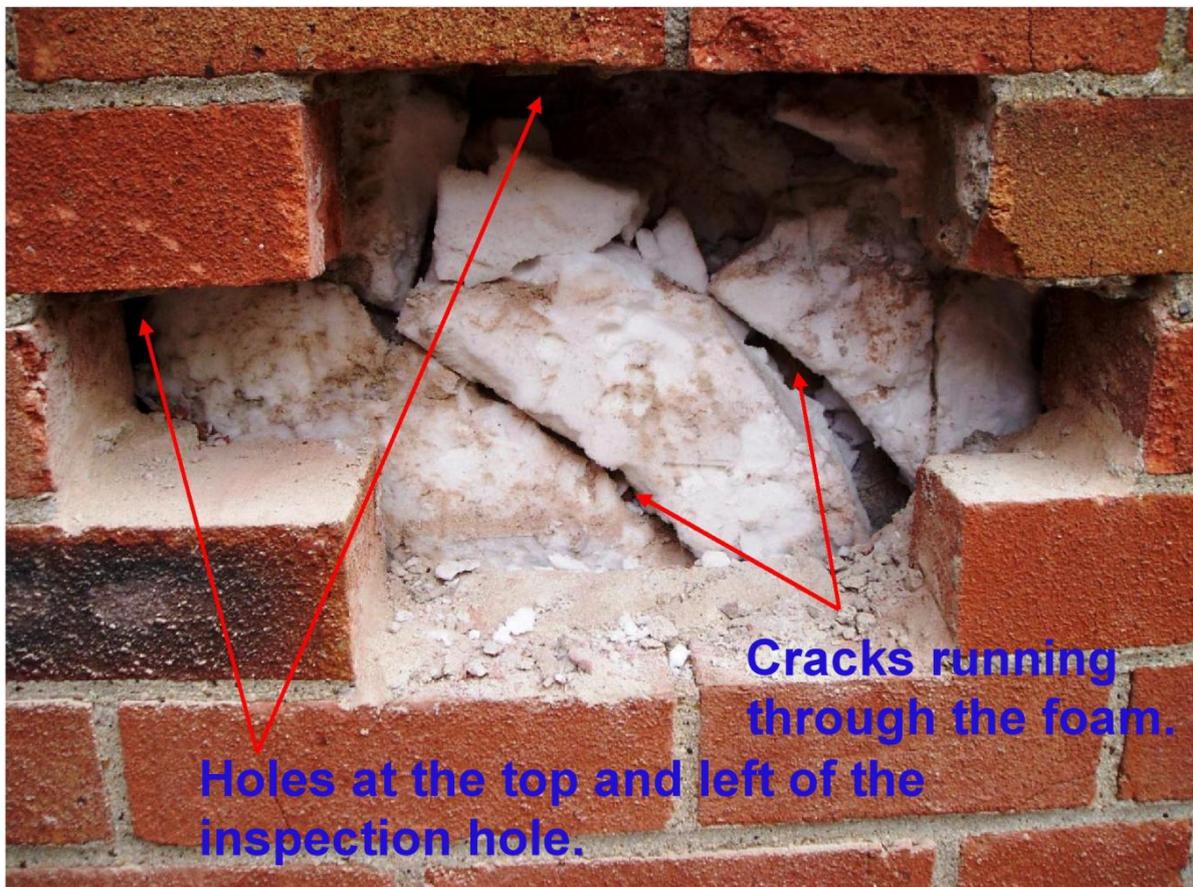
Four bricks were removed from a south facing wall, the UFFI was in a poor condition with cracks running through and around the inspection area, a large piece of the foam had actually broken away and was only held in place by the bricks that were removed (See Figure 24.).

Figure 24. A view of the investigation hole showing cracks in the foam and holes at the top and to the left.

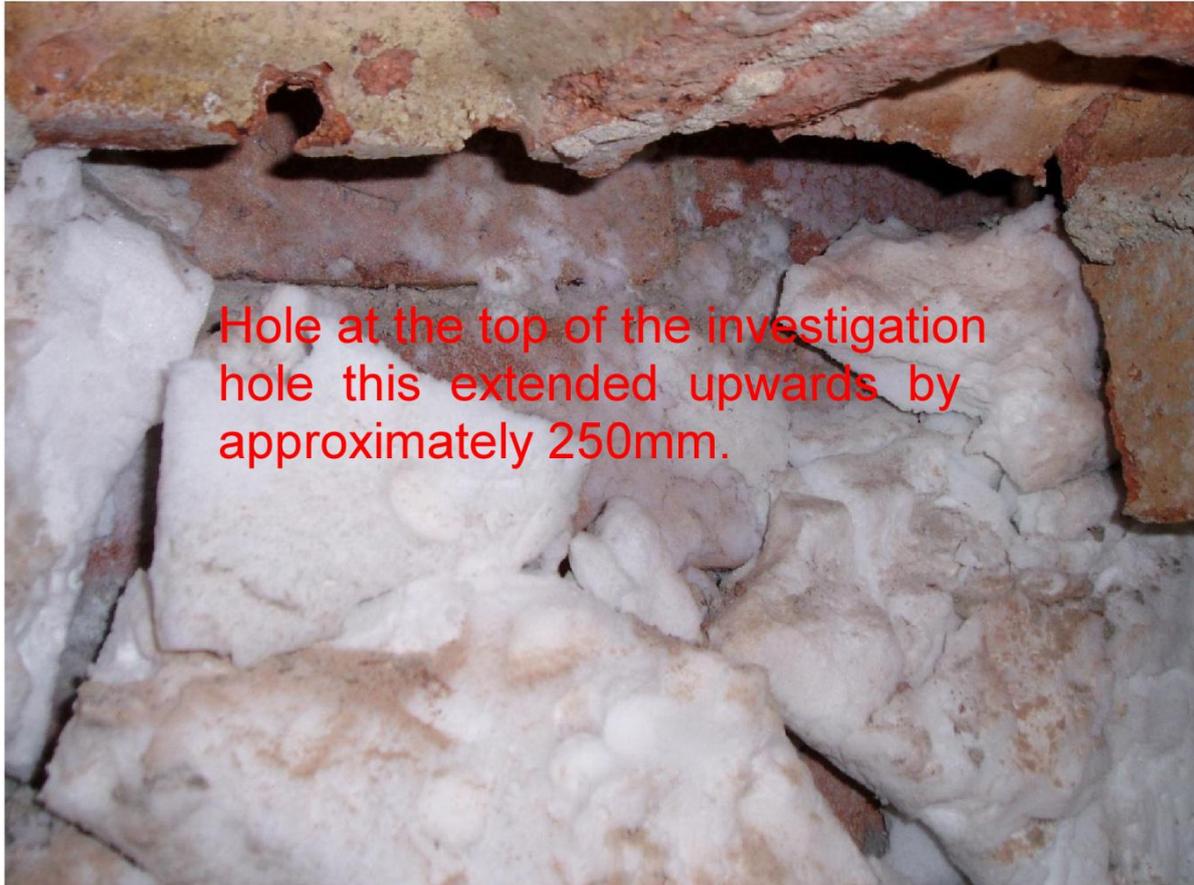
Figure 25. Close up of the hole at the top of the inspection hole, notice the remains of UFFI on the brickwork at the back of the hole.

The hole at the top of the inspection area was measured and was found to extend upwards by at least 250mm before any further UFFI was found.

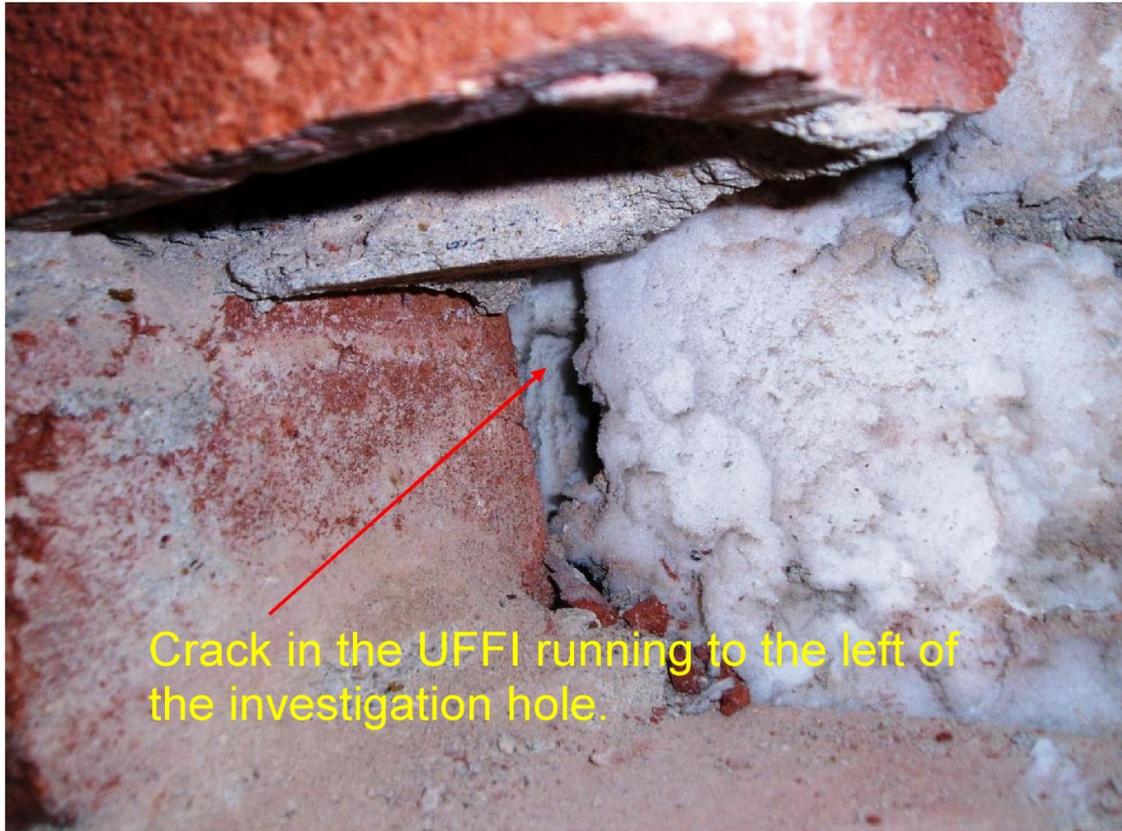
Crack in the UFFI running to the left of the investigation hole.

Figure 26. Evidence of further cracks.

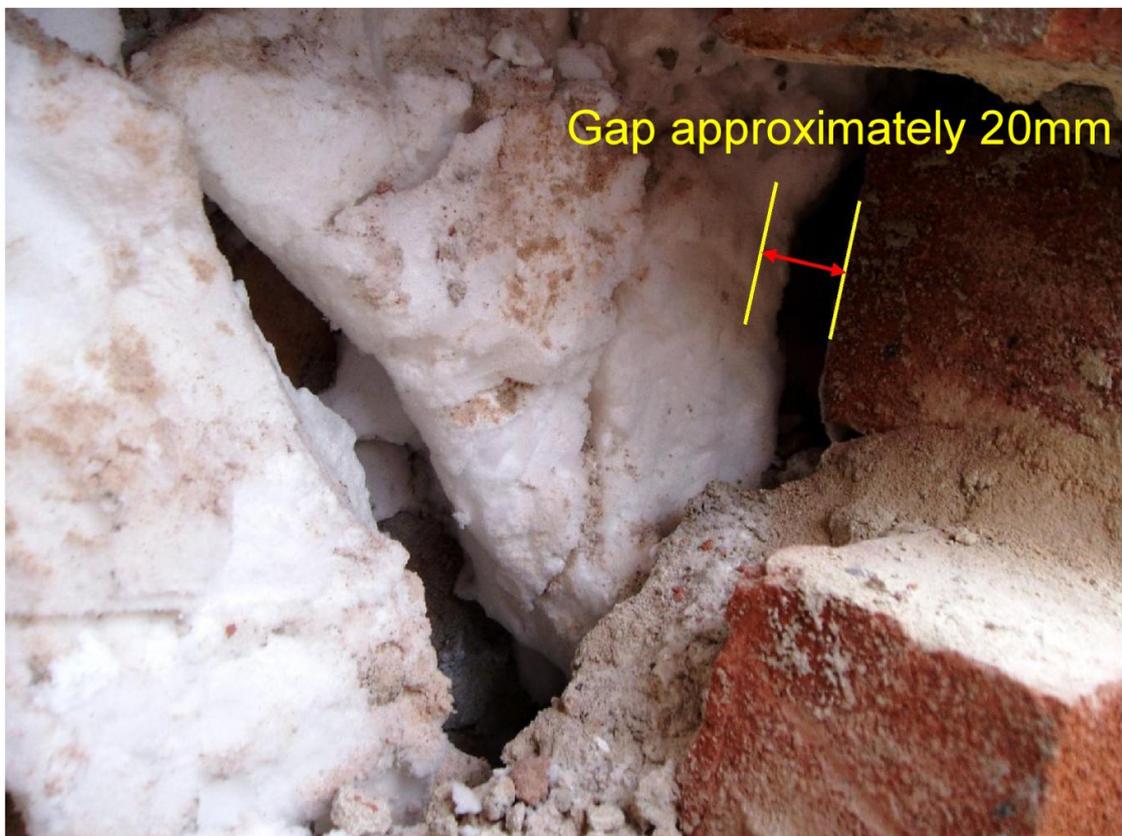
Gap approximately 20mm

Figure 27. Gap indicating a 20mm gap and approximately 30% shrinkage.

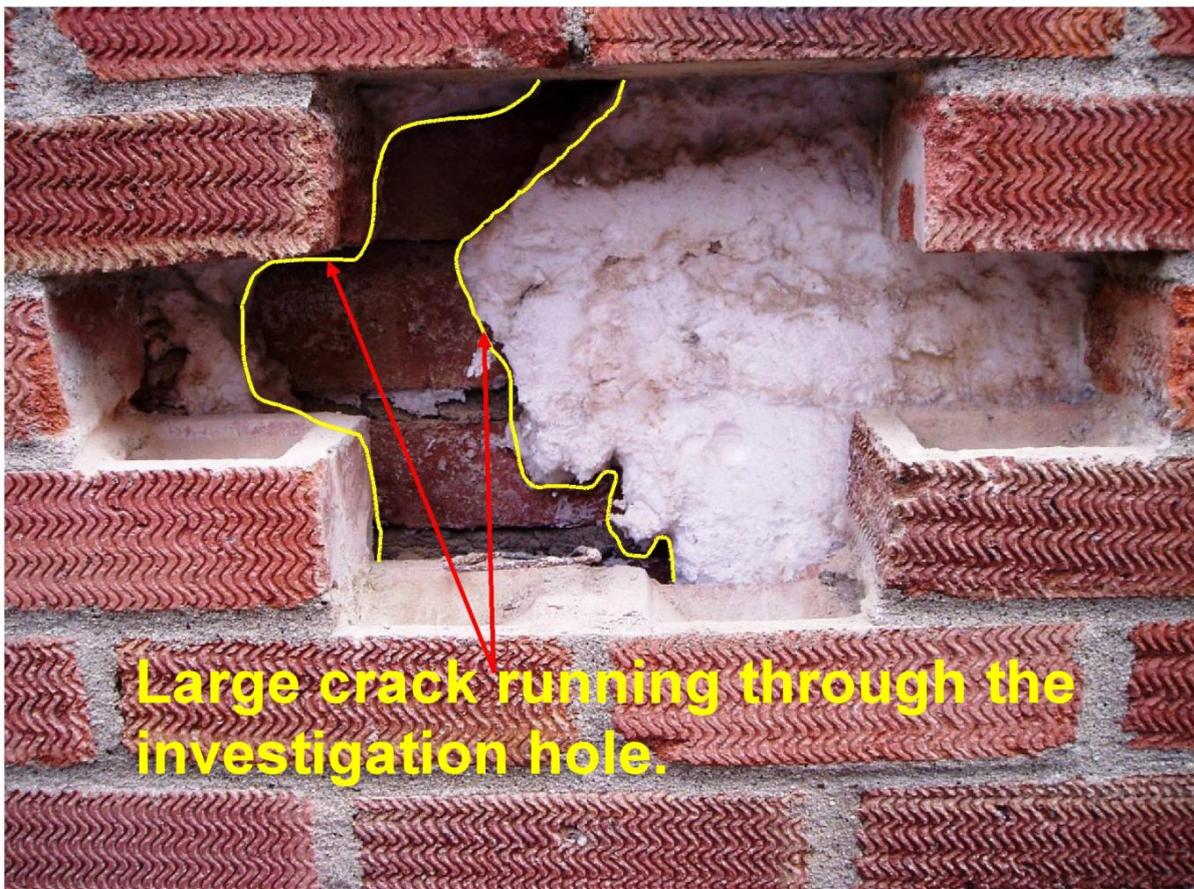
Four bricks were removed from a west facing wall on the side of the property. As can be seen in *Figure 29*, there was a significant crack discovered over 150mm wide in some places, running vertically through the investigation hole. The crack was measured upwards from the hole (See *Figure 30*.) and was found to extend at least 250mm, and downwards (See *Figure 31*.) extending to over 500mm.

Figure 29. View showing the investigation hole and the large crack that was present.

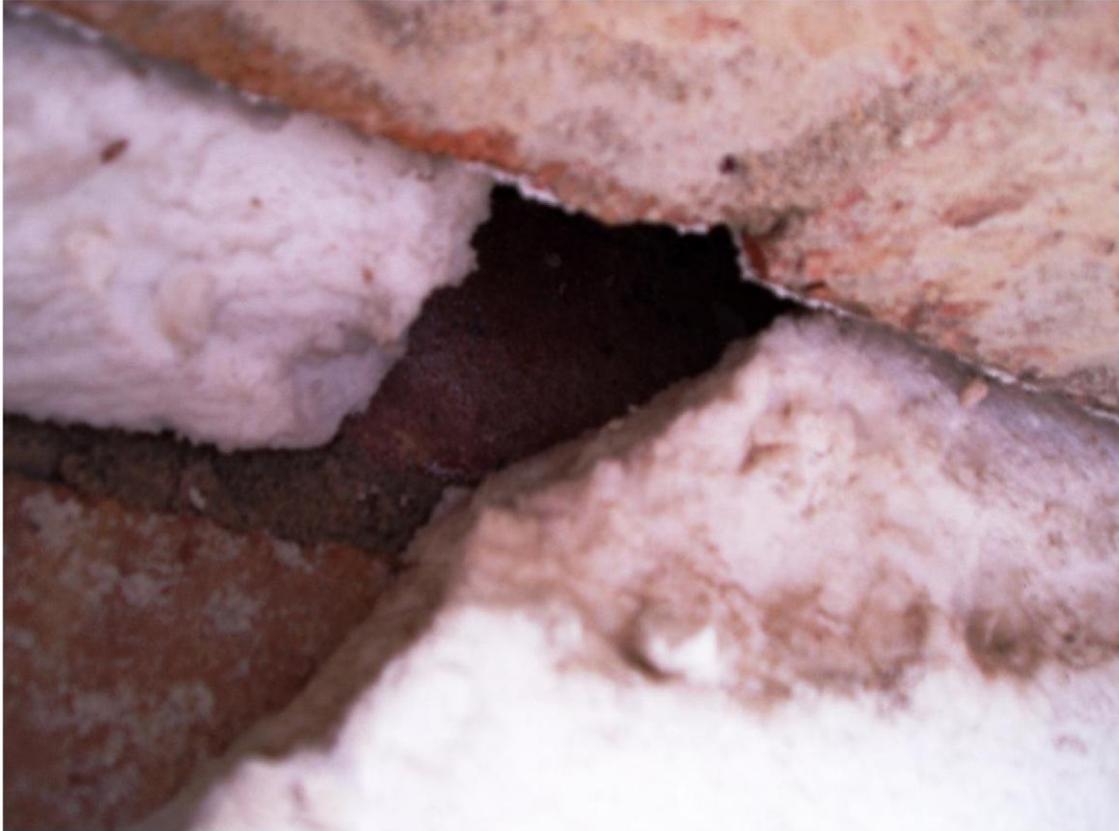
Figure 30. A view of the hole at the top of the investigation hole.
