Urea Formaldehyde cavity wall insulation,
after many years of service is it still
insulating adequately and was it ever fit
for purpose?

Paul Buckingham

MSc Architecture: Advanced Environmental and Energy
Studies.

July 2011

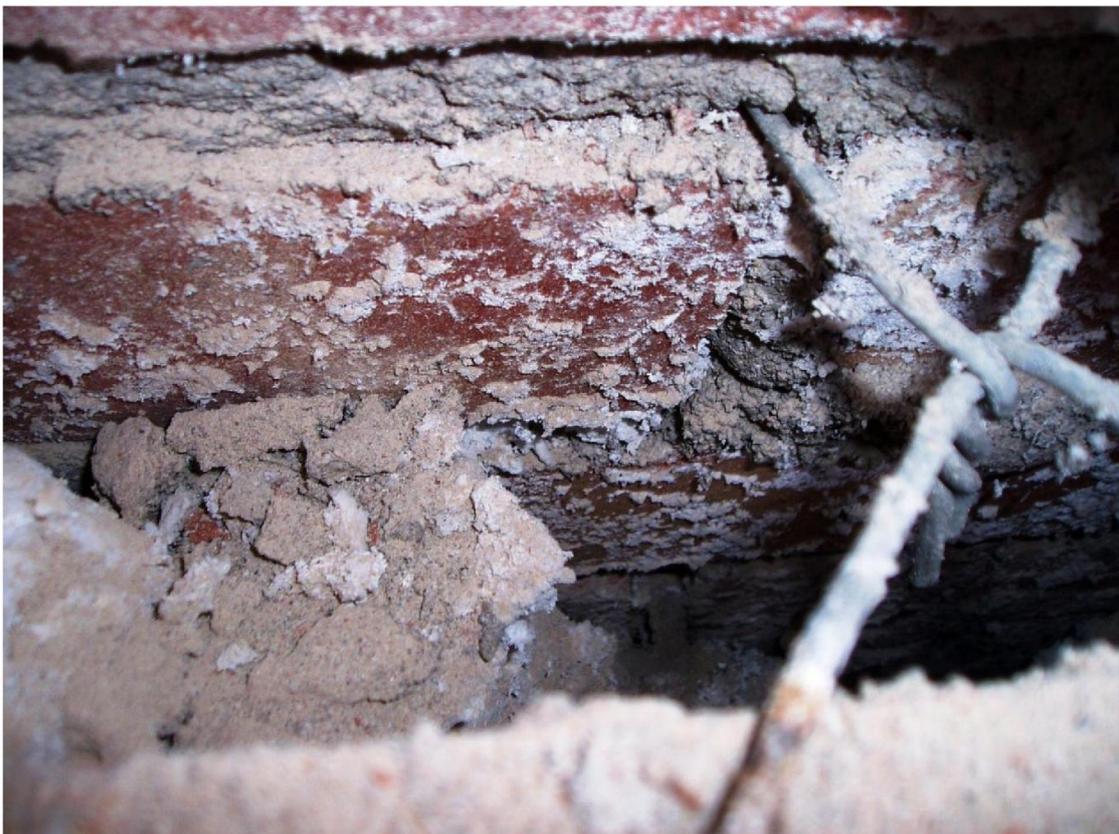
Figure 31. A view down the hole at the bottom of the investigation hole.

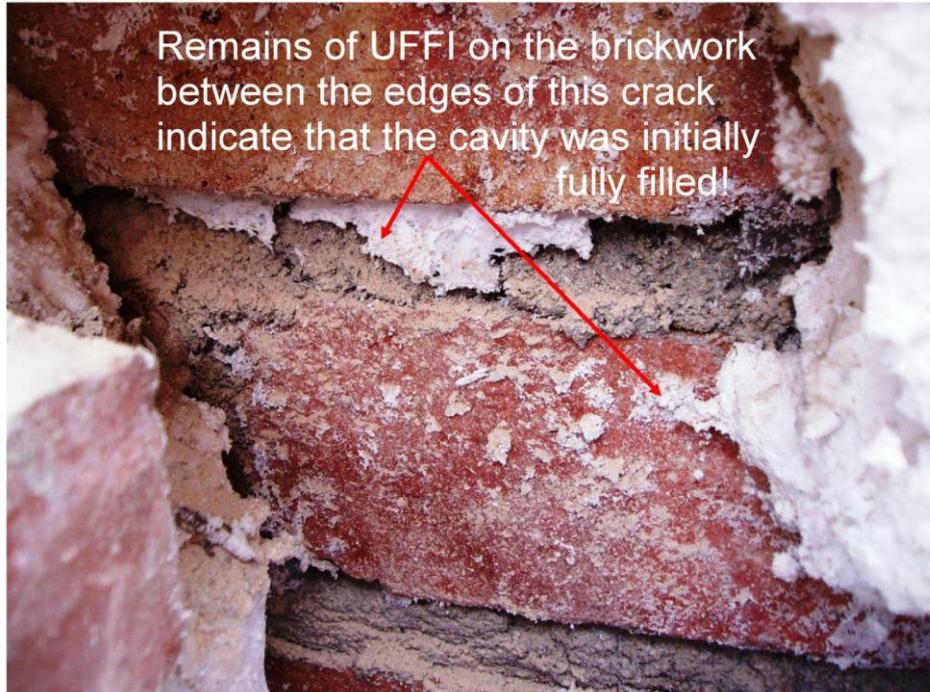
Figure 32. Remnants of UFFI stuck to the brickwork.

Figure 32. shows remnants of UFFI stuck to the brickwork within the crack in the foam which indicates that the cavity was originally fully filled. This crack is likely to have developed due to shrinkage but it is not known how long it took for the crack to form, this may have happened over many years or could have occurred during the first year or two after installation. If cracking occurred during the first few years (within the 20 year guarantee period), which is highly likely, a claim could have been made against the guarantee but as it cannot be seen this was never likely to happen.

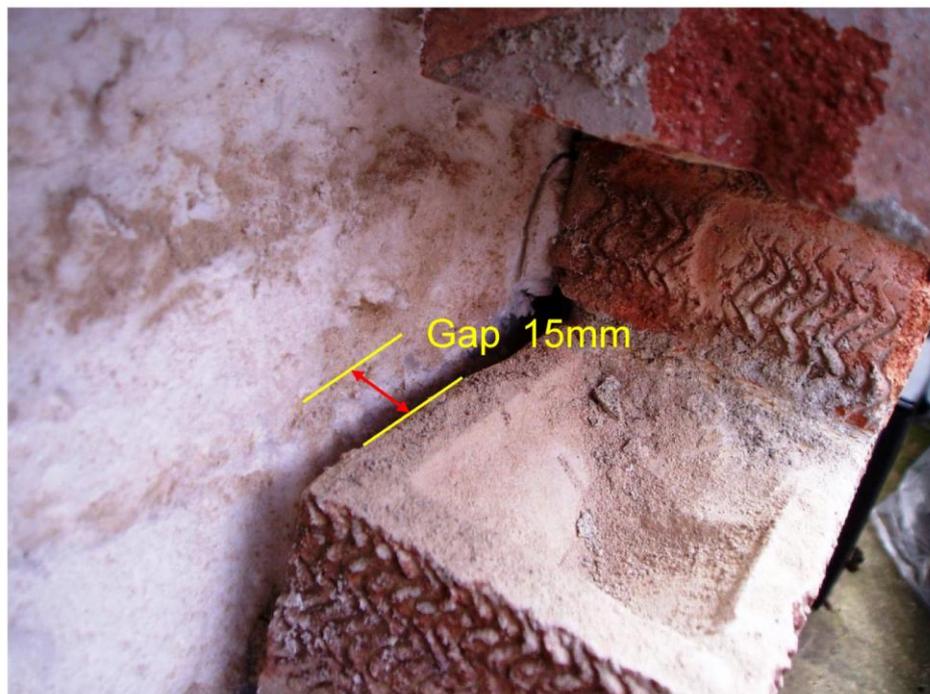
Figure 33. Gap between outer wall leaf and UFFI.

The cavity was approximately 65mm wide, *Figure 33.* shows a gap of approximately 15mm between the foam and the outer wall leaf indicating 23% shrinkage.
