Thermal Imaging Survey

Date 6/3/2016

Inspection Report

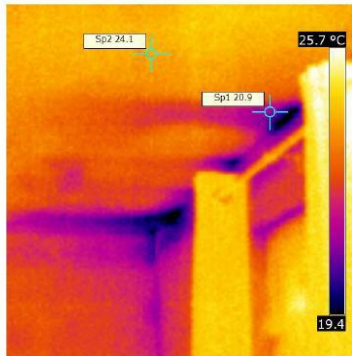
Bedroom 1 external corner adjacent to the ensuit bathroom, air leakage behind the dry lining and air flow above the ceiling.

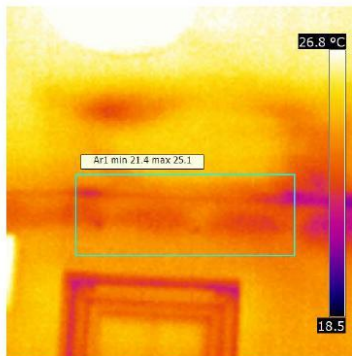
Right hand corner of bedroom 5, significant air leakage behind the dry lining and air flow above the ceiling from the roof eaves.

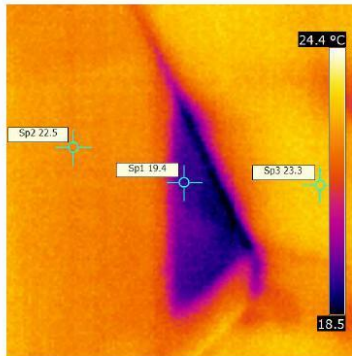
Top floor landing, bottom of the roof light window, there is air leakage behind the plasterboard in the bottom corners of the window aperture.

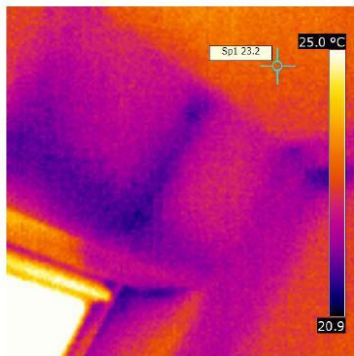
Bedroom 2, again poorly installed and missing insulation.

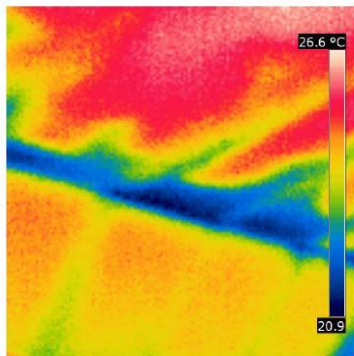
Bedroom 2, poor insulation and air leakage behind dry lining on gable end wall.
