Urea Formaldehyde cavity wall insulation,
after many years of service is it still
insulating adequately and was it ever fit
for purpose?

Paul Buckingham

MSc Architecture: Advanced Environmental and Energy
Studies.

July 2011

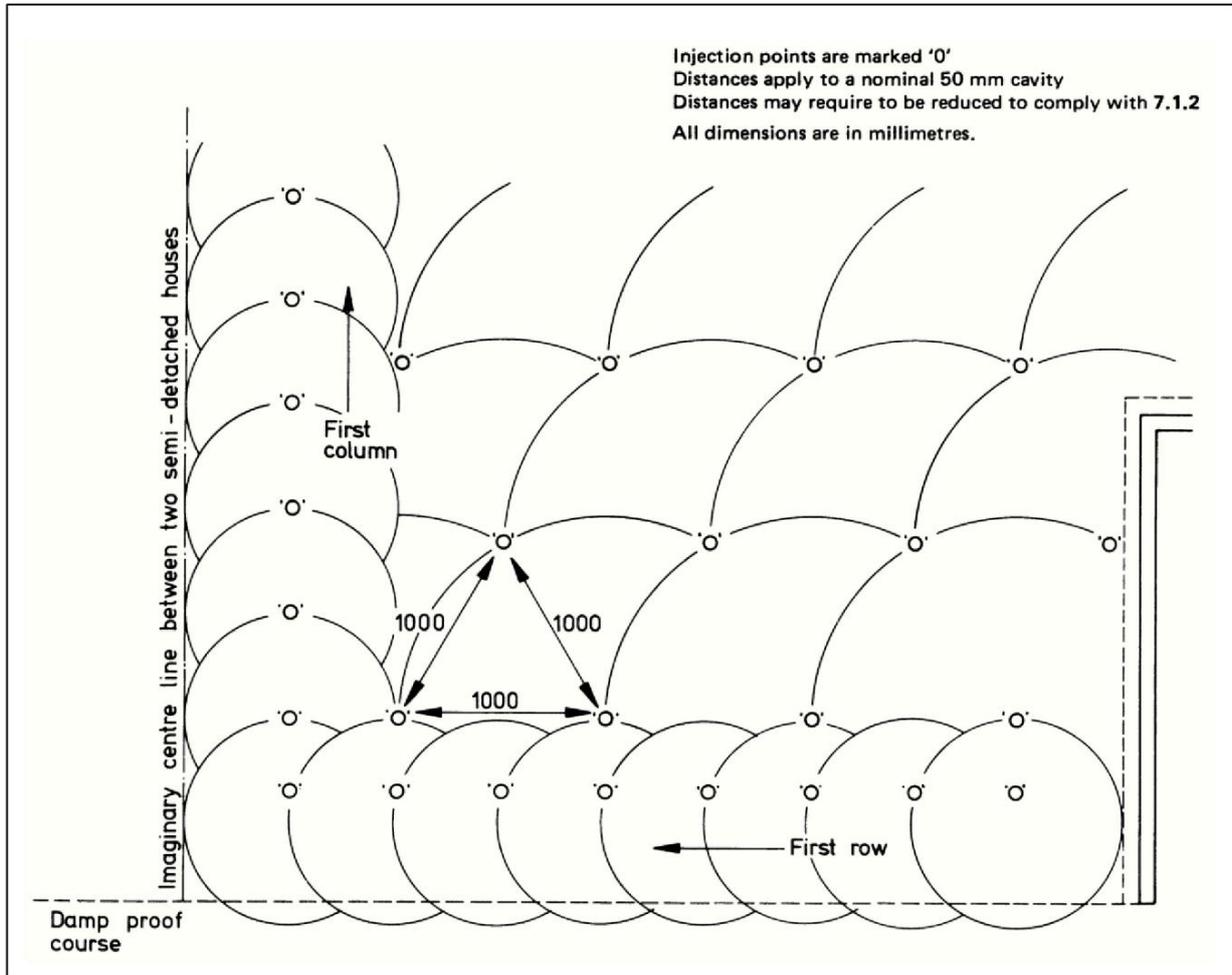
Figure 5. Overall pattern of filling for a nominal 50mm width cavity, BSI² (1999).

A series of holes in a triangular staggered pattern with a spacing of approximately 1m are required to ensure that an even fill is achieved, an example of this is shown in *Figure 5*. The pattern varies when the installation of a semi-detached/ terraced house meets the next property to form a barrier between the two and also along the line of the damp proof course. Around doors and windows there is a requirement to put in additional holes where necessary to ensure a full fill is achieved around these areas.

It is difficult to prove conclusively without removing further bricks but all the evidence suggests that the patches do correspond to where the insulation was likely to have been injected (See *chapter 3.5.2 Figure 5.*), which brings into question the installation and in fact the installer. It appears very likely that insufficient and poor quality insulation was injected into the cavity.

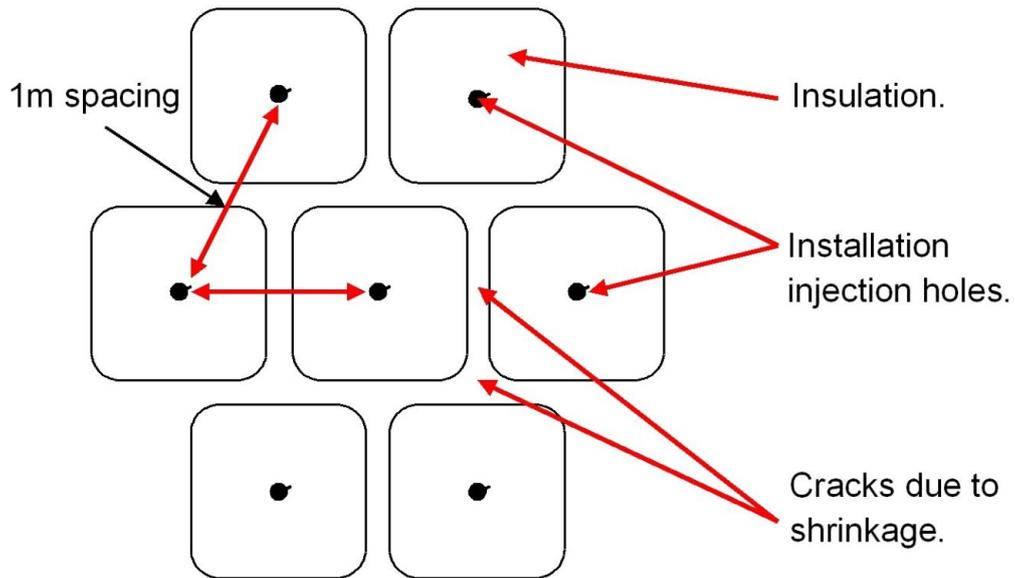
Figure 15. An impression of how the UFFI may appear if fully exposed.

How the UFFI insulation may look if the outer wall leaf was removed.

There was a similar crack in the insulation to that found in **House 2**, as can be seen in *Figure 20*. From the injection holes indicated in *Figure 19*, it would appear that the crack has formed half way between the injection holes which would correspond to where the join in the insulation from the separate injections would be. This is evidence that points to the possible cracking pattern illustrated in *Figure 15*, for **House 2** above.

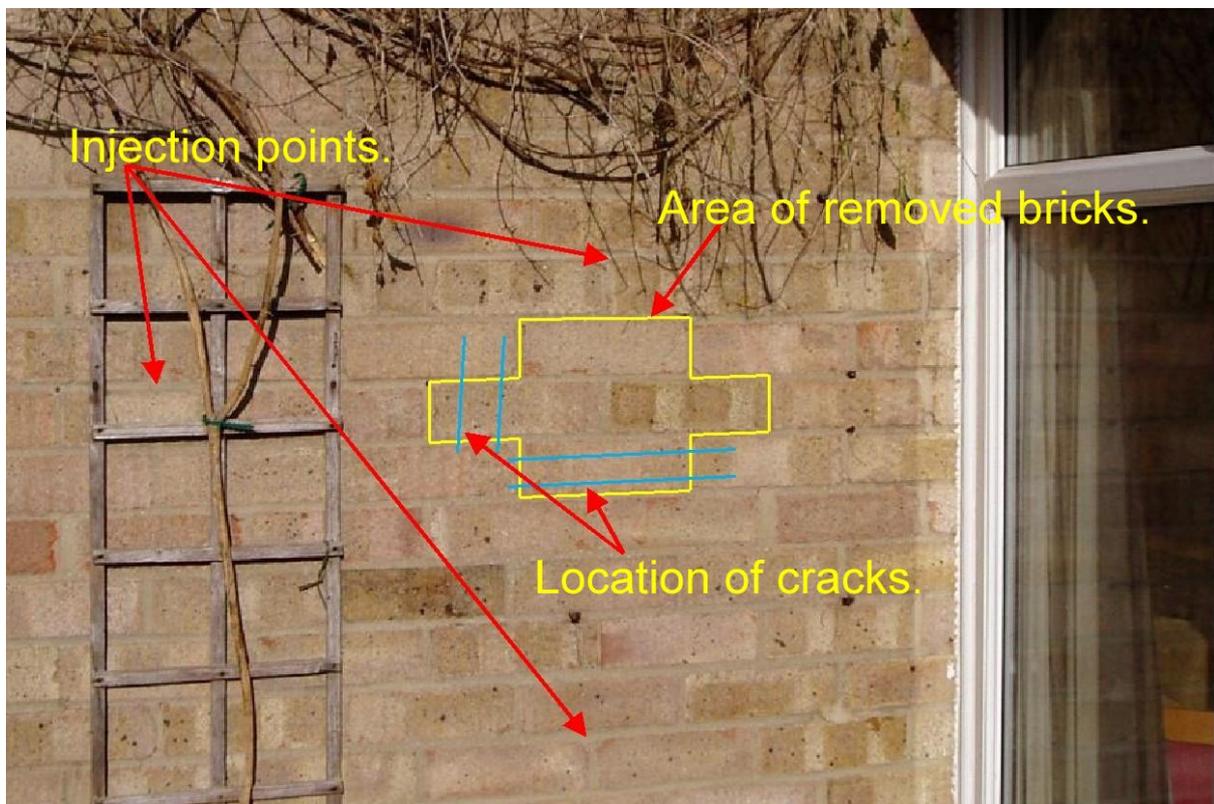
Figure 16. Photograph of House 2 investigation wall.

The assumption from finding these cracks is that the foam has been subjected to shrinkage which has effectively produced patches of foam by pulling the foam apart. It would appear that the cracks have developed at the joint where two injections meet, this is likely to be a weak point in the structure of the foam. *Figure 15.* is an impression of how the foam may appear if the UFFI was fully exposed, the centre of each patch being the point of injection. This would be very difficult to prove conclusively without removing the whole of the outer wall leaf, if this did prove to be the case, it would indicate that the wall was incorrectly filled because the foam pattern would not be as specified in BS 5618:1985 and shown in *Figure 5*, chapter 3.

Figure 16. is a photograph of the wall investigated showing the area where the bricks were removed, the location of the cracks and the position of the injection holes. This provides evidence to support the assumption that the foam may have cracked between the injections.

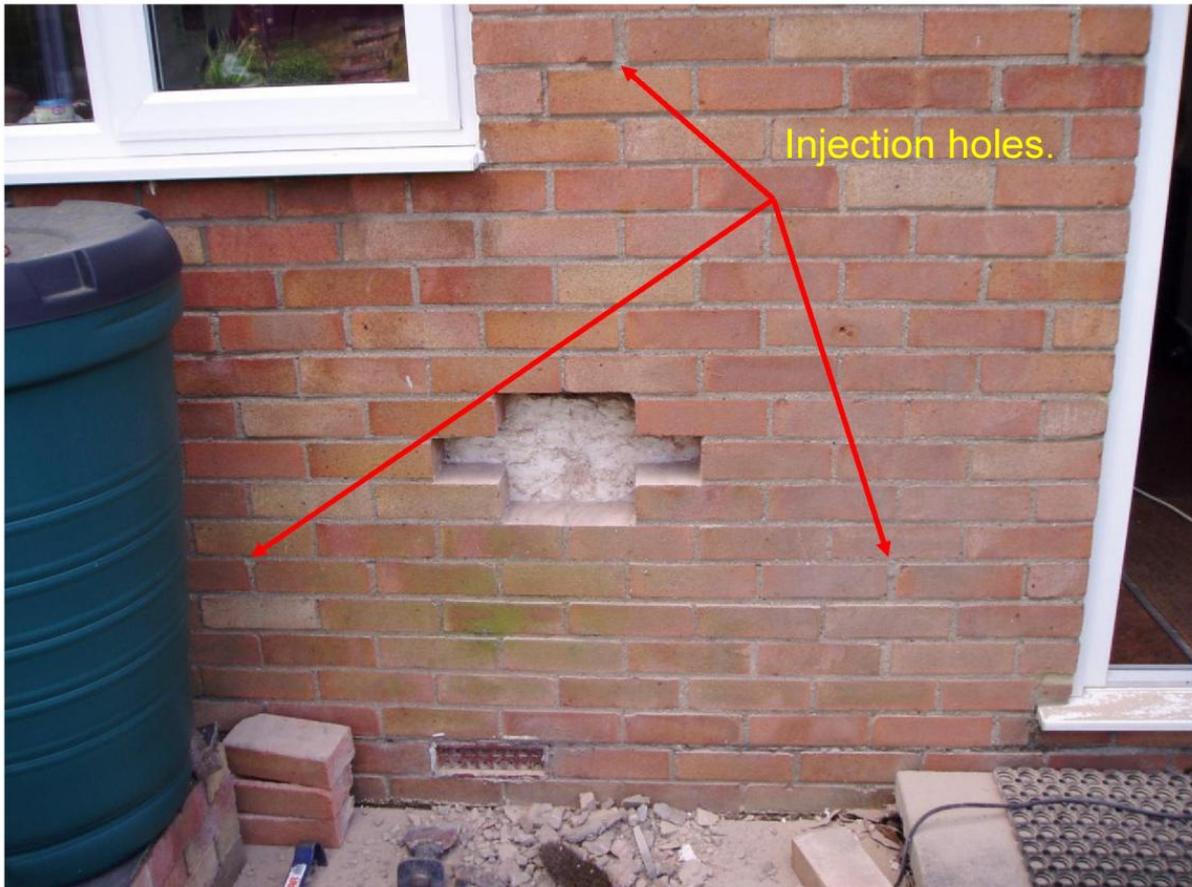
Figure 19. Photograph of House 3 investigation wall.

The third building investigated was built in 1968 by the present owner, it had CWI installed in the early 1970's but no date or further details were available. Four bricks were removed from the north facing wall on the ground floor. *Figure 19.* shows the wall and the original injection holes that were used during the installation.

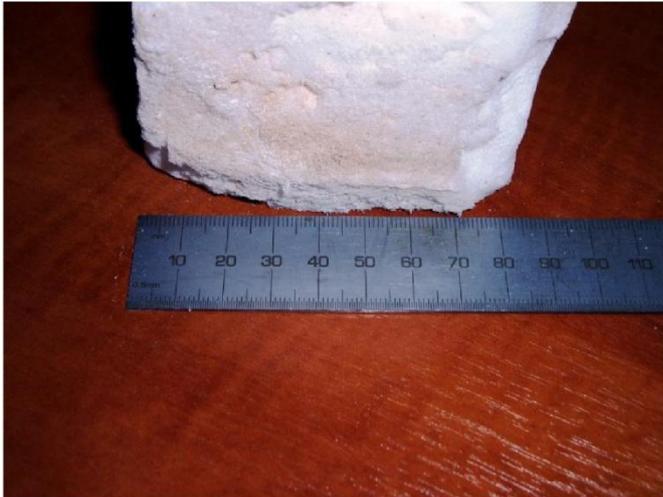
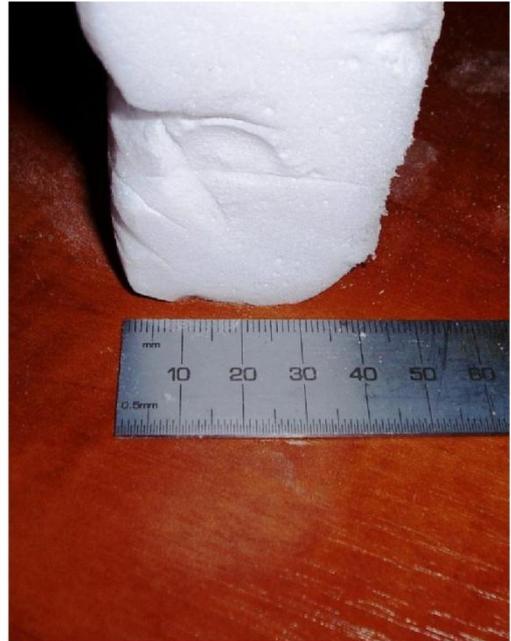
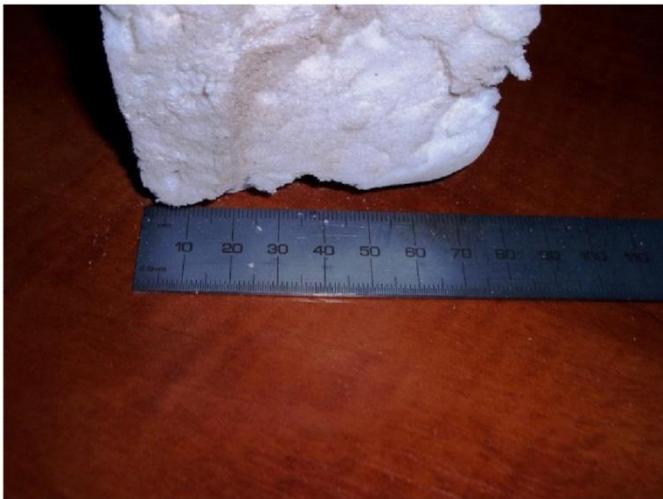
Figure 28. Sample 4.

Sample 4. (See Figure 28.) This was taken from House 4;

Photographs 1, 2 and 3 show the dimensions of sample 4 that were used to calculate the density.

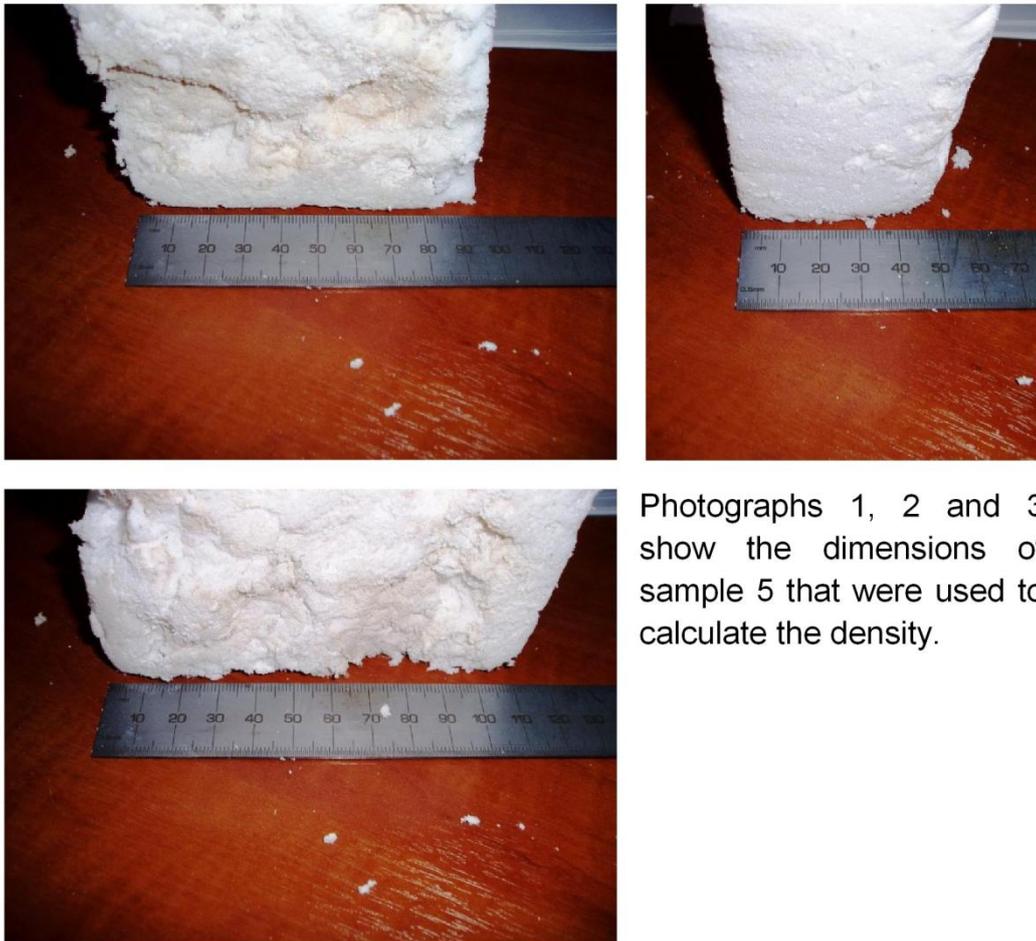
Figure 34. Sample 5.

The sample has a density well within the limits set out in BS 5617:1985.

Photographs 1, 2 and 3 show the dimensions of sample 5 that were used to calculate the density.

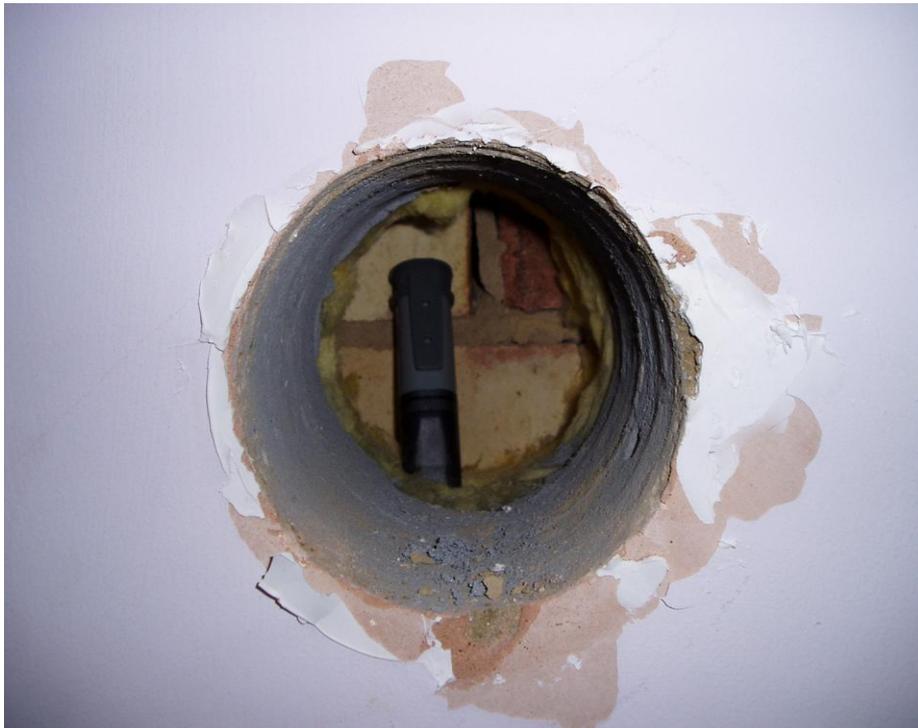
Figure 35. Cavity monitoring.

of -35 to $+80^{\circ}\text{C}$ (accuracy $\pm 0.3^{\circ}\text{C}$) and 0 to 100%RH (accuracy $\pm 2.0\% \text{RH}$) set to take readings at 30 minute intervals, was placed in a west facing wall cavity in the writers home, *Figure 35*. for 16 weeks. The period monitored was 24th February to 16th June 2011.

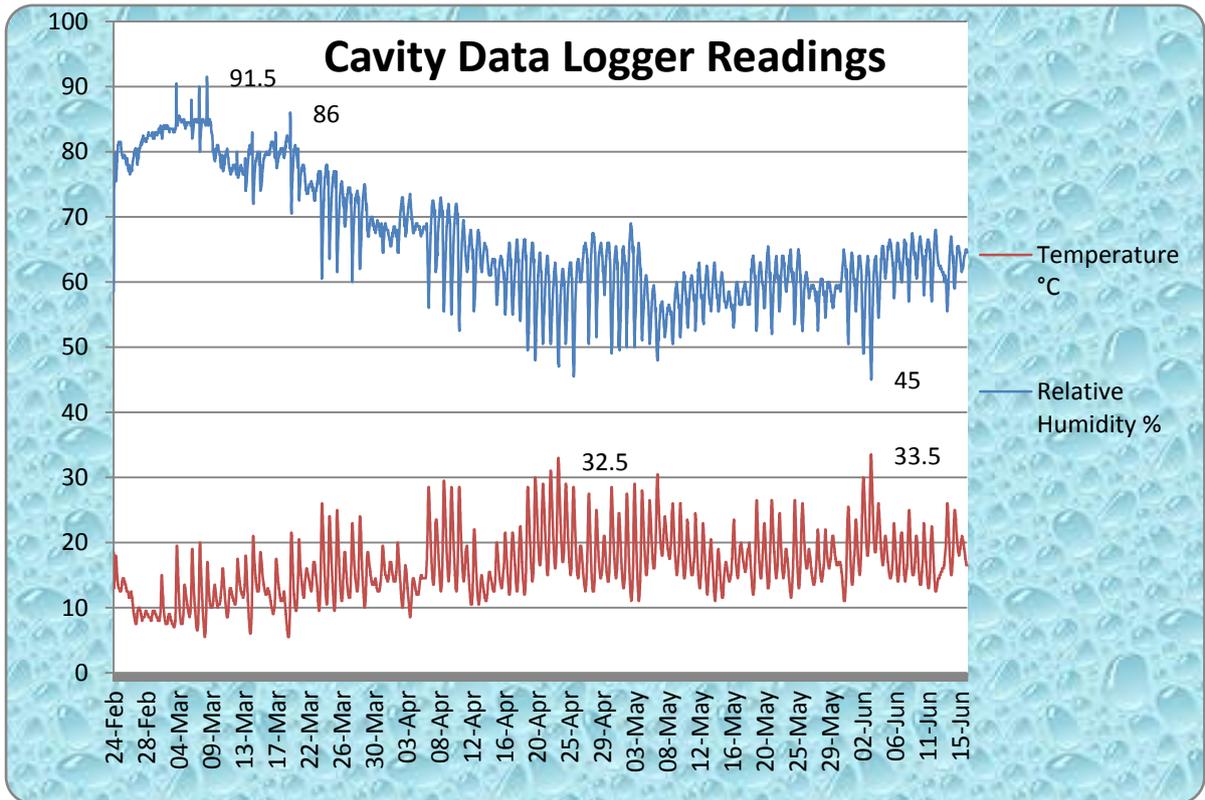
Figure 36. Cavity data graph.

Figure 36. is a graph showing the temperature and RH readings obtained from the data logger, inserted into the cavity of the writers home, covering the period 24th February to 16th June 2011 a total of 16 weeks.

Referring to *Figure 36*. if the cavity temperature can be up to 10°C higher than the external readings this could push the cavity temperature up to almost 50°C at times which is in the high temperature region used during the laboratory testing, (See 4.2.1).
