Thermal imaging report for;

The building is a traditionally built 2 storey detached house built in 2016.

Sustainable Lifestyles Ltd were commissioned to carry out a thermal imaging survey of the property in response to concerns raised by the owner, [client name] with regards to cold areas of the house indicative of defective construction. We undertook thermography and air tightness testing, to identify air paths, location of air leakages and cold areas indicating possible missing, limited or poorly installed insulation and other potential issues such as damp.

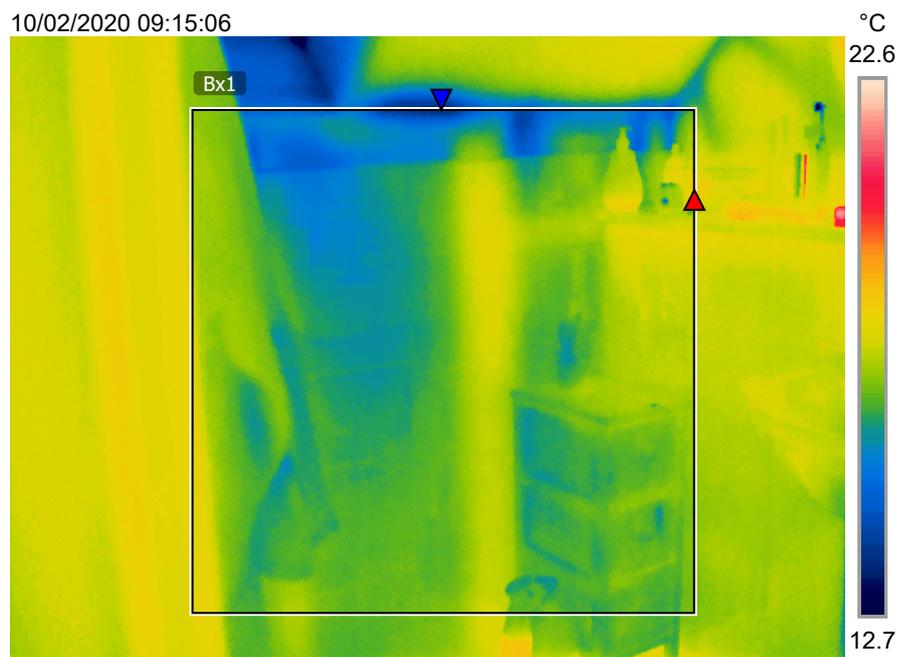
IR_2020-02-10_0209.jpg

Top floor en-suite knee wall showing ineffective insulation.
